# Bicycle-Pedestrian Safety Corridors Study

# **FINAL REPORT**

## **SWRPA BICYCLE - PEDESTRIAN SAFETY CORRIDORS STUDY**

**June, 2012**

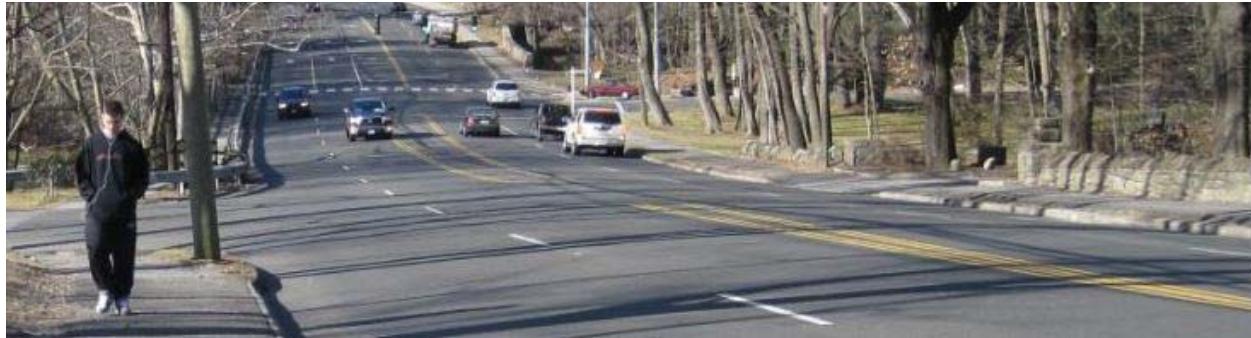
High design speeds in areas with high levels of pedestrian activity (Greenwich US 1 corridor)

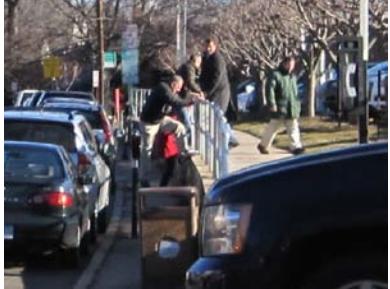
Pedestrians climbing railings in front of Whole Foods Market

A walk audit, conducted in January, 2012 revealed risky and illegal behavior by pedestrians and cyclists, suggesting inadequate accommodations for non-vehicular travel. Pedestrians were observed crossing US 1 at the signalized intersections, although most did not wait for the pedestrian signal phase. Many pedestrians were also observed crossing at more convenient, unmarked mid-block locations. This was especially evident in front of the Whole Foods Market where pedestrians were seen crossing US 1 directly in front of the store, rather than using the existing crosswalks at Church Street or Maher Avenue, which are 820 feet apart. Once on the sidewalk, the pedestrians then climbed over a railing in order to take a direct route to the store entrance.

- Further investigate pedestrian volumes and behaviors in front of Whole Foods Market including how site access and layout for Whole Foods are contributing to unsafe conditions. Consider options to encourage pedestrians to use existing crosswalks, add other treatments to facilitate safer crossing, or possibly install a crosswalk mid-block or at the Sherwood Place intersection.

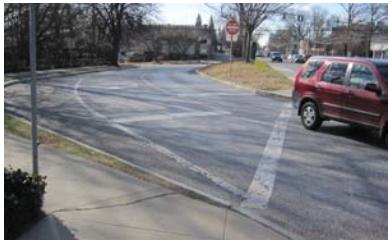
Milbank Avenue right-turn (slip) lanes

The Milbank Avenue intersection is particularly dangerous for pedestrians. The angle of the slip lanes and the 45-foot turning radius allow for potentially high vehicular speeds. Drivers may be preoccupied with looking left to find a safe gap in traffic, and may not see pedestrians trying to cross from the right. During the walk audit, an elderly pedestrian was observed navigating the Milbank Avenue side street intersection with great difficulty, taking a very indirect route to avoid crossing the slip lanes.

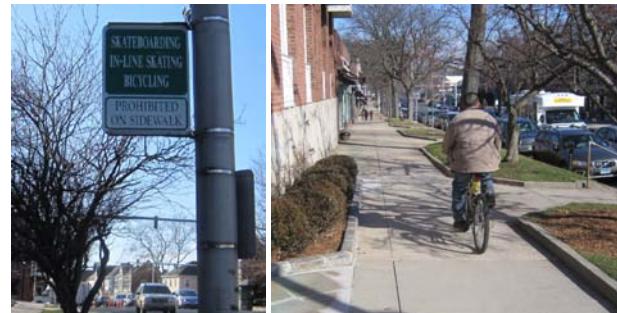
The *Town of Greenwich Bicycle Master Plan* currently identifies the entire length of US 1 through the town as not meeting recommended guidelines for any type of bicycle facility and having considerable constraints to widening. There is no on-street bicycle infrastructure along this section, where current street markings suggest only vehicles have a right to be in the travel lane. Despite posted signs forbidding it, the two observed cyclists in this section were riding on the sidewalk.

Bicycling Prohibited Sign Cyclist riding on sidewalk

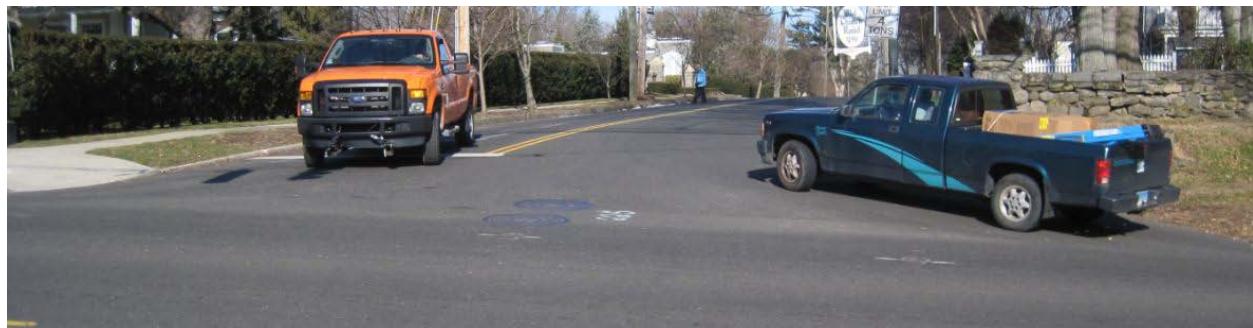
Unmarked crosswalk over Old Church Road side street

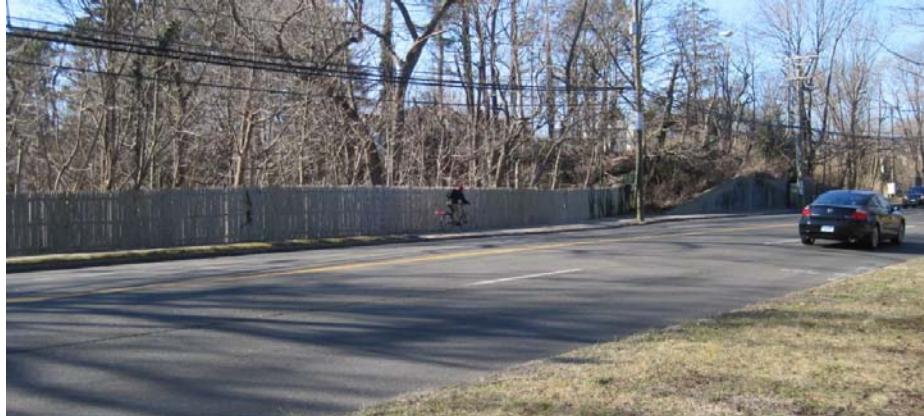
Cyclist riding on the sidewalk

Cyclist behavior observed during the walk audit showed the preference of cyclists to be separated and protected from traffic, choosing to cross the street and use the protected pedestrian sidewalk. However, the current sidewalk does not have sufficient width to be used safely as a shared bike and pedestrian side path.

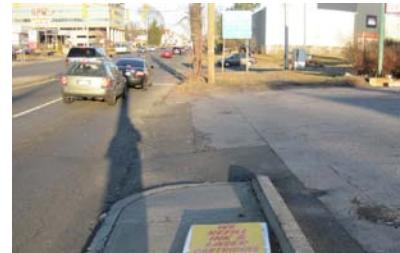
Incomplete sidewalk network at northern end of corridor

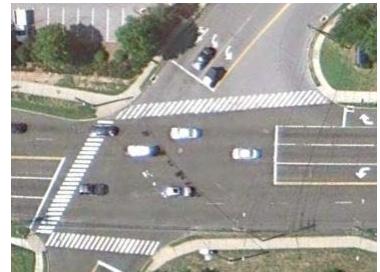
125-foot pedestrian crossing over Keeler Avenue

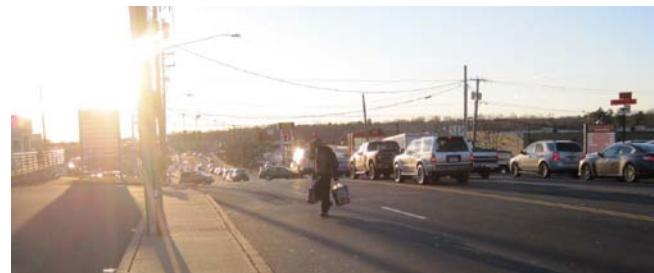
Pedestrian crossing at unmarked location

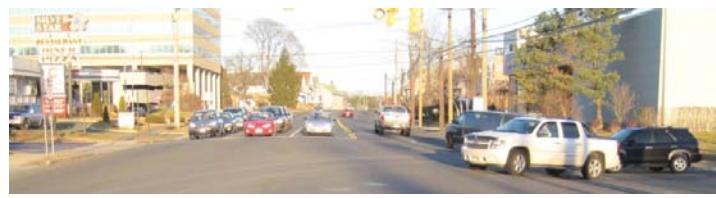
Intimidating environment for cyclists

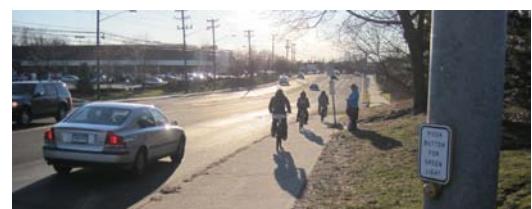
Cyclists using pedestrian infrastructure

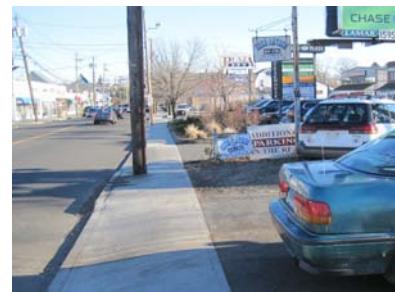
Low pedestrian comfort near Plymouth Avenue

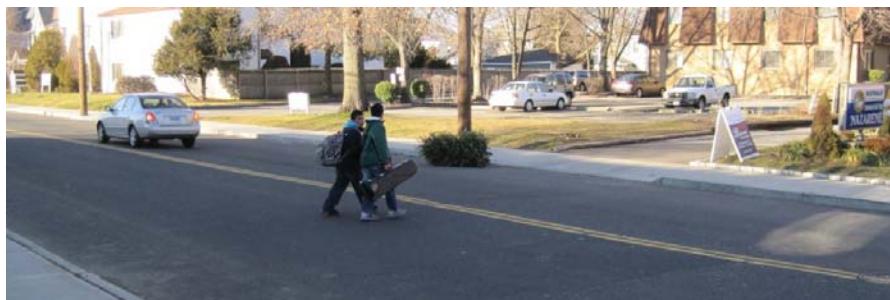
Pedestrians crossing near Holmes Street intersection

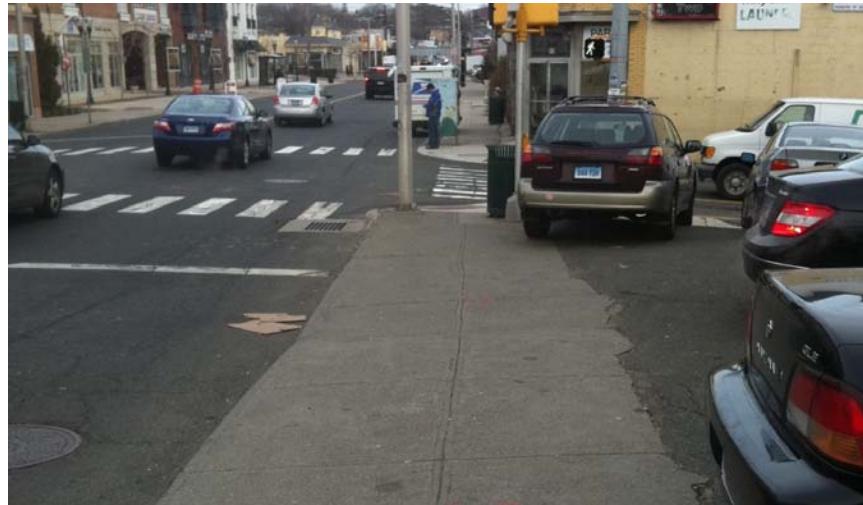
Vehicles are able to cross the sidewalk at many locations along the northern section

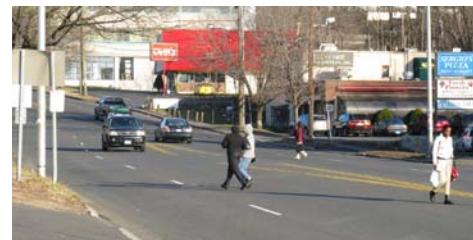
Jaywalking between Lockwood Avenue/Sherman Street and Lawn Avenue

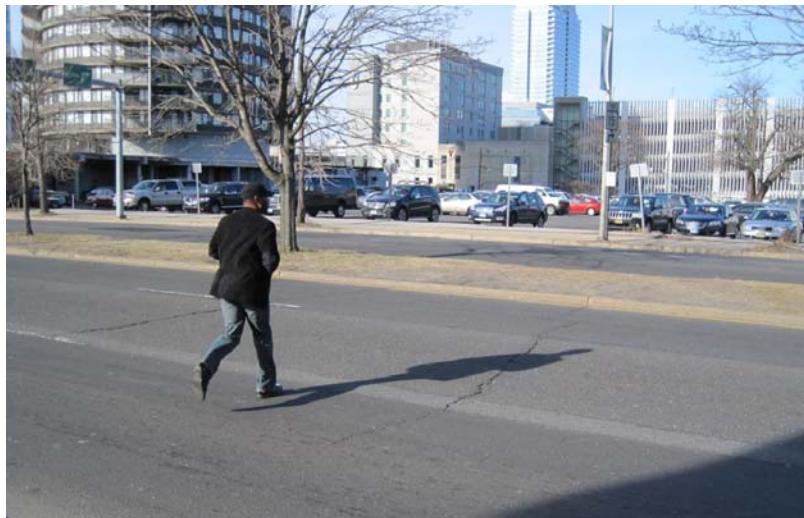
Pedestrian crossing at unmarked mid-block location between Washington Boulevard and Atlantic Street

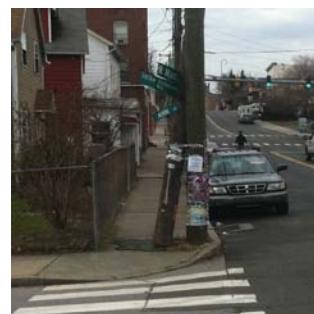
Narrow effective sidewalk width

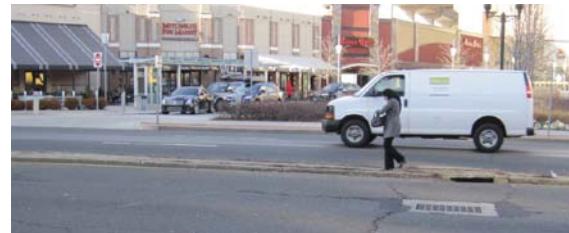
Pedestrian crossing at mid-block location

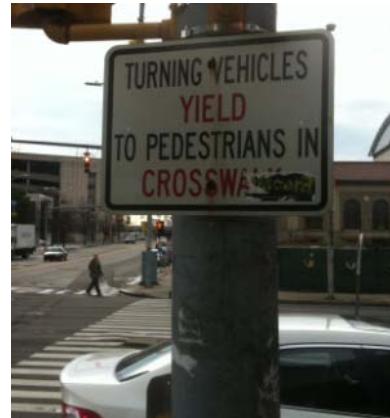
Shared turning and Pedestrian phase at crosswalks over Tresser Boulevard

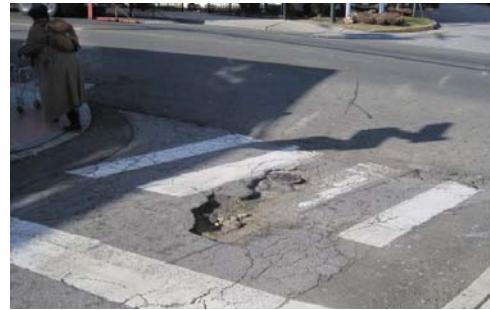
Poor crosswalk condition over Rose Park Avenue

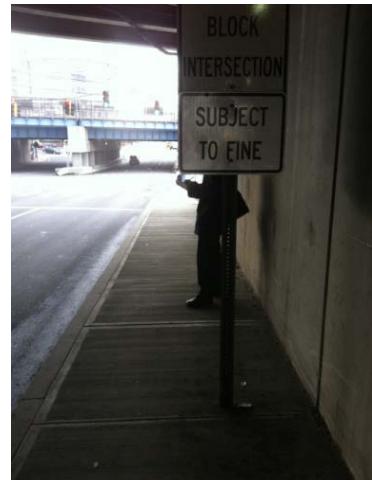
Narrow effective sidewalk width under rail bridge

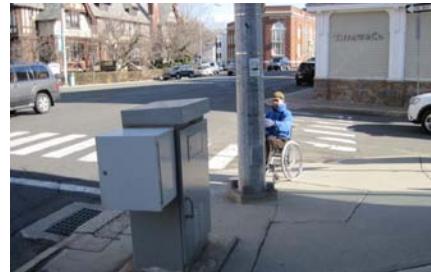
Poor visibility at crosswalk waiting area

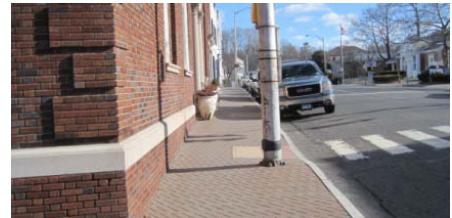
Parked vehicle obscuring pedestrian-driver visibility where parking is allowed up to crosswalk

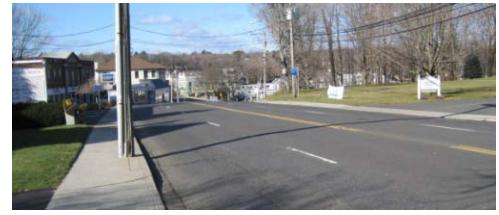
Unprotected concrete sidewalk

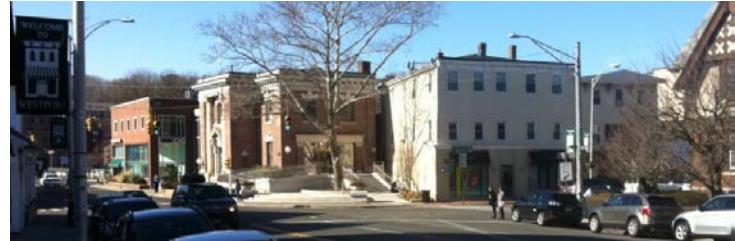
Pedestrians crossing at former crosswalk location at Main Street intersection, where visibility is currently obscured by parked vehicles.

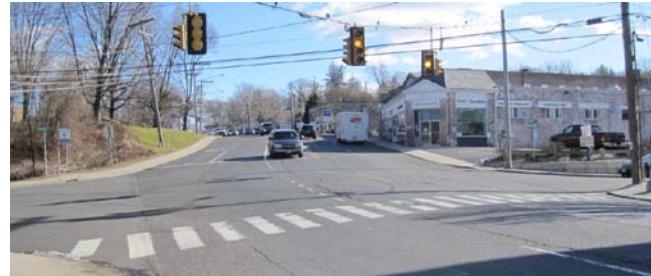
Sixty foot crosswalk over US 1 at Myrtle Avenue/Imperial Avenue intersection, side street crosswalks not marked

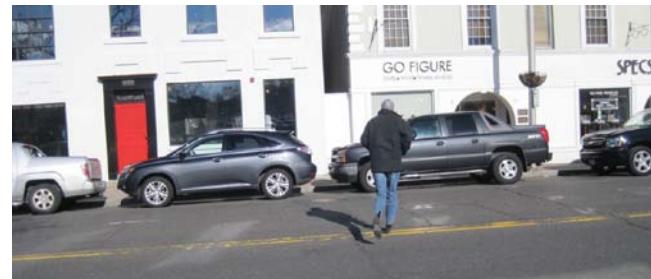
Pedestrian crossing at unmarked location downtown

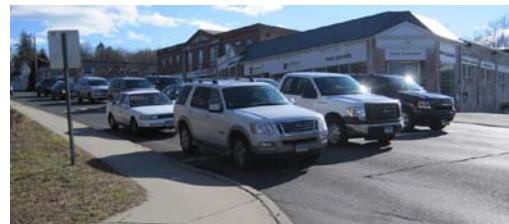
Intimidating environment for cyclists

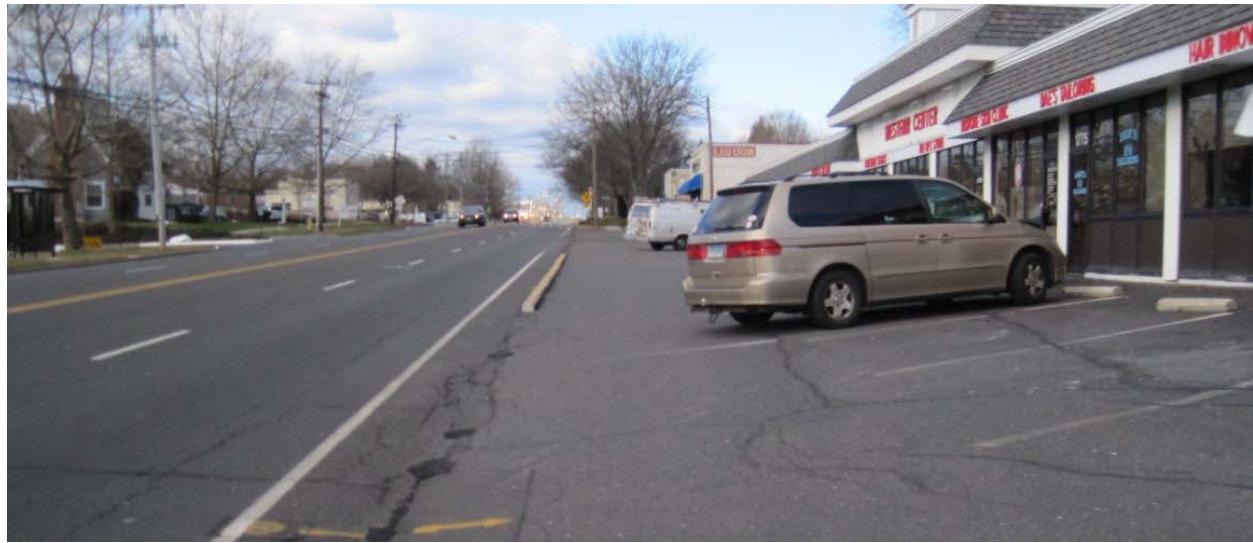
Strip development with continuous access and angle parking

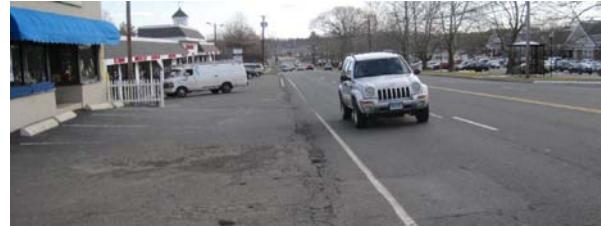
Parking areas adjacent to travel lanes

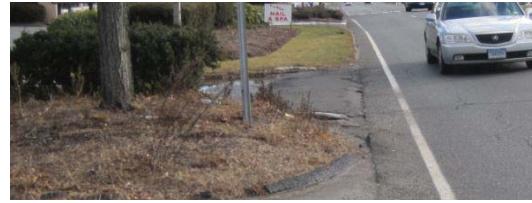
Curb and landscaping forcing pedestrians into travelled way
