# Bicycle-Pedestrian Safety Corridors Study

# FINAL REPORT

## SWRPA BICYCLE - PEDESTRIAN SAFETY CORRIDORS STUDY

June, 2012

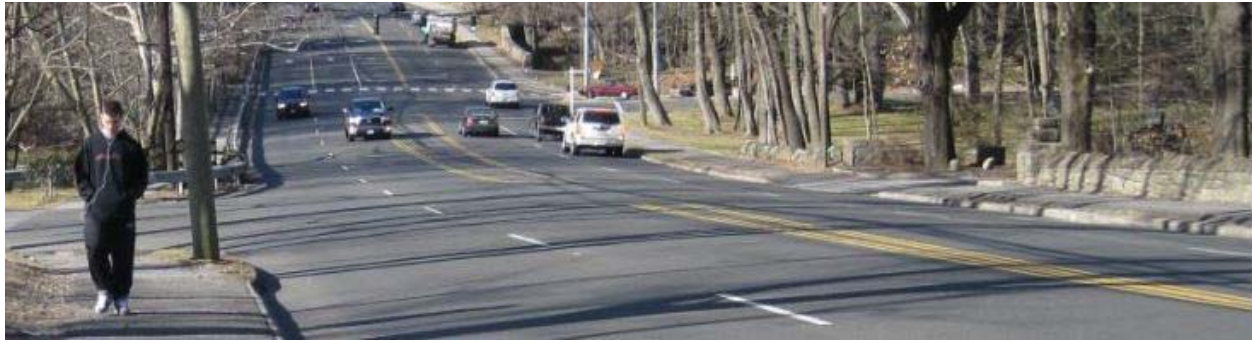
High design speeds in areas with high levels of pedestrian activity (Greenwich US 1 corridor)

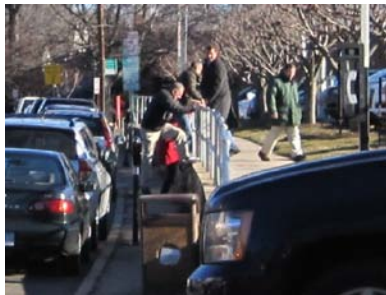
Pedestrians climbing railings in front of Whole Foods Market

A walk audit, conducted in January, 2012 revealed risky and illegal behavior by pedestrians and cyclists, suggesting inadequate accommodations for non-vehicular travel. Pedestrians were observed crossing US 1 at the signalized intersections, although most did not wait for the pedestrian signal phase. Many pedestrians were also observed crossing at more convenient, unmarked mid-block locations. This was especially evident in front of the Whole Foods Market where pedestrians were seen crossing US 1 directly in front of the store, rather than using the existing crosswalks at Church Street or Maher Avenue, which are 820 feet apart. Once on the sidewalk, the pedestrians then climbed over a railing in order to take a direct route to the store entrance.

- Further investigate pedestrian volumes and behaviors in front of Whole Foods Market including how site access and layout for Whole Foods are contributing to unsafe conditions. Consider options to encourage pedestrians to use existing crosswalks, add other treatments to facilitate safer crossing, or possibly install a crosswalk mid-block or at the Sherwood Place intersection.

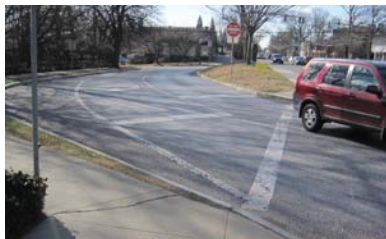
Milbank Avenue right-turn (slip) lanes

The Milbank Avenue intersection is particularly dangerous for pedestrians. The angle of the slip lanes and the 45-foot turning radius allow for potentially high vehicular speeds. Drivers may be preoccupied with looking left to find a safe gap in traffic, and may not see pedestrians trying to cross from the right. During the walk audit, an elderly pedestrian was observed navigating the Milbank Avenue side street intersection with great difficulty, taking a very indirect route to avoid crossing the slip lanes.

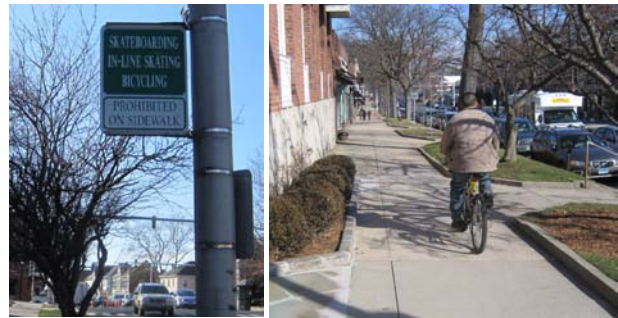
Bicycling Prohibited Sign Cyclist riding on sidewalk

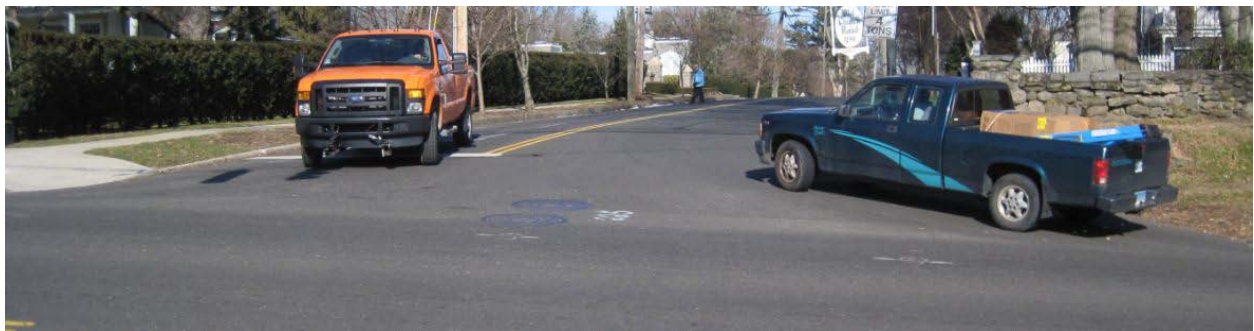
Unmarked crosswalk over Old Church Road side street

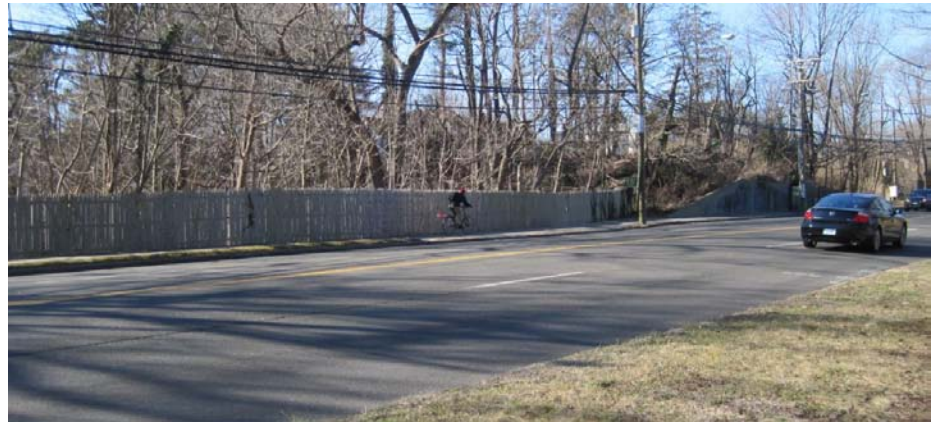
Cyclist riding on the sidewalk

Cyclist behavior observed during the walk audit showed the preference of cyclists to be separated and protected from traffic, choosing to cross the street and use the protected pedestrian sidewalk. However, the current sidewalk does not have sufficient width to be used safely as a shared bike and pedestrian side path.

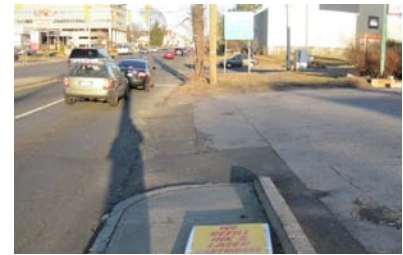
Incomplete sidewalk network at northern end of corridor

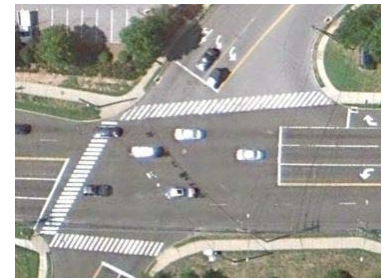
125-foot pedestrian crossing over Keeler Avenue

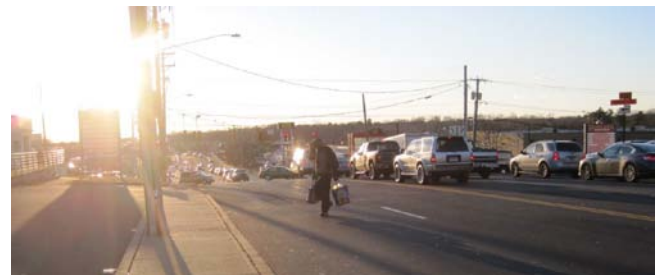
Pedestrian crossing at unmarked location

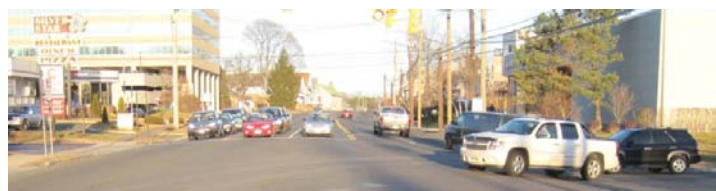
Intimidating environment for cyclists

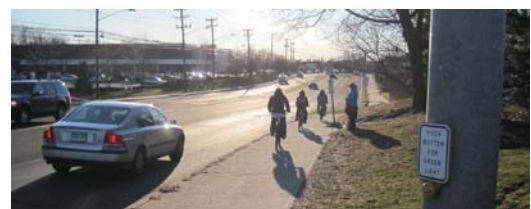
Cyclists using pedestrian infrastructure

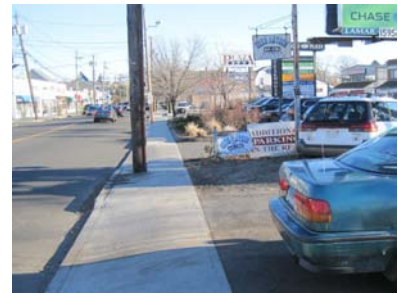
Low pedestrian comfort near Plymouth Avenue

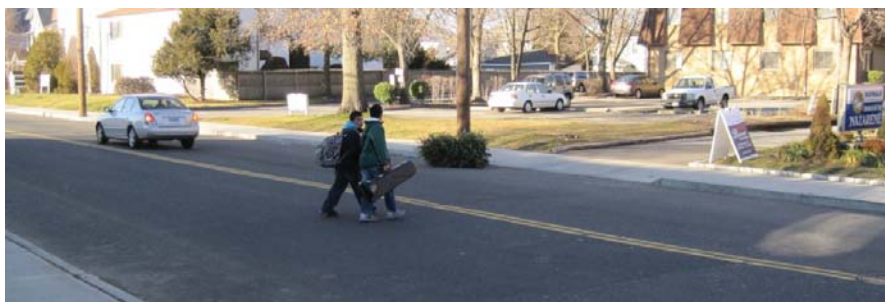
Pedestrians crossing near Holmes Street intersection

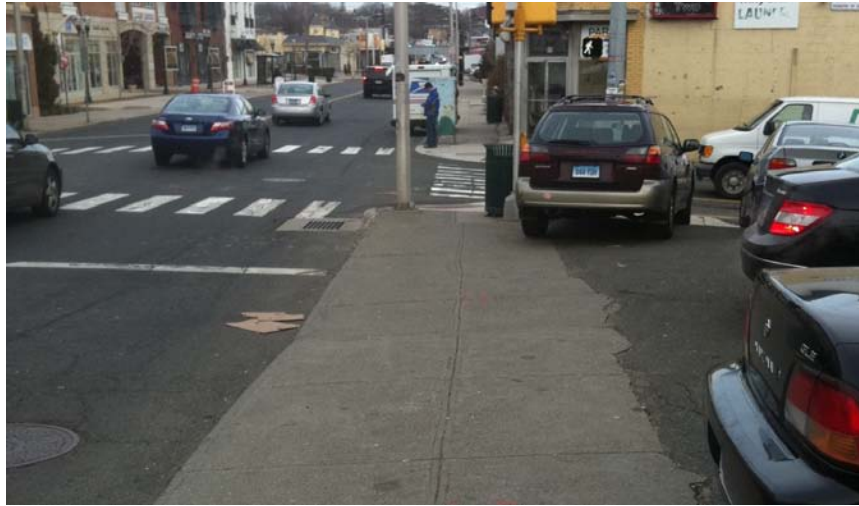
Vehicles are able to cross the sidewalk at many locations along the northern section

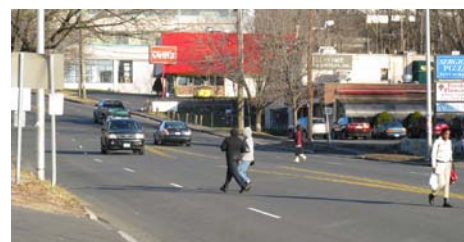
Jaywalking between Lockwood Avenue/Sherman Street and Lawn Avenue

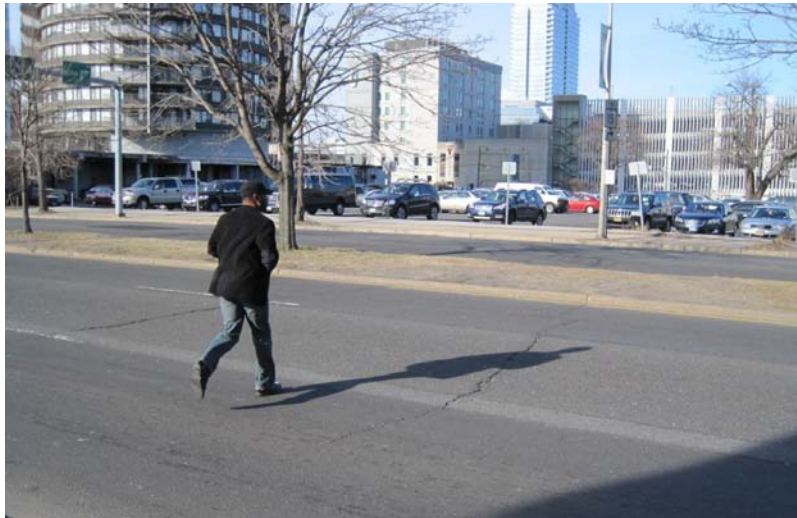
Pedestrian crossing at unmarked mid-block location between Washington Boulevard and Atlantic Street

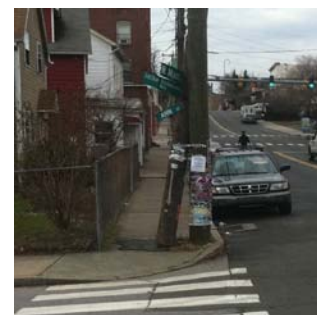
Narrow effective sidewalk width

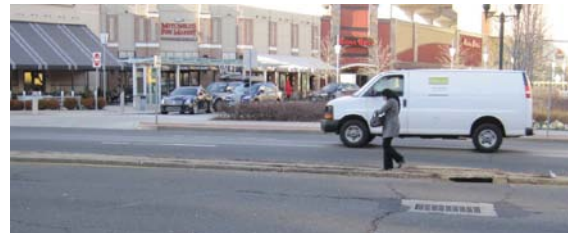
Pedestrian crossing at mid-block location

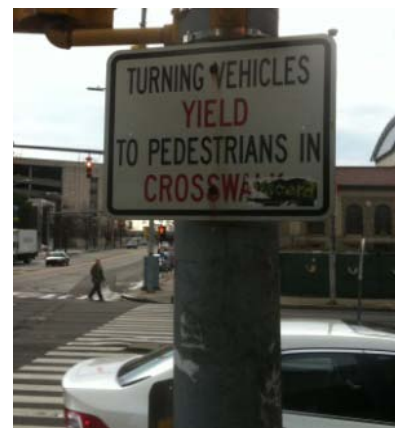
Shared turning and Pedestrian phase at crosswalks over Tresser Boulevard

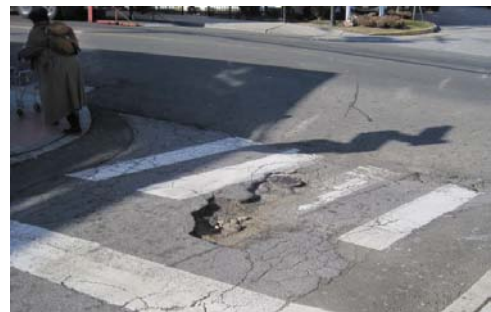
Poor crosswalk condition over Rose Park Avenue

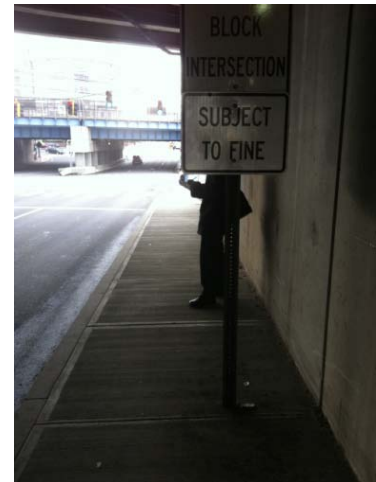
Narrow effective sidewalk width under rail bridge

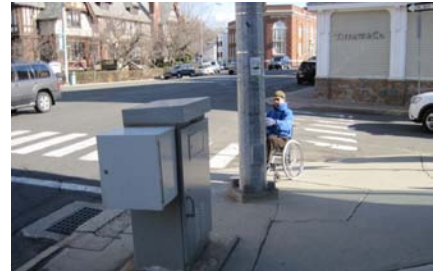
Poor visibility at crosswalk waiting area

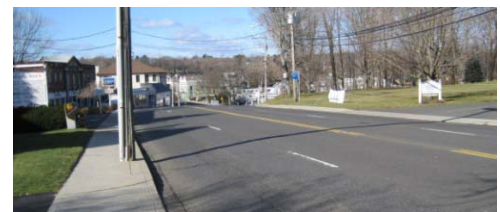
Unprotected concrete sidewalk

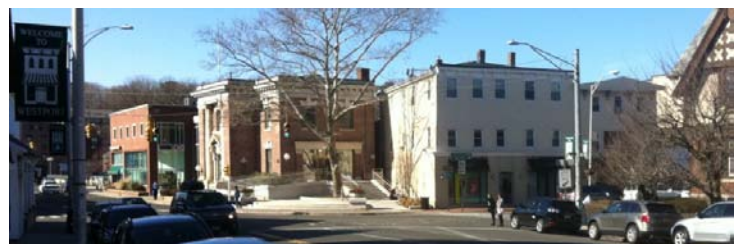
Pedestrians crossing at former crosswalk location at Main Street intersection, where visibility is currently obscured by parked vehicles.

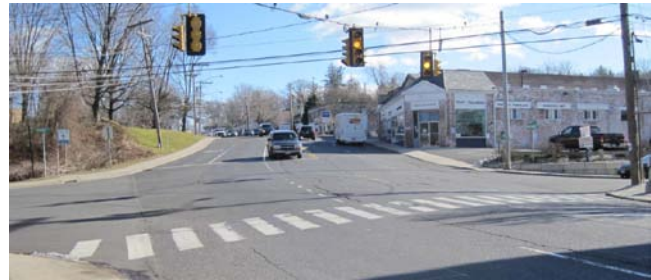
Sixty foot crosswalk over US 1 at Myrtle Avenue/Imperial Avenue intersection, side street crosswalks not marked

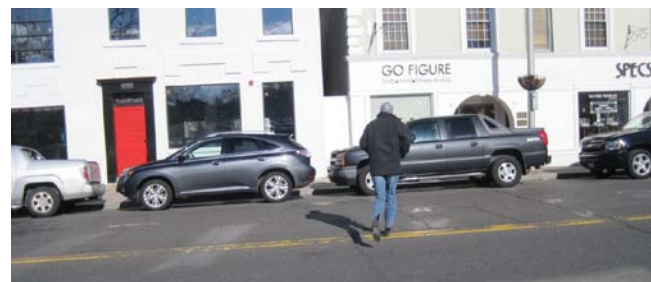
Pedestrian crossing at unmarked location downtown

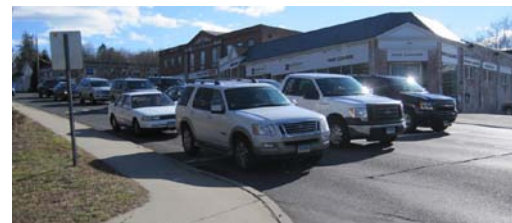
Intimidating environment for cyclists

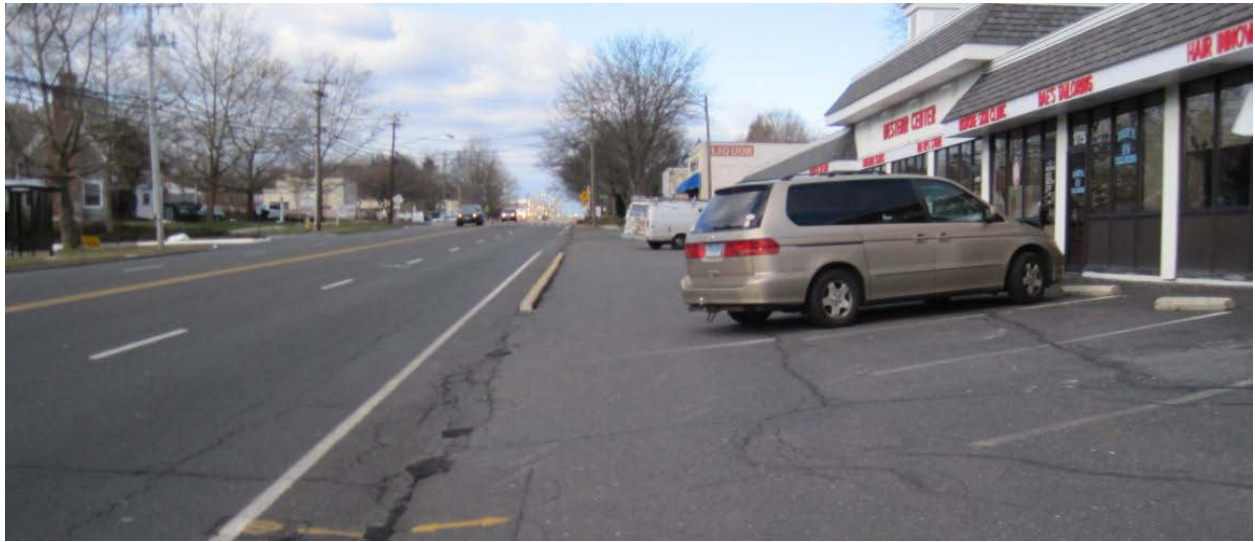
Strip development with continuous access and angle parking

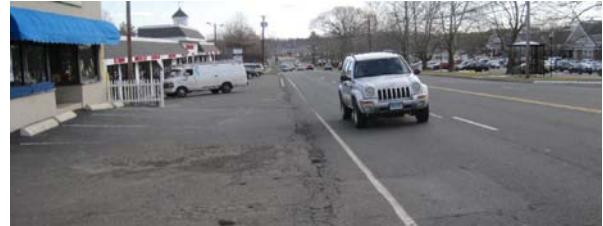
Parking areas adjacent to travel lanes

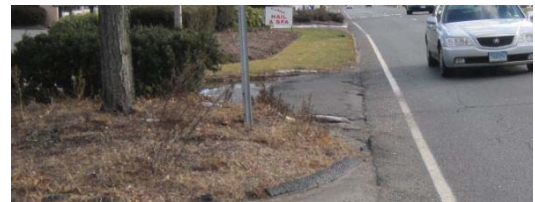
Curb and landscaping forcing pedestrians into travelled way
