ROAD SAFETY AUDIT

New Fairfield—Gillotti Road

September 21, 2016

Western Connecticut
Council of Governments

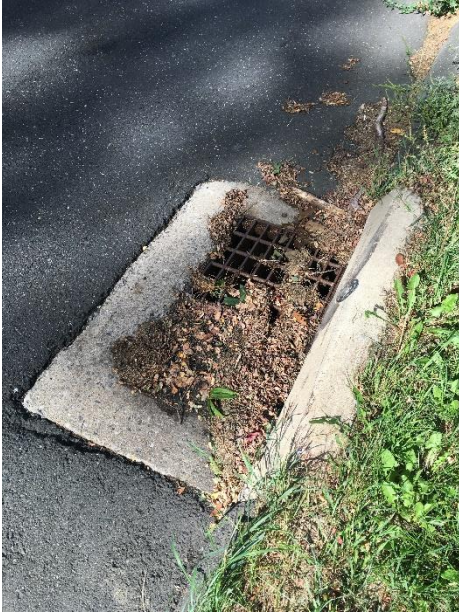
- Catch basins are blocked with debris (Figure 7).
- On the westbound side of Gillotti Road, tire marks are visible in the middle of the “S curve” indicating a vehicle had veered off the roadway (Figure 8).
- Vegetation is overgrown, particularly along the “S curve” area.
- The intersection at Ball Pond Road East has a wide radius.
- Vehicles were observed stopping past the stop sign or rolling through the stop.
- There are no stop bars painted at the intersection roads.
- Cyclist traveling westbound onto Gillotti Road from Ball Pond Road East did not stop at the stop sign.
- There are no shoulder lines striped on Gillotti Road (Figure 9).
- Road width varies through the RSA area.
- There are no sidewalks for pedestrians.
- Some of the signs are outdated and are not retroreflective (Figure 10).

Figure 7. Catch basin blocked by debris

Overgrown vegetation and debris – There are areas with overgrown vegetation, particularly around the "S curve" section which is heavily wooded. In addition to reducing sightlines, this also contributes to the debris that has accumulated in the catch basins. Blocked catch basins impede drainage and may cause ponding or wet roadway conditions that contribute to crashes.

2. **Clear catch basins of debris.** Observations during the RSA indicated several of the grates were blocked by debris including branches and leaves (Figure 13). Clearing the blockage may improve drainage, potentially reducing wet or icy roadway conditions.

Figure 13. Clear all catch basins of debris

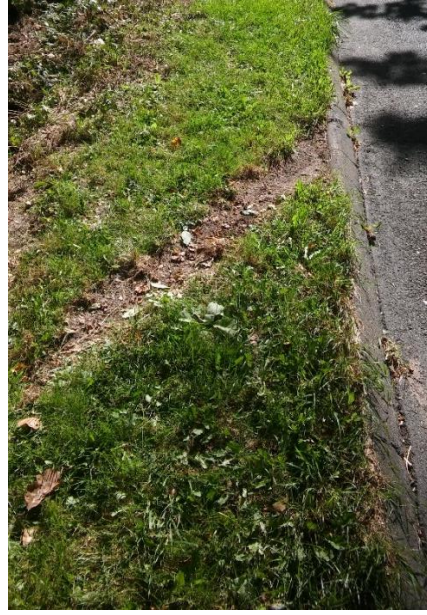
Figure 8. Tire marks visible on grass

Roadway geometry – The biggest challenge with roadway geometry pertains to the "S curve" due to grading and cross slope and sightline issues. Westbound traffic travels downhill through this section. Several reported crashes involved vehicles losing control and veering off the roadway through the "S curve".

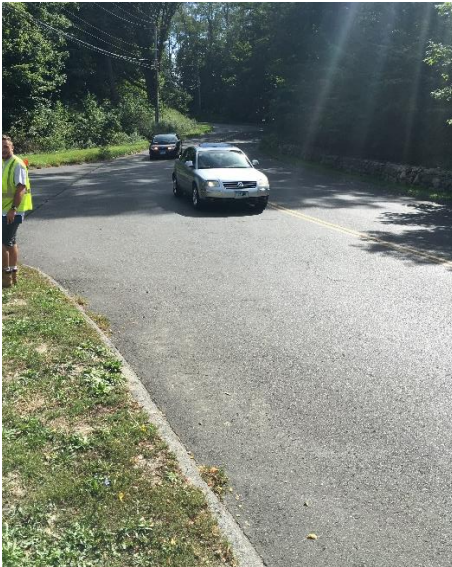
Figure 9. There are no shoulder lines

Pavement markings – While the centerlines are painted on Gillotti Road, there are no shoulder lines. Road width varies throughout the corridor, and shoulder lines could help keep lane width consistent. In addition, shoulder lines create a perceived smaller lane and may reduce travel speeds and help guide vehicles through the curves by better showing the edge of road.

1. **Paint shoulder lines along Gillotti Road.** Striping the shoulder lines could provide a visual guide to help vehicles stay in their lane (Figure 12). Depending on shoulder width, the newly defined shoulder area may also serve as space for cyclists to use.

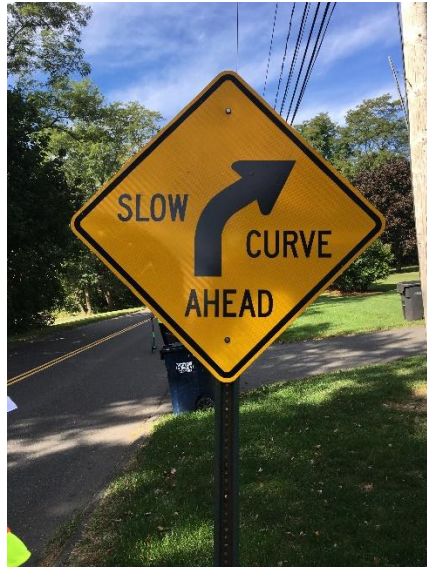
Figure 10. Outdated sign

5. **Install new signage and upgrade outdated signage.** Consider installing chevron signing along the “S curve” (Figure 15). Installing flashing beacons at key sections on Gillotti Road could aid in alerting motorists of approaching roadway challenges, such as a steep grade change or curve, or of school bus stops. Signage should be updated to ensure proper retroreflectivity for maximum visibility. Consider adding reflectors to existing utility poles and sign posts.

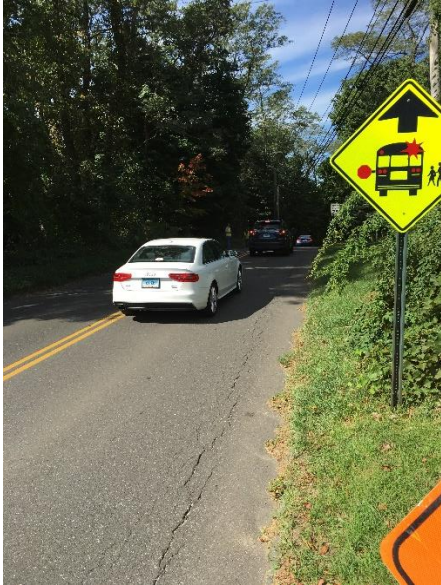
Figure 12. Paint shoulder lines

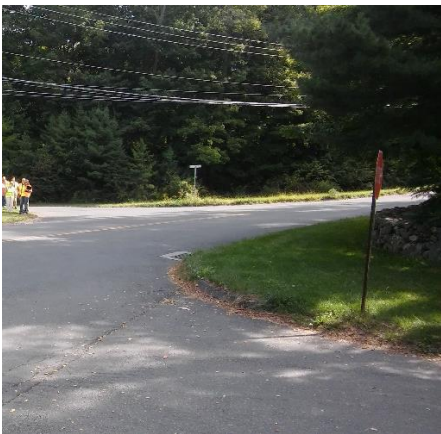
Figure 14. Paint stop bars

3. **Paint stop bars.** Adding stop bars at each of the intersecting roads will alert motorists where to stop and may reduce the amount of vehicles rolling through the stop (Figure 14).

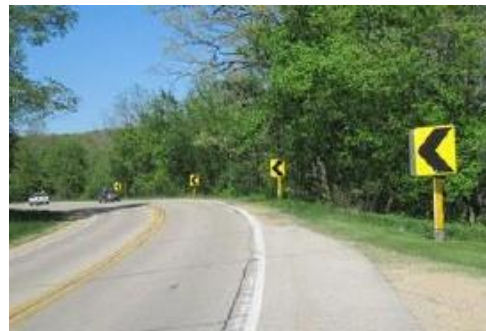
Figure 15. Chevron Signs

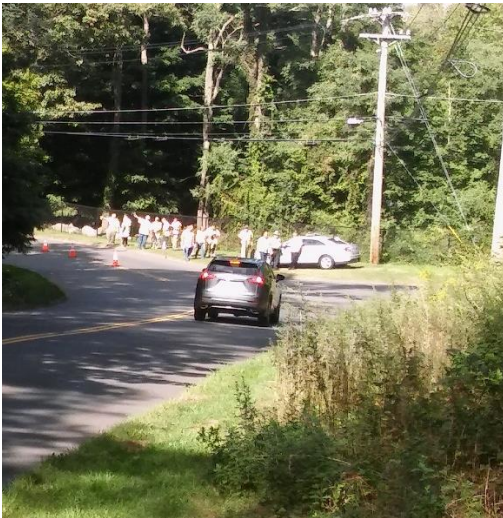
Figure 18. Utility pole near intersection of Ball Pond Road East

- a. **Installing a roundabout at the intersection of Gillotti Road and Ball Pond Road East.**
 - b. **Realigning the “S curve” to be straighter.**
2. **Relocate utility pole at the Ball Pond Road East intersection.** This utility pole is located on the northwest corner of the intersection and on the outside curve of the roadway (Figure 18). Relocating this pole to the opposite side and on the inside curve of the roadway could reduce the potential of vehicles hitting the pole in an accident. When motorists lose control of their vehicle in a curve, the vehicle is more like to veer to the outside of the curve.

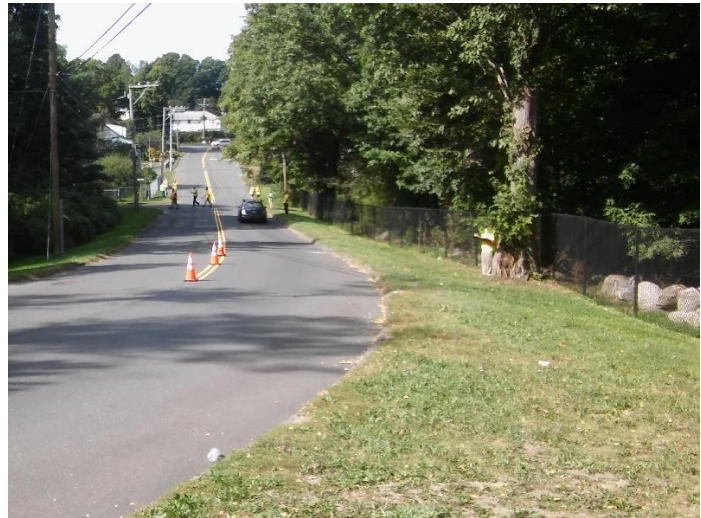
Figure 19. Install sidewalks along Gillotti Road

3. **Install sidewalks.** Consider installing sidewalks on at least one side of Gillotti Road for pedestrians (Figure 19).
