# Route 7 Corridor Assessment and Implementation Plan

City of Norwalk and Town of Wilton, CT

## Existing Conditions Report

Prepared by  
Urban Engineers, Inc.

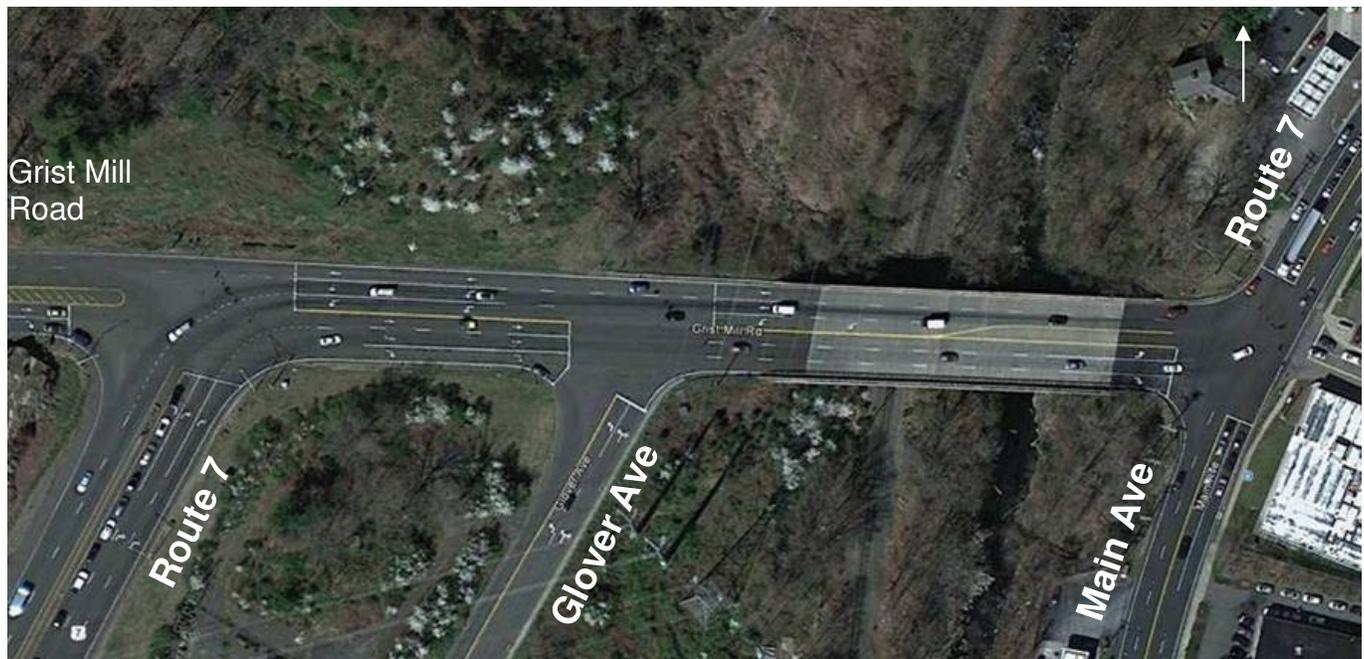
**Figure 3: Grist Mill Road**

Significant congestion occurs approaching Grist Mill Road in both the northbound and southbound directions on Route 7. In the northbound direction, there is a significant left-turn volume towards Belden Hill Road and this queues back past the approximate 500-foot storage lane which causes drivers to slow down and increase delay for the northbound right-turning vehicles. In the southbound direction on Route 7 approaching the DMV intersection, queuing extends well past West Rocks Road and appears to be mostly due to the westbound lane configuration towards Grist Mill Road and Belden Hill Rd area.

The westbound lane configuration on Grist Mill Road causes all vehicles staying on Route 7 southbound to stay in the left/through lane between Main Ave and Glover Ave. The right/through lane in this area is empty even though southbound queuing extends through West Rocks Road and further north. The gas station and Starbucks shopping center located north and west of the Route 7/Main Ave/DMV intersection also contribute to the overall congestion in this area.

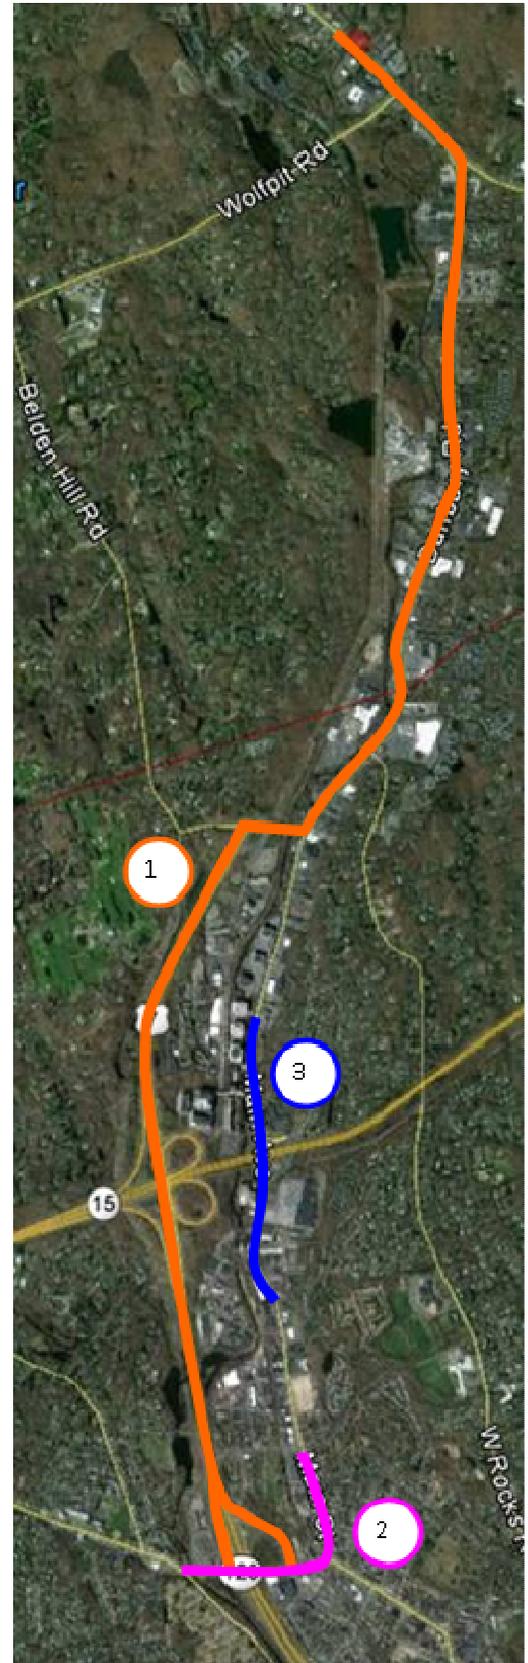
**Figure 4: Travel Time Run Locations**

The travel time results comparison show the model within 20% of field travel time runs. Because visual queuing were also within acceptable ranges, the model could proceed to the final step of calibration, which is to process LOS and delay results and check to make sure results approximately match field conditions.

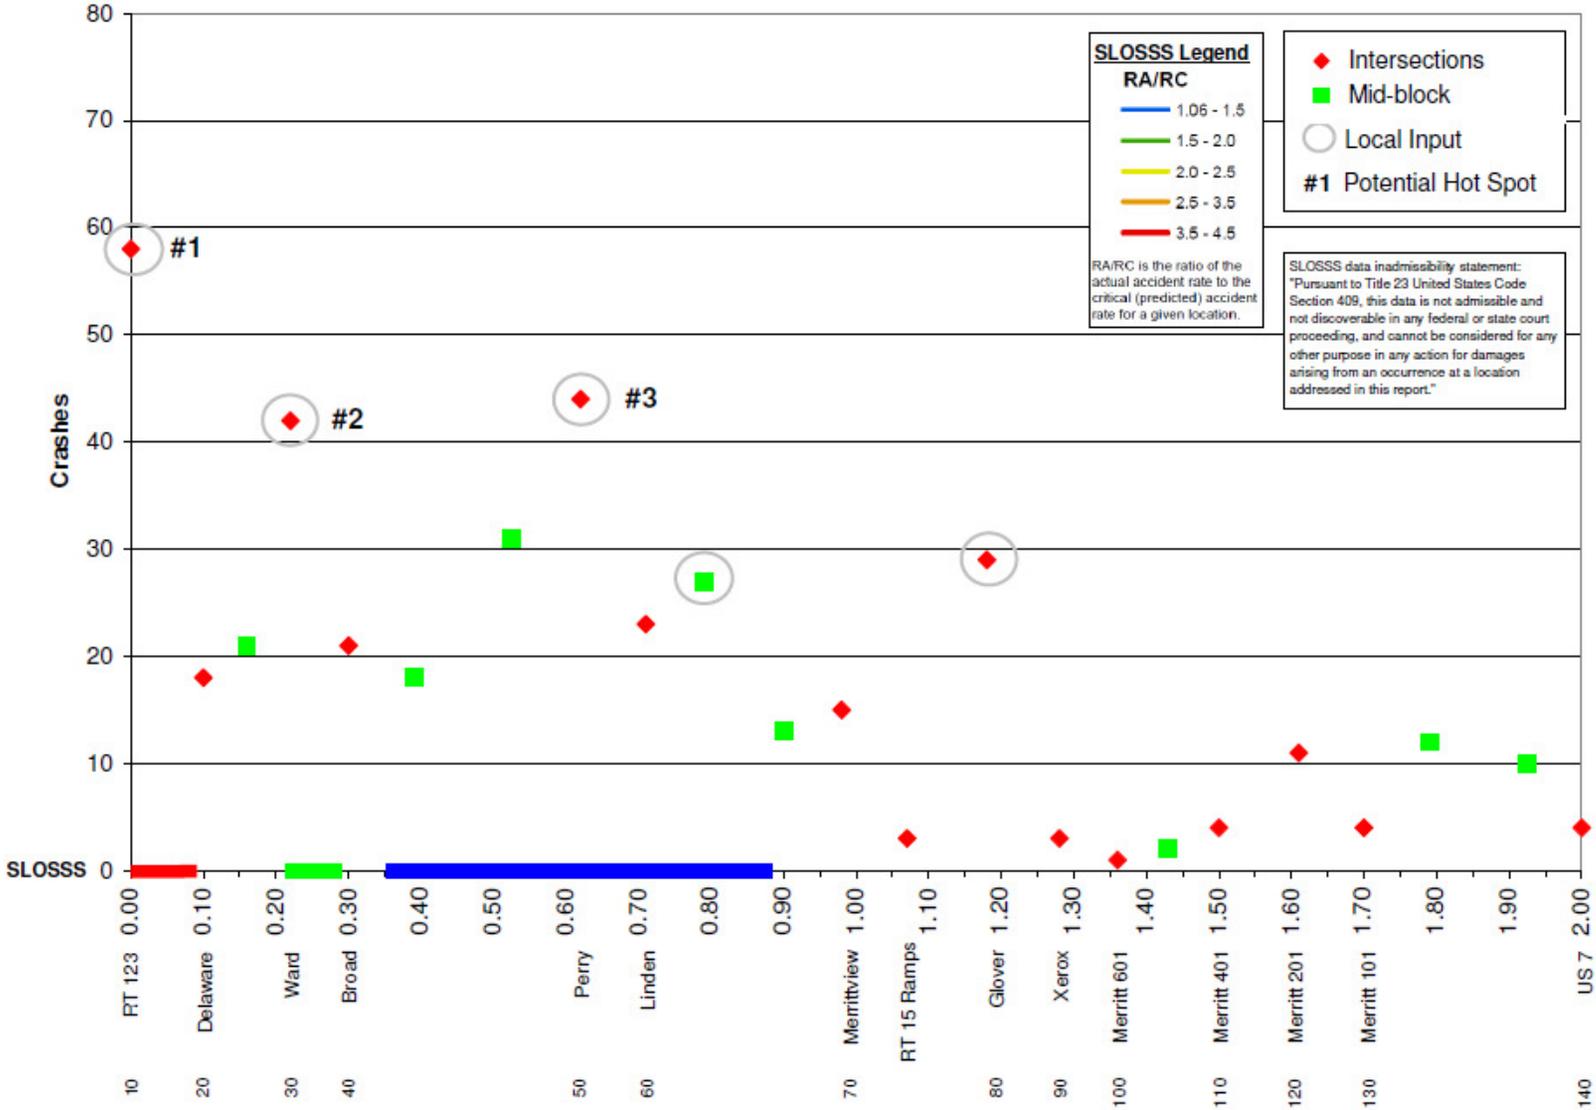
Figure 5: TAVS Main Avenue Graph

The TAVS program allows the user to display and print various information about traffic crashes that occur on state-maintained roadways. Post-processing spreadsheets were used on the raw TAVS data to produce an excel graph showing the number of crashes at each intersection and mid-block locations. An intersection was generally defined as +/- 0.02 miles from the milepost the signal is located on, and mid-block locations were broken down into multiples of 0.10 miles between signals (e.g., Grumman Hill Road to RT 33 is 0.78 miles which turned into seven, 0.11 miles mid-block sections). If a mid-block location was less than 0.05 miles in length then it would be considered part of the neighboring signals (e.g., between Route 7/Grist Mill Road and Route 7/Glover Ave).

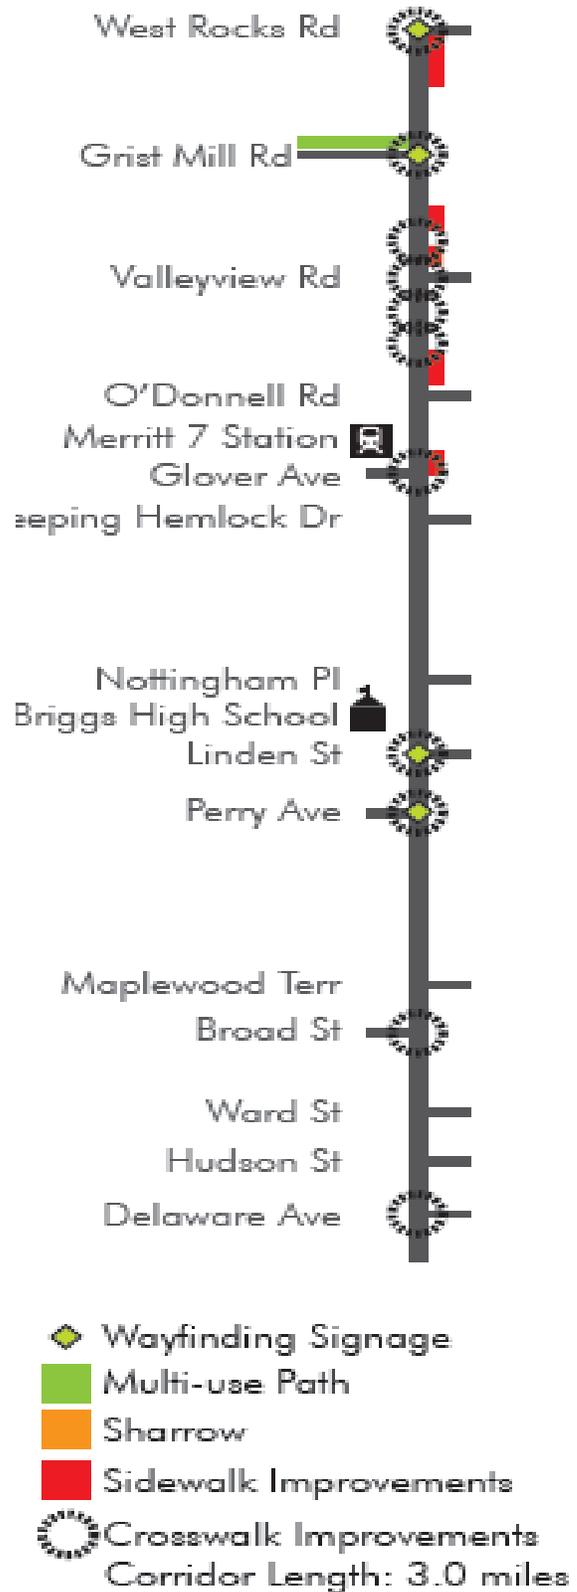
**Figure 7: Pedestrian and Bicycle Transportation Plan**

The pedestrian and bike transportation plan noted above made numerous recommendations to improve the walking environment on Main Avenue (**Figure 7**). It classified Route 7 as a high priority area for improvements due in large part to demand for pedestrian access and the presence of the Merritt 7 rail station.

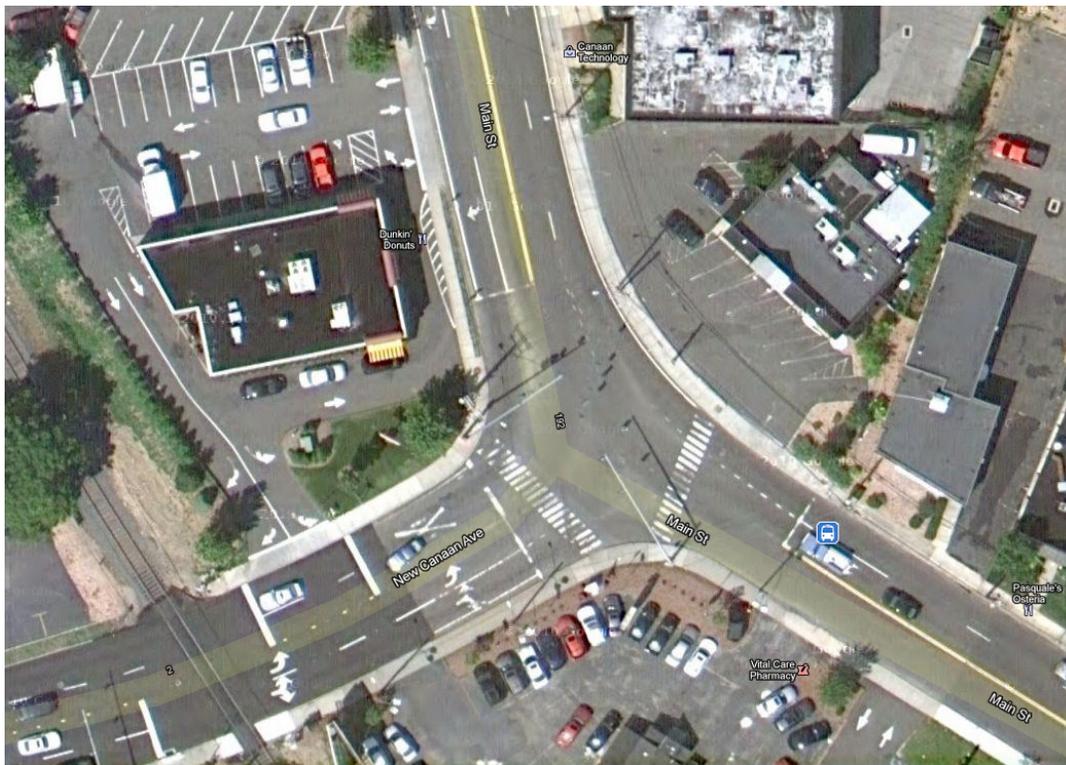
**Figure 11: Intersection of SR 719 (Main Ave) and Route 123 (New Canaan Ave)**

**Figure 11**, below, shows the signalized intersection of SR 719 (Main Avenue) and Route 123 (New Canaan Ave). The northbound Main Street approach is skewed with a dedicated left-turn lane and a dedicated thru lane. The southbound Main Avenue approach has a dedicated right-turn lane and a dedicated thru lane. The eastbound Route 123 approach has a dedicated left-turn lane and a shared right- or left-turn lane, and also has a positive approach grade where traffic is metered by a railroad crossing signal, approximately 200 feet to the west of the intersection.

On the northwest corner of the intersection is a drive-thru Dunkin' Donuts with driveways within 100 feet of the intersection on both legs. The close proximity of the access points to the intersection contributes to congestion, driver confusion, visibility and blind spot issues, left-turn weaving, left-turn queuing, and potentially unsafe roadway entrances for motorists, as well as for pedestrians. On the east side of the intersection is a vacant lot (previously a diner restaurant) with angled parking spaces. The southwest corner of the intersection contains a car dealership with low volume driveways approximately 150 feet from the intersection on both legs.

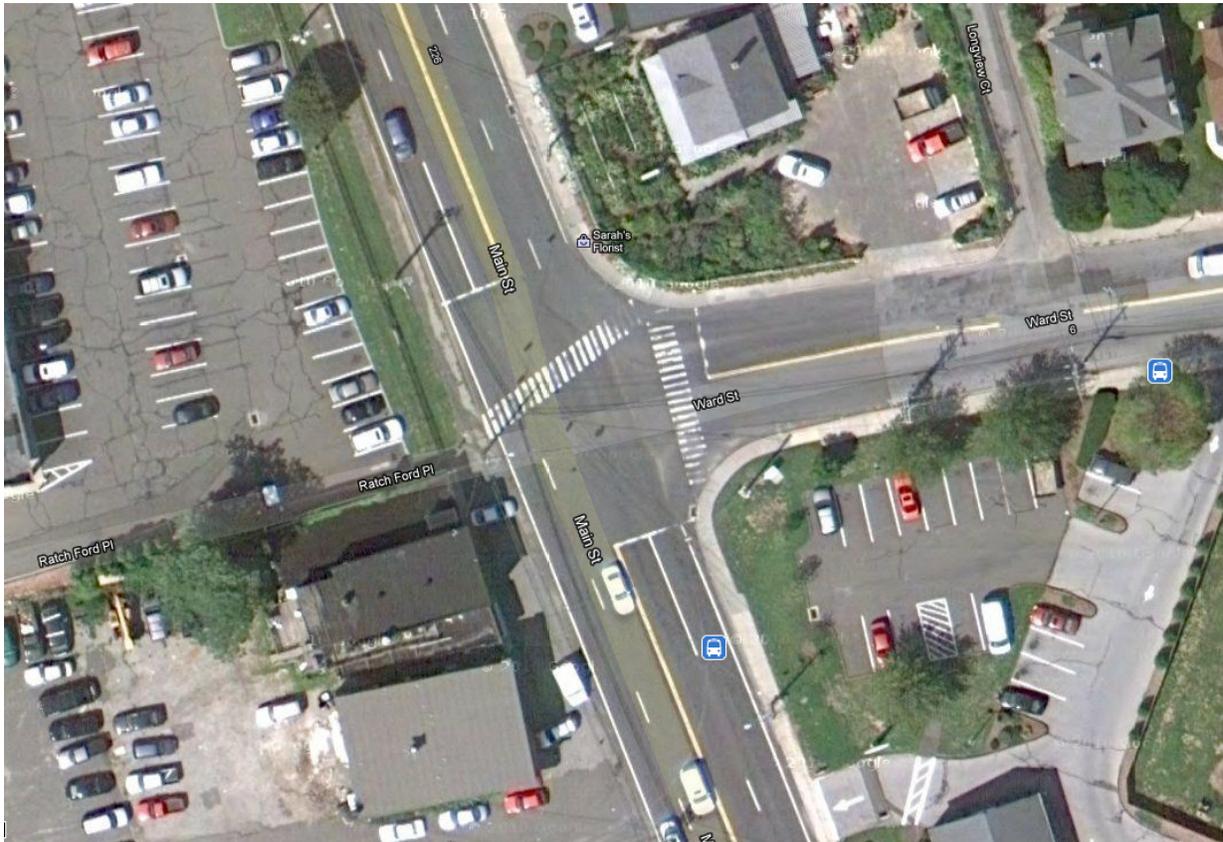
**Figure 13: Intersection of SR 719 (Main Ave) and Ward St**

**Figure 13** shows the intersection of SR 719 (Main Avenue) and Ward Street, which is a signalized T-intersection where Ward Street is the sidestreet leg. The northbound and southbound Main Avenue approaches have two thru-lanes in each direction and narrow (less than 1-foot wide) shoulders. The westbound Ward Street approach has been re-striped as two (2) approximately 11.5-foot lanes with dedicated left- and right-turn lanes. In the northbound direction vehicles are permitted to turn right on red.

The western side of the intersection has a number of shops including a Chinese food restaurant and beauty salon whose patrons park directly off Main Avenue as well as a shopping center with an entrance approximately 200 feet north of the intersection. With the shops having parking directly off the street, there is potential for conflicts with entrances/exits for motorists and unsafe conditions for pedestrians, specifically with motorists backing out of the parking areas. On the southeast corner of the intersection is a Bank of America with driveways within 100 to 200 feet of the intersection. On the northeast corner of the intersection is a florist and drapery company that both have driveways within 100 feet of the intersection.

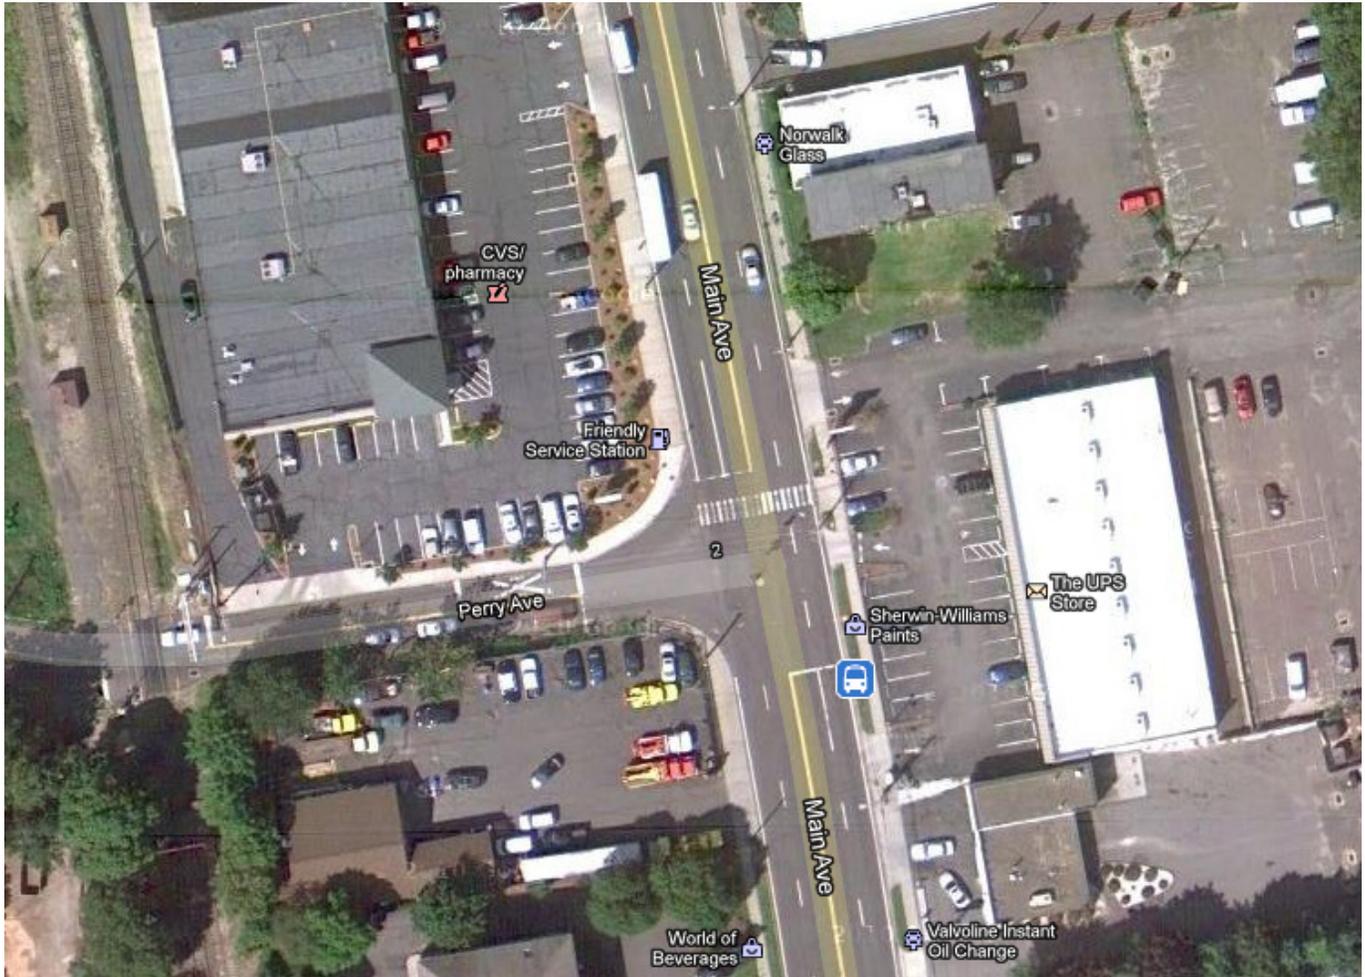
**Figure 15: Intersection of SR 719 (Main Ave) and Perry Ave**

**Figure 15** shows the signalized T-intersection of SR 719 (Main Ave) and Perry Avenue. The eastbound approach to the intersection has a positive grade approaching the intersection with a at-grade railroad crossing approximately 250 feet from the intersection. There are no dedicated turn lanes on Main Avenue at this intersection. All turns are shared with thru lanes and there are no shoulders. The southbound right turns are permitted to turn right on red.

On the northwest corner of the intersection is a CVS pharmacy with driveways approximately 200 feet from the intersection on both legs. This potentially creates unsafe roadway entrances for motorists along Main Avenue. The close proximity of the Linden Street intersection to the north (350 feet) and mid-block entrance to the CVS contributes to slower travel speeds, Main Avenue turning vehicle queuing, and weaving to avoid the turning vehicle queues. On the east side of the intersection is Perry Plaza which includes shops such as a UPS store with an exit-only driveway at the intersection and a two-way driveway approximately 100 feet on either side of the intersection. On the southwest corner of the intersection is an auto body shop with an

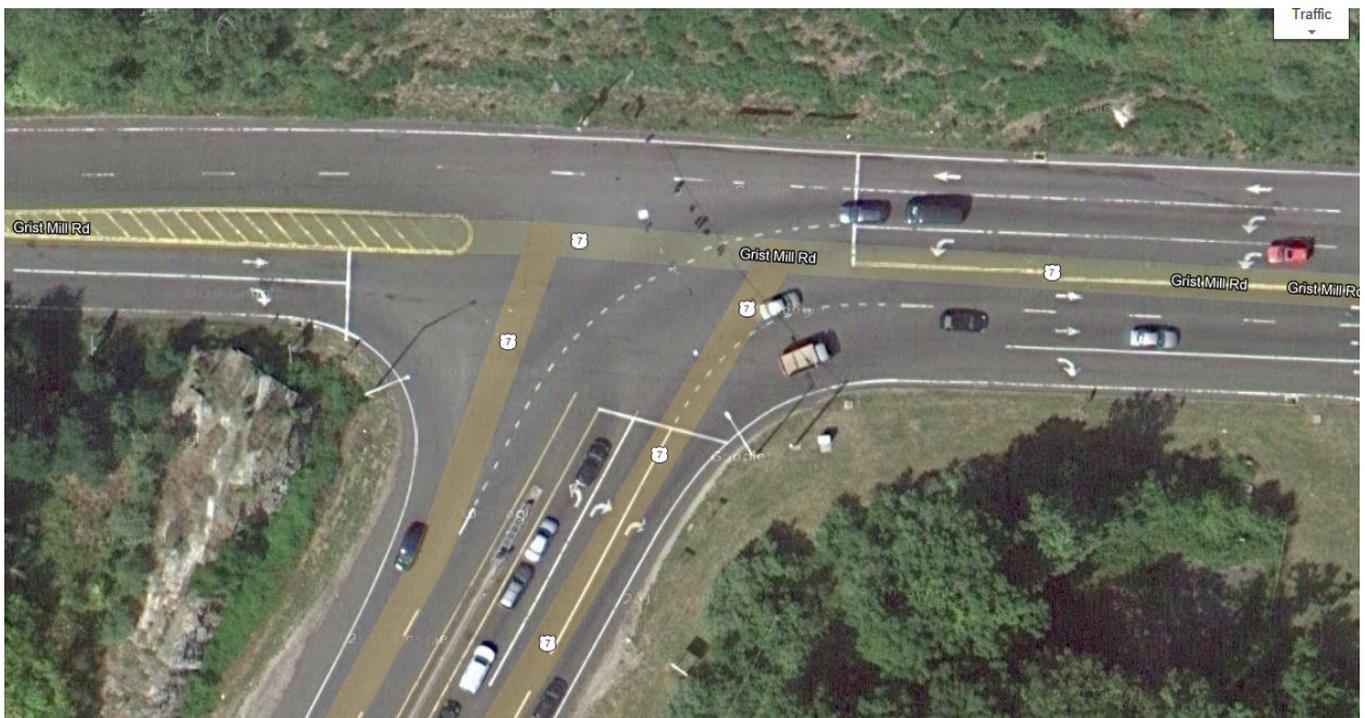
**Figure 17: Intersection of US Route 7 and US Route 7 (Grist Mill Rd)**

**Figure 17** shows the intersection of US Route 7 and Grist Mill Road, where the US Route 7 freeway comes to an end and US Route 7 continues eastbound towards Main Avenue and the Norwalk Motor Vehicle Department (DMV). The limited-access freeway is two lanes in each direction with wide shoulders and a wide grass median. At the intersection, the northbound approach has one left-turn lane and dual right-turn lanes. The westbound approach has dual left-turn lanes and one thru lane, while the eastbound approach has a thru lane and a right-turn lane. Once US Route 7 (Grist Mill Road) makes the easterly turn towards the DMV there is little to no shoulder and no median. Major queuing occurs on the northbound and westbound approaches during peak periods. There are no driveways within the immediate area of this intersection.

The traffic operations during both peak periods included heavy queuing on the northbound Route 7 approach which is a combination of a heavy left-turn move towards Grist Mill Road and Belden Hill Road, with minimal green time, and a very heavy right-turn movement for all vehicles destined to continue on Route 7 northbound. The northbound right movement can be affected by the eastbound queuing that spills back from the Route 7 (Grist Mill Road) and Main Avenue/DMV intersection.

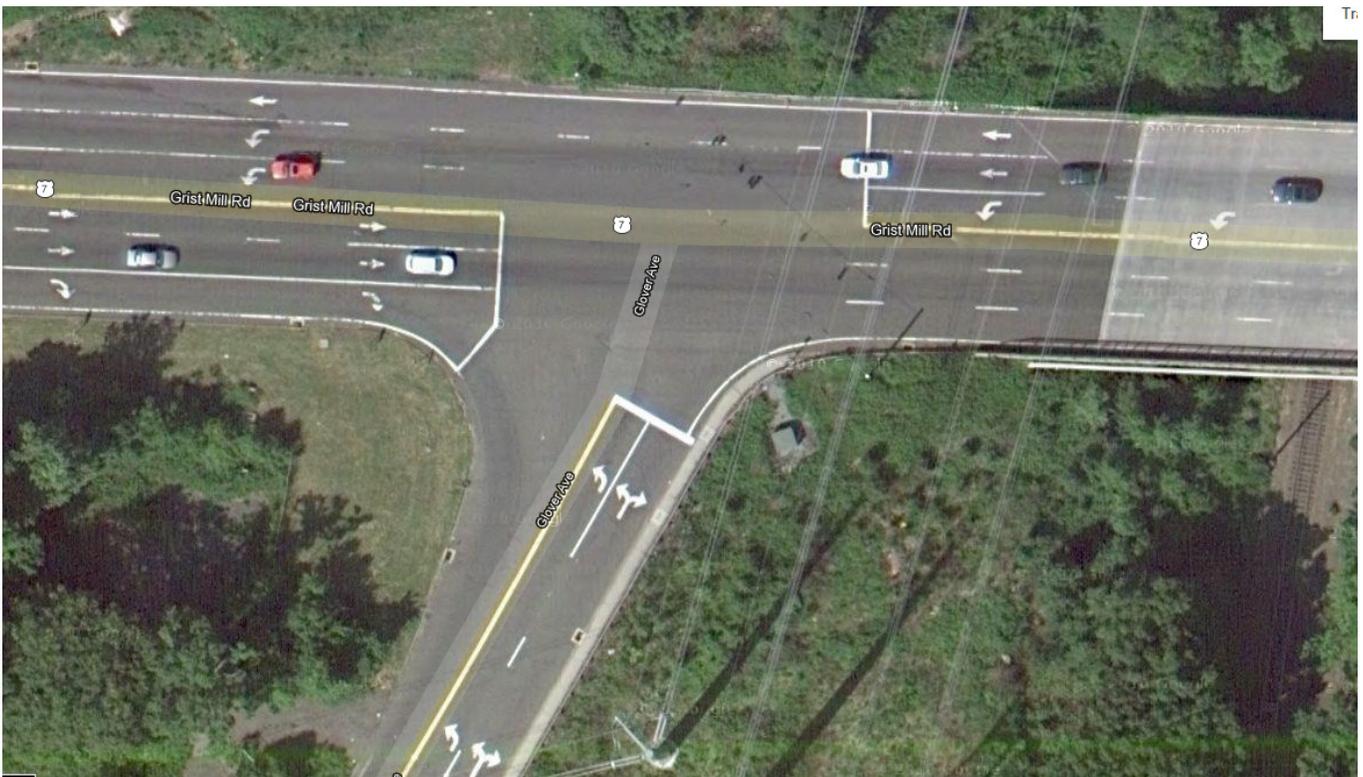
**Figure 18: Intersection of US Route 7 (Grist Mill Rd) and Glover Ave**

**Figure 18** shows that US Route 7 (Grist Mill Road) and Glover Avenue meet at a signalized T-intersection. This signalized intersection is less than 250 feet east of the US Route 7 and US Route 7 (Grist Mill Road) intersection and less than 450 west of the US Route 7 (Grist Mill Road) and Main Avenue/DMV intersection and as a result contributes to congestion in this section US Route 7. The eastbound approach has two thru lanes and one dedicated right-turn lane. The westbound approach has two thru lanes and one dedicated left-turn lane. The northbound approach has one dedicated left-turn lane and one shared left/right/turn lane. There is significant queuing that occurs in the eastbound and westbound directions on Route 7 (Grist Mill Road) that stems from the neighboring intersections and frequently extends into this intersection.

The traffic operations during both peak periods included heavy queuing on the eastbound and westbound Route 7 approaches. The northbound Glover Ave approach was generally clear during the AM peak with minor queuing during the PM peak. Vehicles were consistently noted using the dedicated turn lanes on Route 7 to Glover Ave in both directions as through lanes to avoid the extensive queuing. It was also noted in the westbound direction that almost all vehicles destined for Route 7 southbound would occupy the left/through lane at the Route 7/Glover Ave intersection. The right/through lane at this intersection would generally remain empty with the exception of the few vehicles destined for Belden Hill Road or vehicles attempting to avoid the westbound queue and “slide” over into the left-turn lane at Route 7/Route 7(Grist Mill Road) intersection.

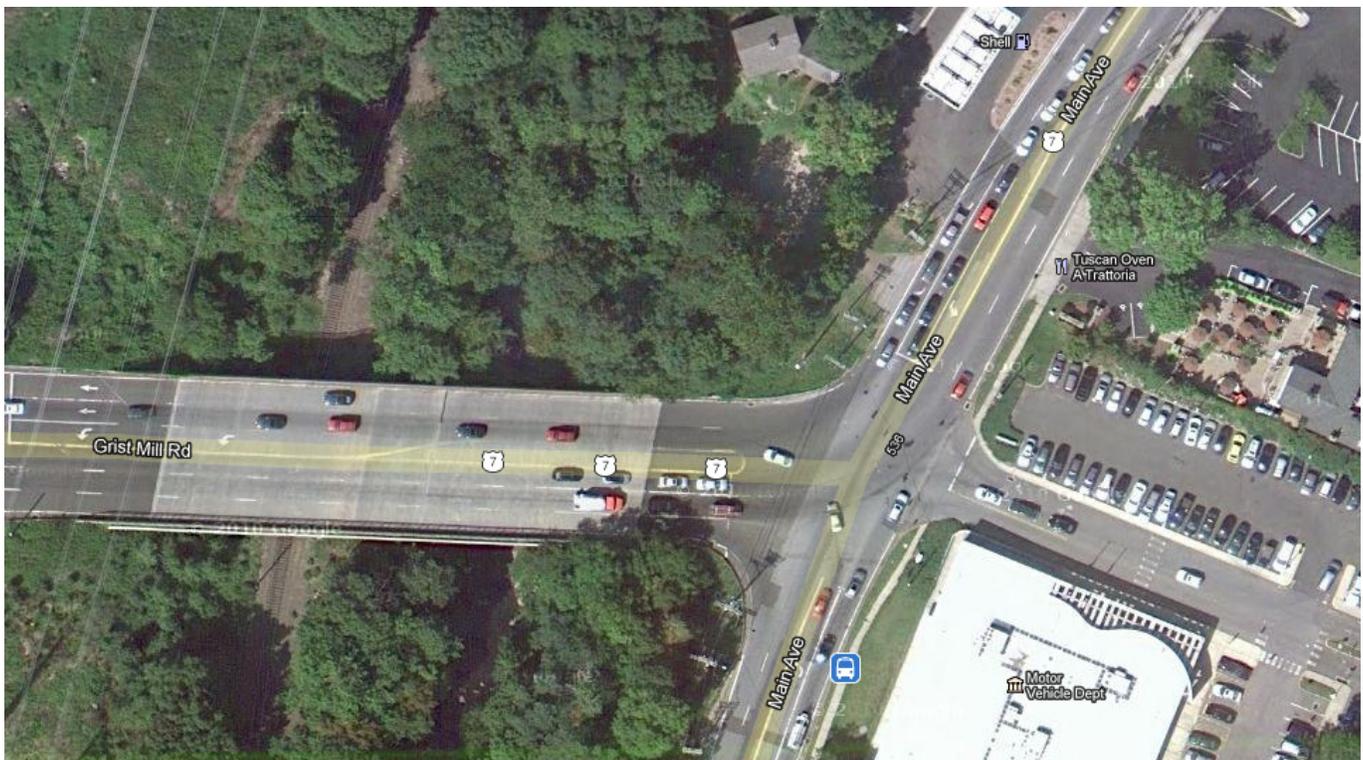
**Figure 19: Intersection of US Route 7 (Grist Mill Rd) and Main Ave/DMV**

**Figure 19** shows the intersection of US Route 7 (Grist Mill Road) and Main Avenue (SR 719)/DMV. This intersection is probably the busiest intersection in the corridor as it serves traffic for both US Route 7 and Main Ave. The eastbound approach has one left-turn lane, one shared left/thru lane and a right-turn lane. The southbound approach has a left-turn, thru and right-turn lane, while the northbound approach has a left-turn lane and a thru/right lane. The westbound approach from the DMV has a shared left/thru lane and a shared thru/right turn lane. Major queuing occurs at the southbound and eastbound approaches during peak periods. There is a driveway to a Shell gas station and Starbucks restaurant within 100 feet north of the intersection. The proximity of these driveways to the intersection and the queuing that frequently exists in the southbound lanes contributes to difficulties for vehicles entering and exiting particularly from/to northbound Route 7. The southbound and eastbound approaches both come into the intersection at a downgrade.

The traffic operations during both peak periods included heavy queuing on the eastbound and southbound Route 7 approaches. The eastbound dual left is an extremely heavy move where vehicles are continuing on Route 7 northbound from the Route 7 freeway section. Just north of the intersection on Route 7 are the gas station and Starbucks entrances with no left-turn pockets. This appears to cause over-utilization of the outside, northbound through lane, and under-utilization of the inside lane for drivers fearing the left-turn queue.

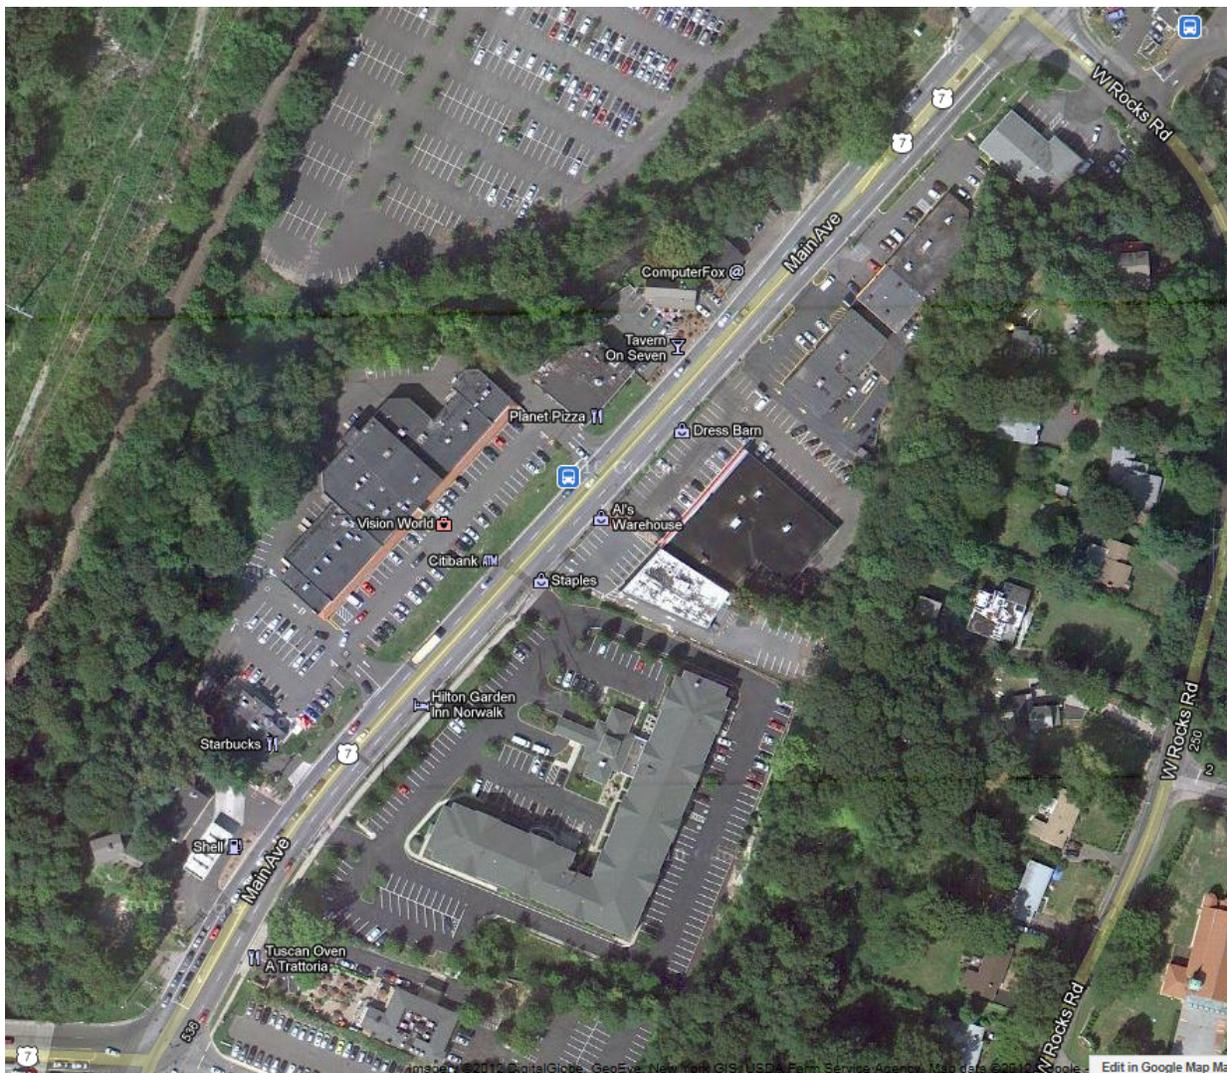
**Figure 21: US Route 7 between Grist Mill Rd and West Rocks Rd**

The mid-block segment between the signalized intersections of Grist Mill Road and West Rocks Road is a four-lane section of US Route 7 (Main Avenue) with no shoulders. It contains strip malls, restaurants, and a gas station as shown in **Figure 21**. The gas station driveways are between 100 and 200 feet north of the Grist Mill Rd intersection on the west side of Route 7. During peak periods, traffic is queued in the southbound direction along the entire mid-block segment, mostly in the right lane. Northbound vehicles attempting to turn left into the gas station remain stopped in a thru lane until a gap is created by drivers in the southbound lanes, which does not occur often. As noted in the previous focus area, this creates a safety concern for rear-end, angle, and sideswipe collisions in both directions. The strip malls on both sides of Route 7 along this segment also create safety concerns due to stopped vehicles and passing attempts.

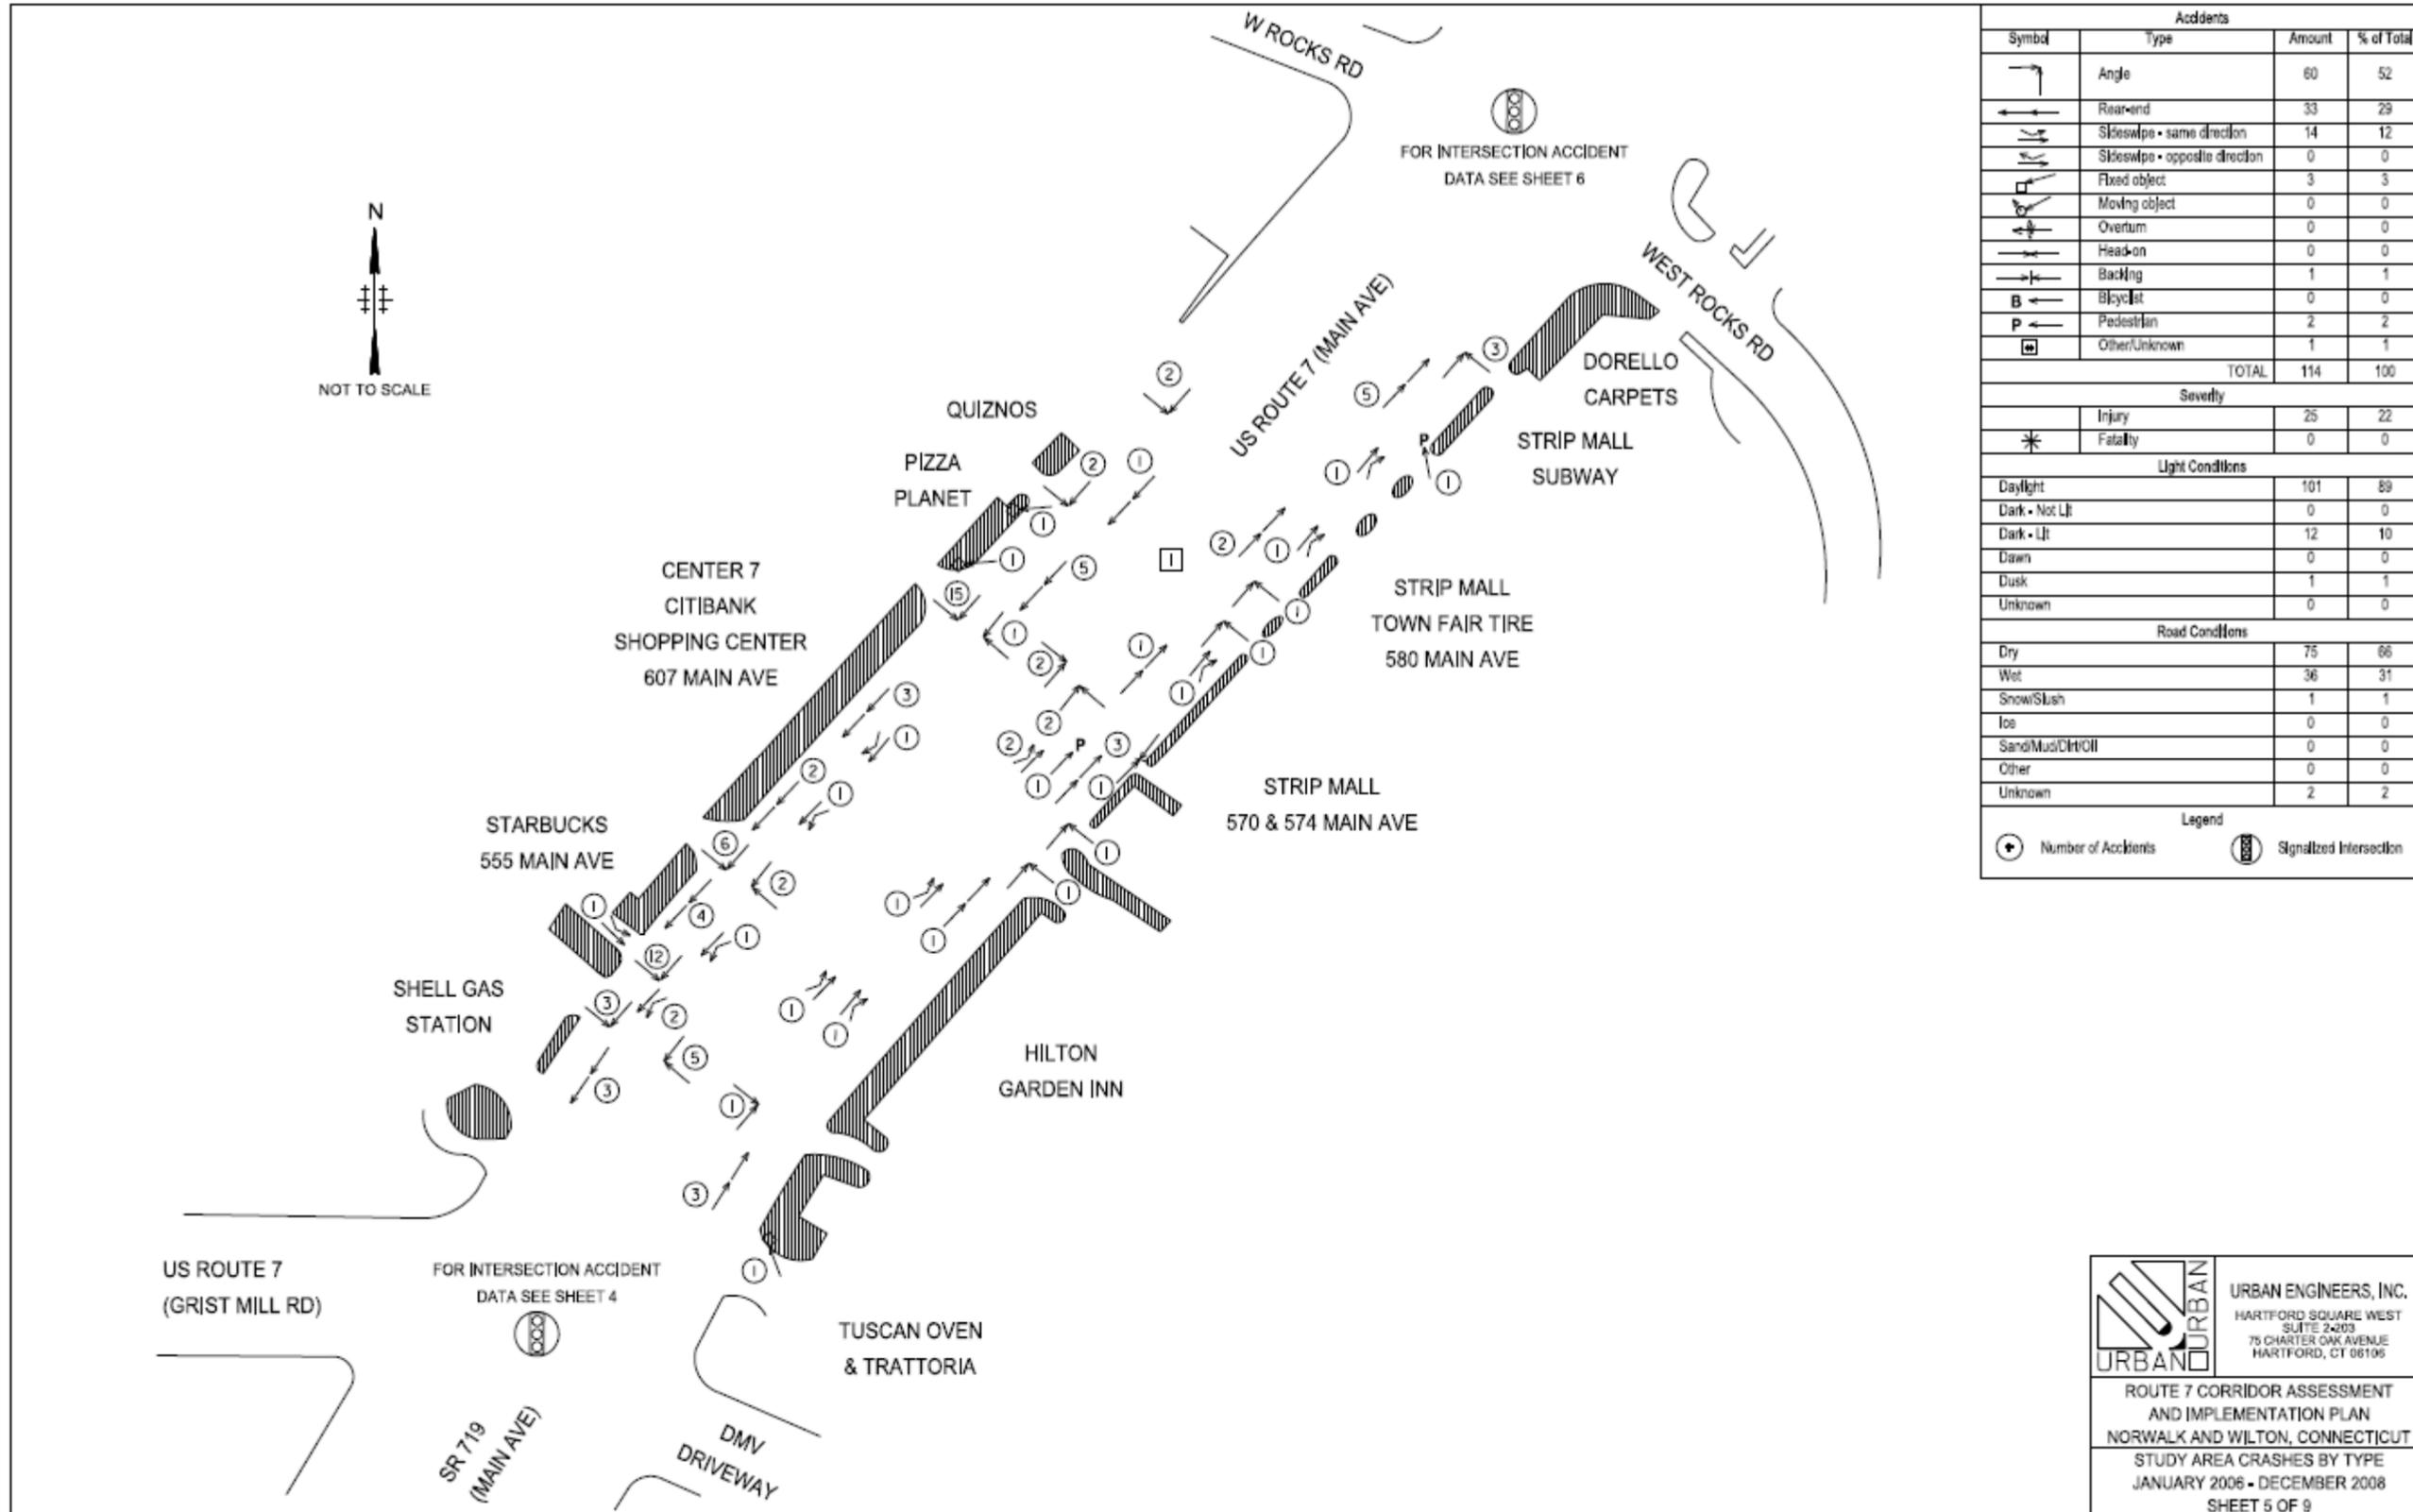
Figure 22: Crashes along US Route 7 between Grist Mill Rd and West Rocks Rd

Accidents			
Symbol	Type	Amount	% of Total
	Angle	60	52
	Rear-end	33	29
	Slideshow - same direction	14	12
	Slideshow - opposite direction	0	0
	Fixed object	3	3
	Moving object	0	0
	Overturn	0	0
	Head-on	0	0
	Backing	1	1
	Bicyclist	0	0
	Pedestrian	2	2
	Other/Unknown	1	1
TOTAL		114	100
Severity			
	Injury	25	22
	Fatality	0	0
Light Conditions			
	Daylight	101	89
	Dark - Not Lit	0	0
	Dark - Lit	12	10
	Dawn	0	0
	Dusk	1	1
	Unknown	0	0
Road Conditions			
	Dry	75	66
	Wet	36	31
	Snow/Slush	1	1
	Ice	0	0
	Sand/Mud/Dirt/Oil	0	0
	Other	0	0
	Unknown	2	2
Legend			
	Number of Accidents		
	Signalized Intersection

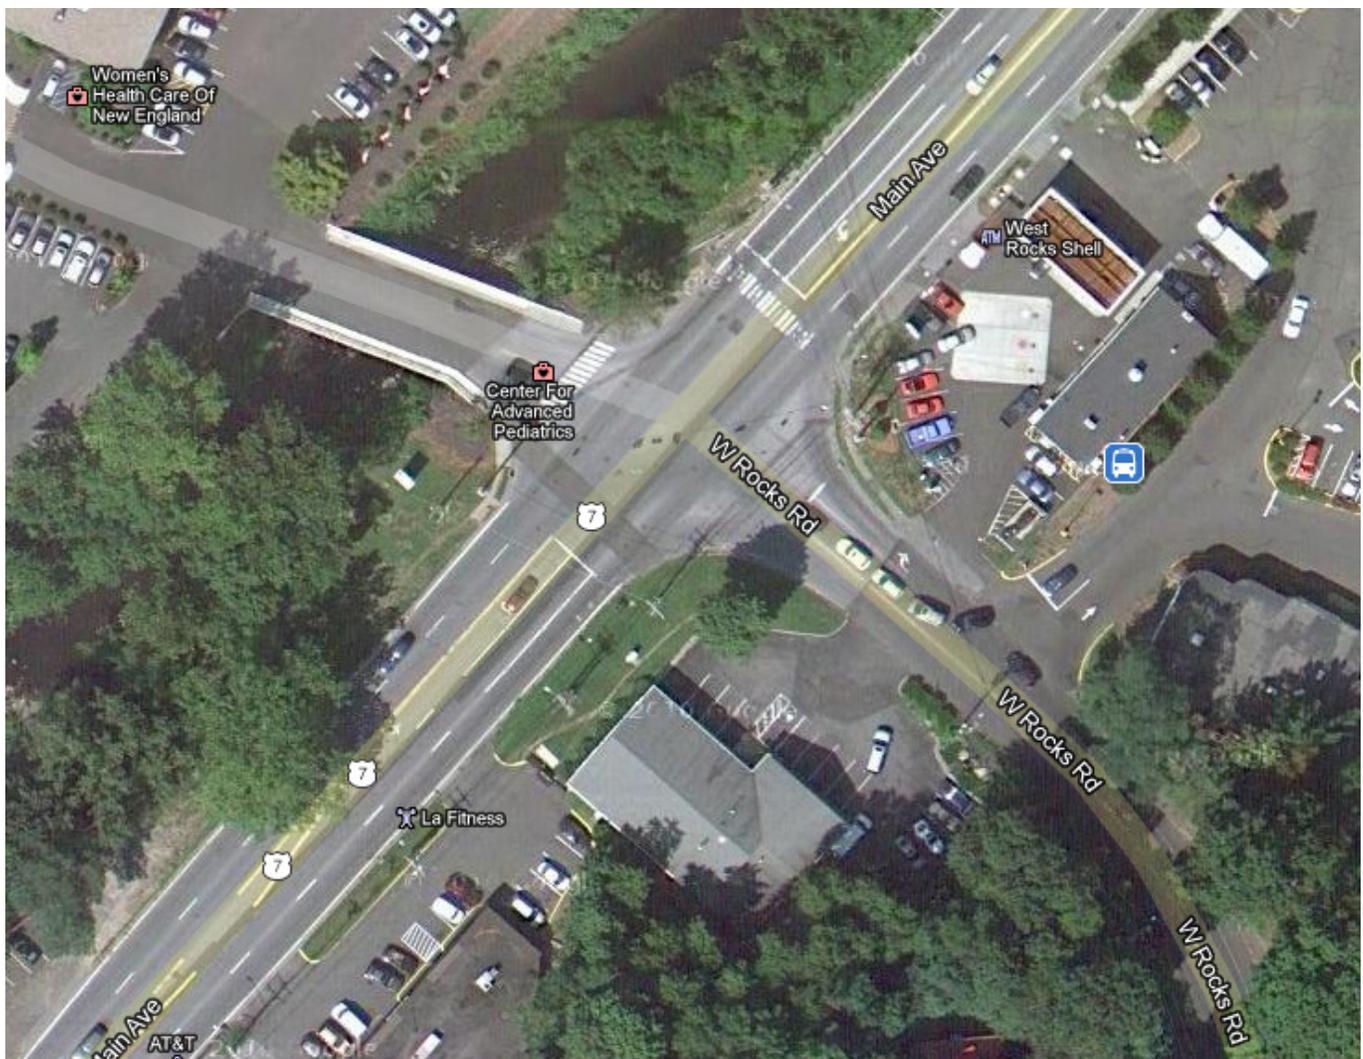
**Figure 23: Intersection of US Route 7 and West Rocks Rd**

As shown in **Figure 23**, the intersection of US Route 7 (Main Avenue) and West Rocks Road, US Route 7 approaches the intersection from the south at an upgrade and both US Route 7 from the north and West Rocks Road from the east approach the intersection at a downgrade. Motorists entering the intersection from westbound West Rocks Road also enter the intersection from a tree-lined horizontal curve, potentially making visibility an issue. Both northbound and southbound approaches on US Route 7 have two thru-lanes and one dedicated left-turn lane. The northbound Route 7 approach currently has a short, 75-foot dedicated right-turn lane. The westbound approach of West Rocks Road has been re-striped as a dedicated left lane and shared thru/right lane which is permitted to turn right on red. The eastbound approach of West Rocks Road is a driveway to the i.park facility, which is a large commercial/medical building. Pedestrian crosswalks are located at the westbound and southbound approaches.

The traffic operations during both peak periods included heavy queuing on the northbound and southbound Route 7 approaches. The southbound queuing is related to the capacity issues

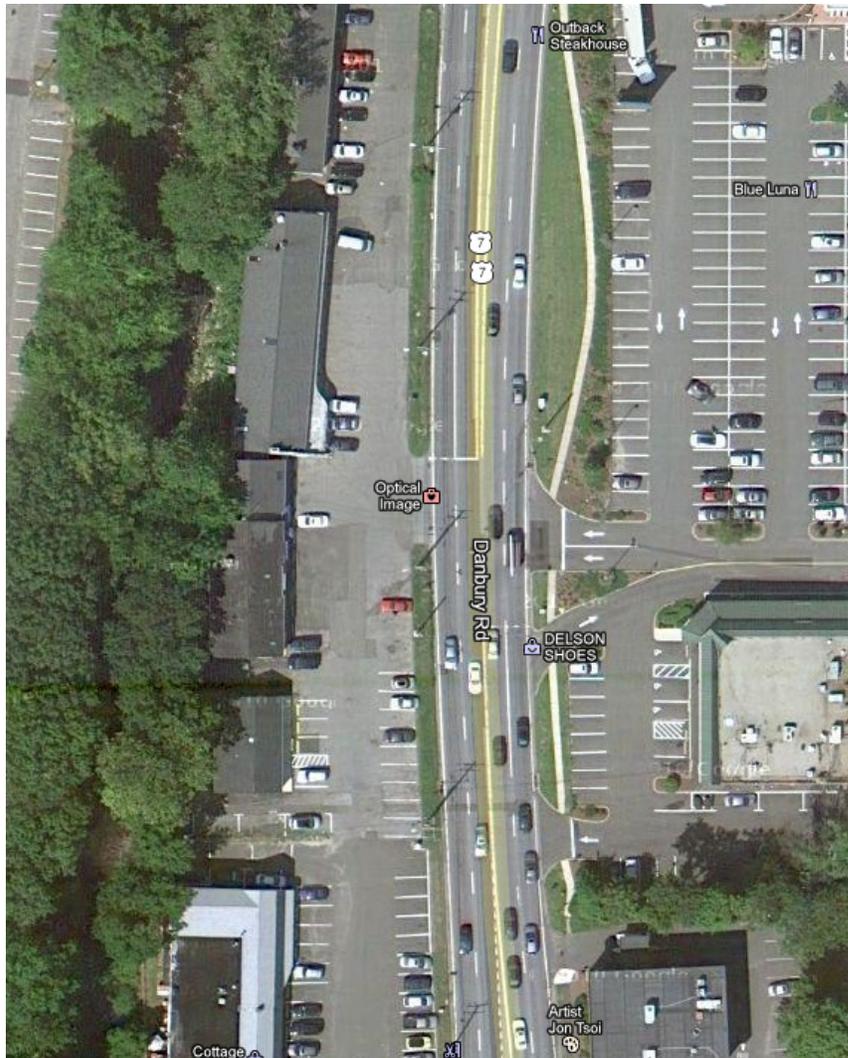
**Figure 25: Intersection of US Route 7 and Gateway Shopping Center**

The southbound traffic operations during the AM peak period generally operated well with minimal queuing and delay. During the PM peak in the southbound direction queuing sporadically extended back to the Gateway Shopping Center. The northbound direction during the AM and PM peak periods had slow moving traffic approaching the signal which could be due to the horizontal curve that begins south of Foxboro Road. During the travel time runs for both peaks, the run stopped at a red light at this intersection, so signal coordination may be an issue as well.
