# Route 7 Corridor Assessment and Implementation Plan

City of Norwalk and Town of Wilton, CT

## Existing Conditions Report

Prepared by  
Urban Engineers, Inc.

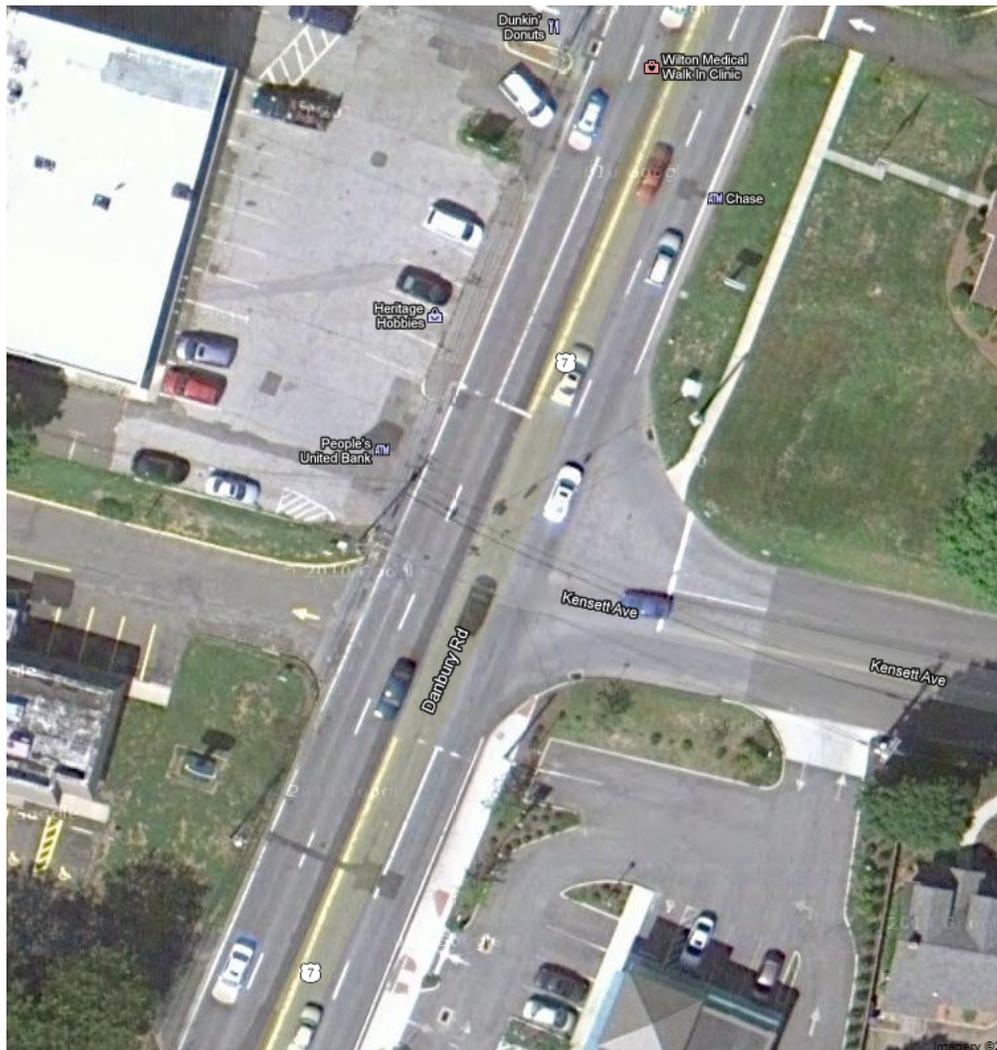
**Figure 27: Intersection of US Route 7 and Kennsett Ave**

**Figure 27** shows the signalized T-intersection of US Route 7 (Norwalk-Danbury Road) and Kennsett Avenue. US Route 7 approaches the intersection from the south at an upgrade and US Route 7 from the north approaches the intersection at a downgrade. Both northbound and southbound approaches on US Route 7 have two shared thru/turn lanes. The westbound approach of Kennsett Avenue has two lanes with worn striping and no signs indicating lane usage. The westbound approach includes two driveways, one an entrance only to a bank and the other an entrance/exit to a small shopping center. Less than 100 feet in any direction is another driveway to more shops or banks. To the north, a bank driveway is exit only and can be difficult for those attempting to go southbound.

On the west side of the intersection are multiple small shopping centers, a bank, and a Dunkin Donuts which creates access issues due to increased activity this business creates and the proximity of the access to the intersection. On the northeast corner is Chase Bank with

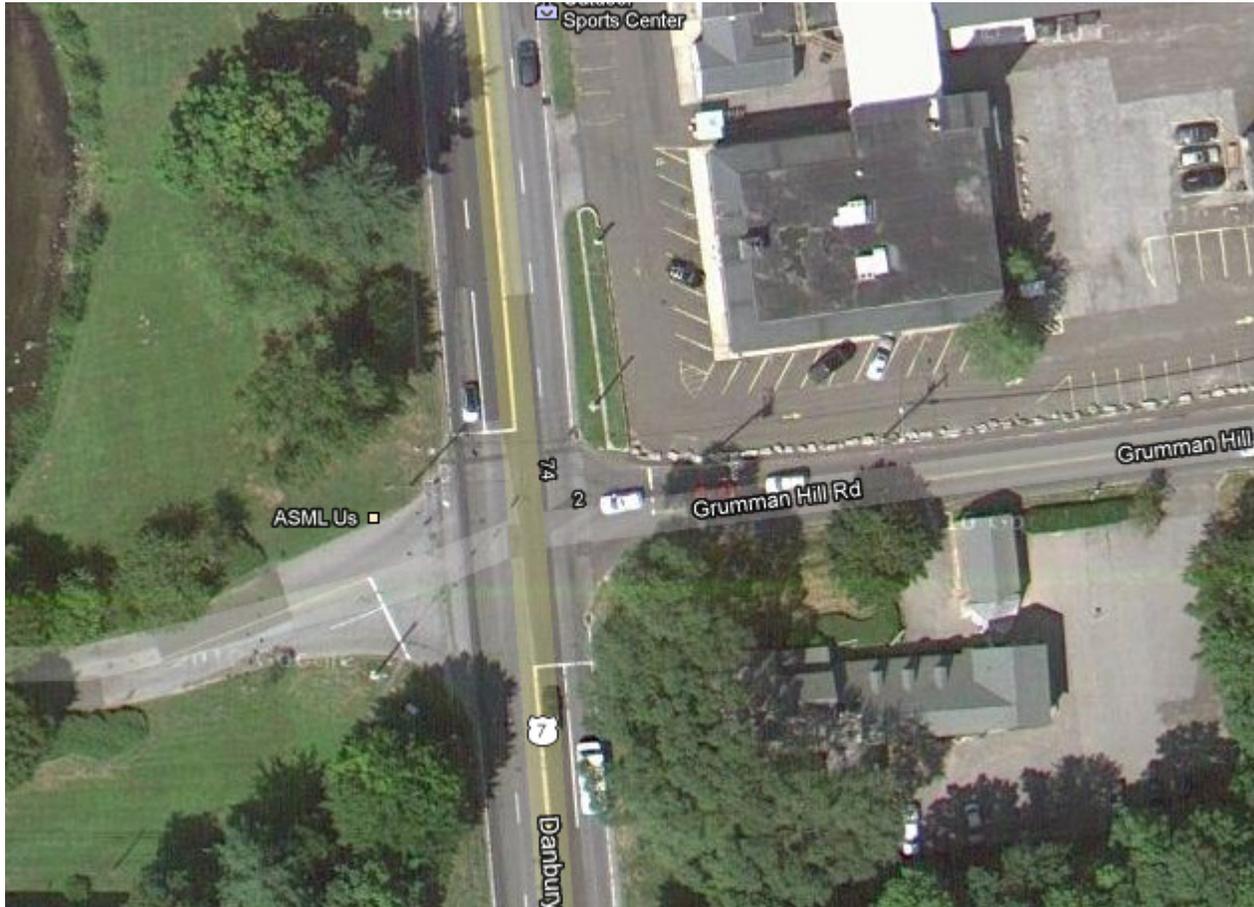
**Figure 29: Intersection of US Route 7 and Grumman Hill Rd**

**Figure 29** shows the signalized intersection of US Route 7 (Norwalk-Danbury Road) and Grumman Hill Road. US Route 7 has a shared thru/left and shared thru/right lane in each direction, and right turn on red is allowed in both directions on Route 7. The westbound approach of Grumman Hill Road has one lane, and the eastbound approach serves as a driveway to ASML and has a shared left/thru lane and a short right-turn lane.

On the west side of the intersection is ASML, a large production company. On the northeast corner of the intersection is a sporting goods store with a driveway 100 feet north of the intersection. On the southeast corner of the intersection is a building with a driveway on Grumman Hill Rd about 100 feet to the east which does not seem to impact the intersection.
