TRANSPORTATION MANAGEMENT PLAN
NEWTOWN ROAD (ROUTE 806)
DANBURY, CONNECTICUT

PREPARED FOR:
HOUSATONIC VALLEY COUNCIL OF ELECTED OFFICIALS (HVCEO)
CITY OF DANBURY

BY:
MILONE & MACBROOM, INC.
IN ASSOCIATION WITH
VN ENGINEERS, INC.

JUNE 2011

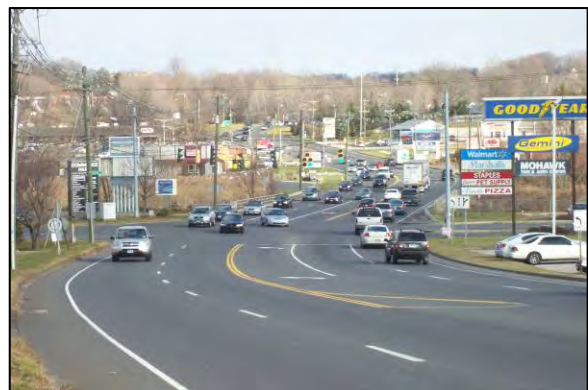
Eastern portion of Route 806 – Looking to the northeast past Eagle Road towards I-84

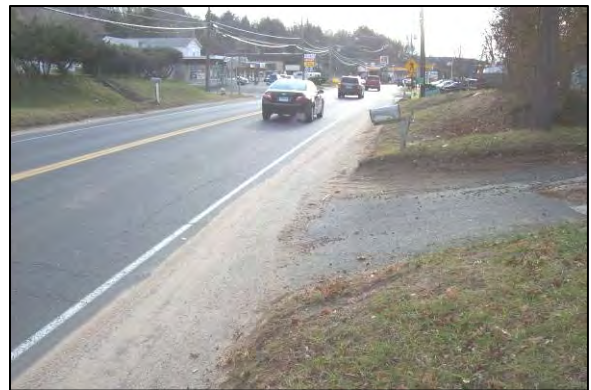
Western portion of Route 806 – Looking to the southwest towards Old Shelter Rock Road

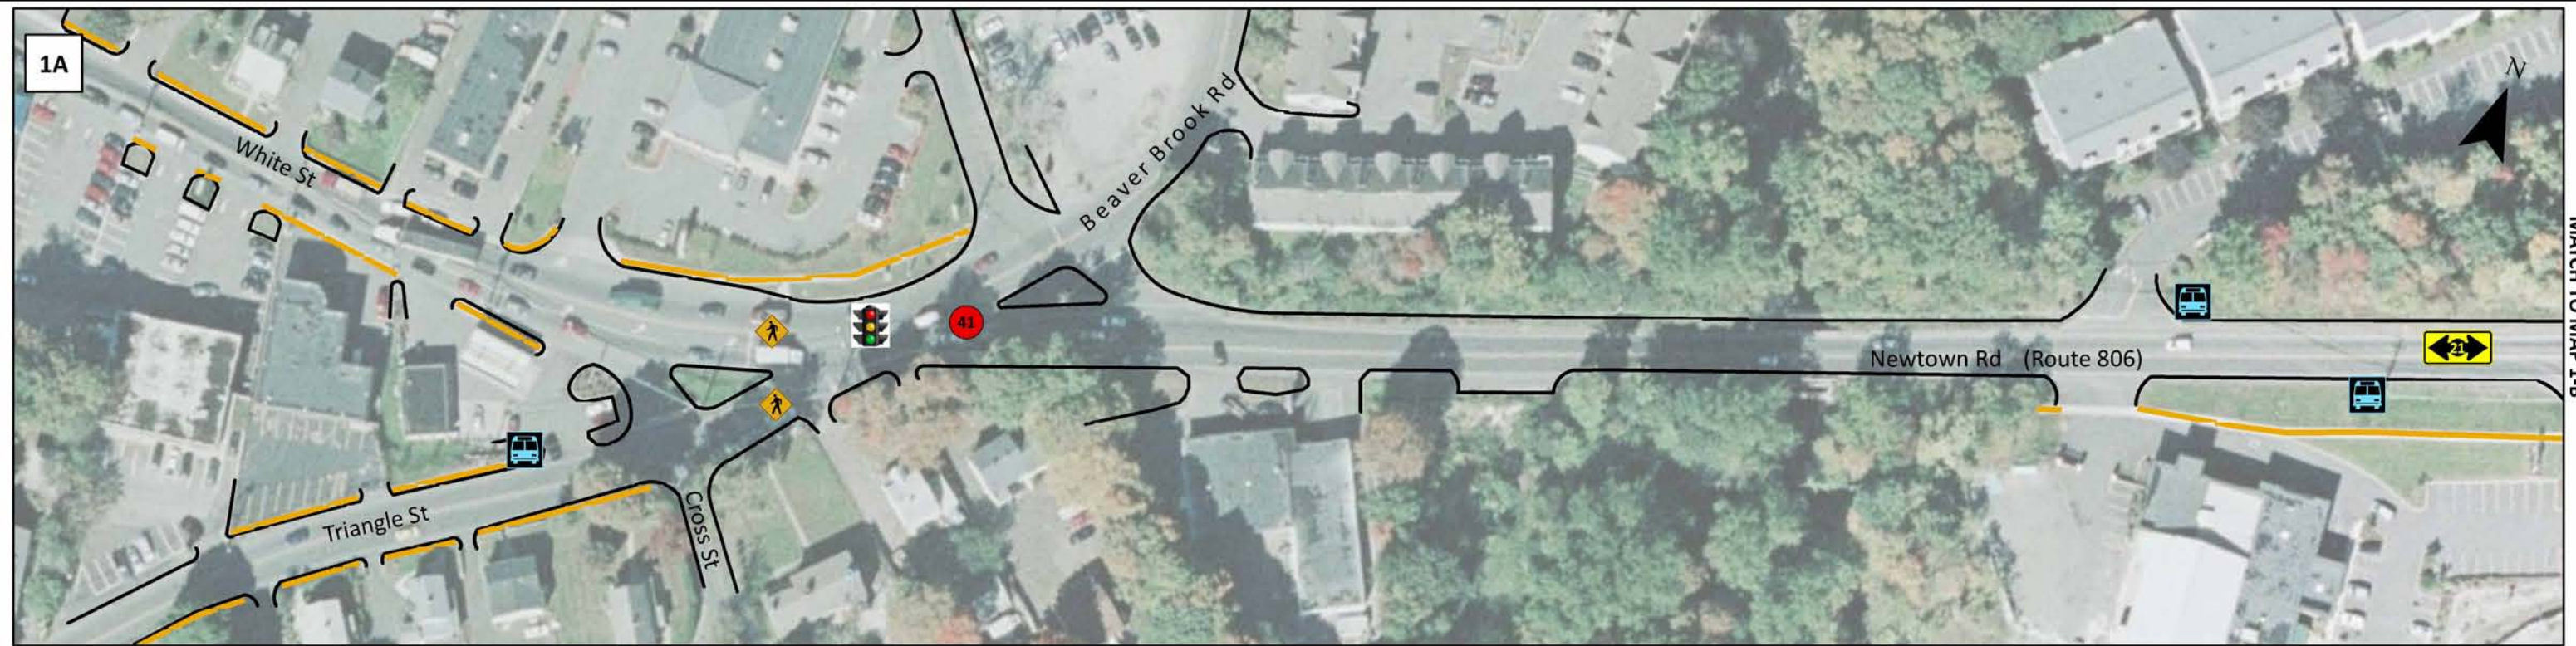
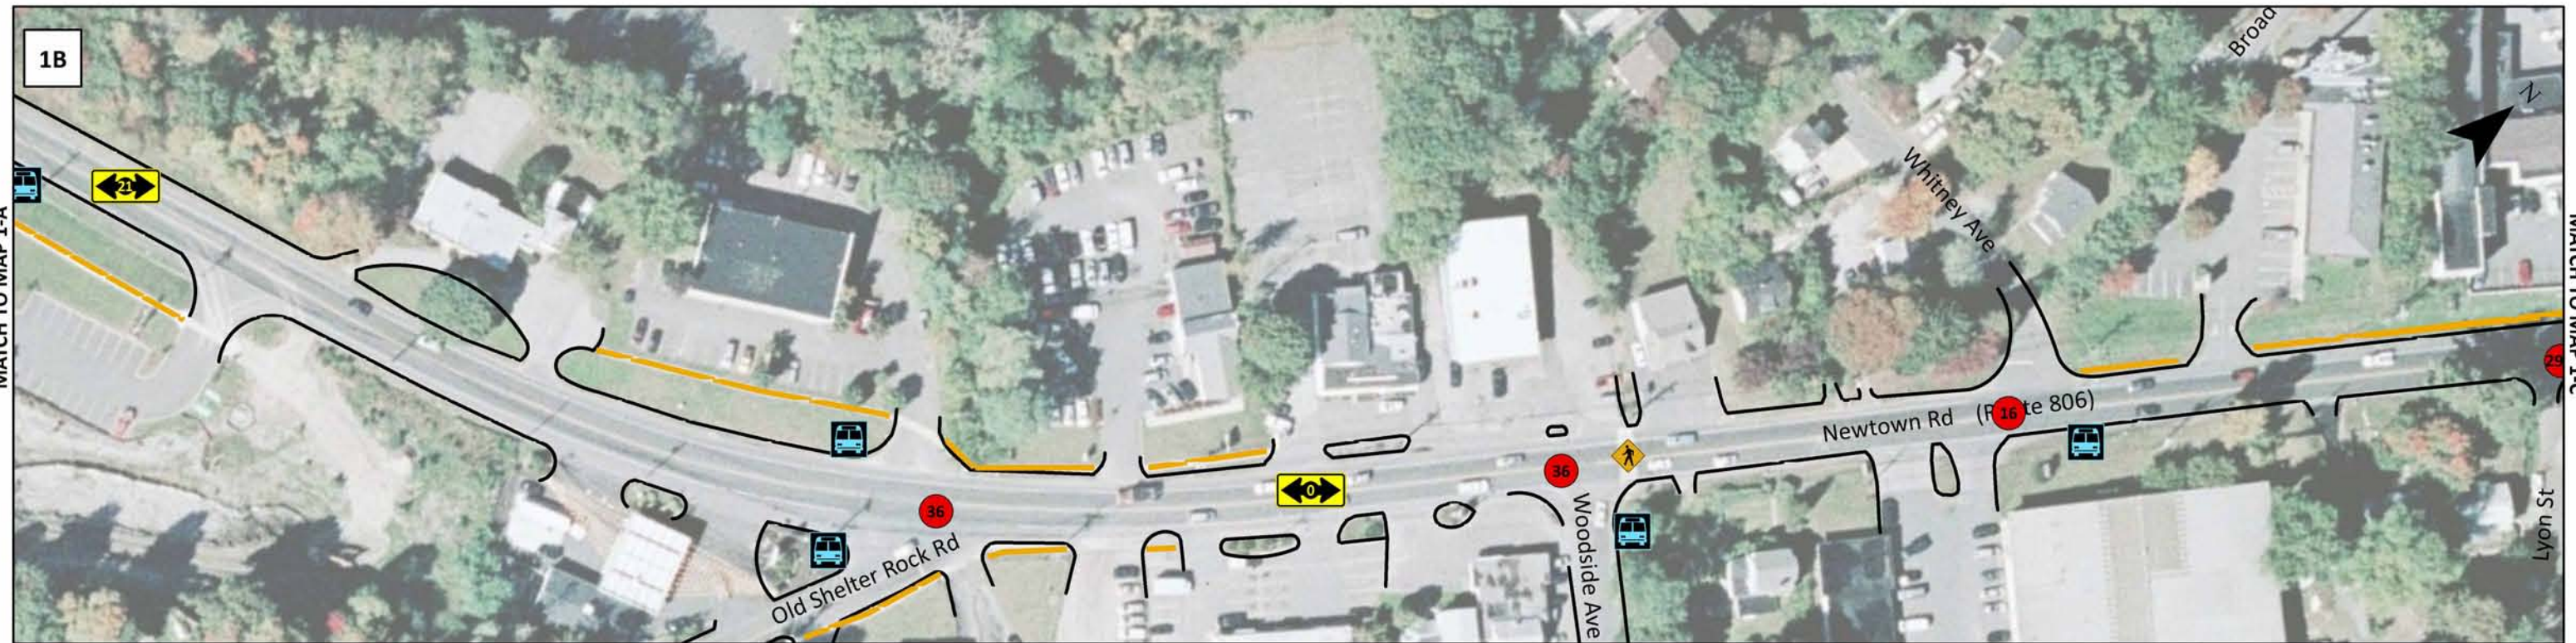
**Figure: 1A & 1B
Existing Conditions**

Existing conditions are presented graphically on Figures 1A through 1F. Conditions on these figures include the location of sidewalks, crosswalks, bus stops, curb cuts and signalized intersections. The figures also show the number of accidents reported from 2006 through 2008 broken out by mid-block and intersection locations.

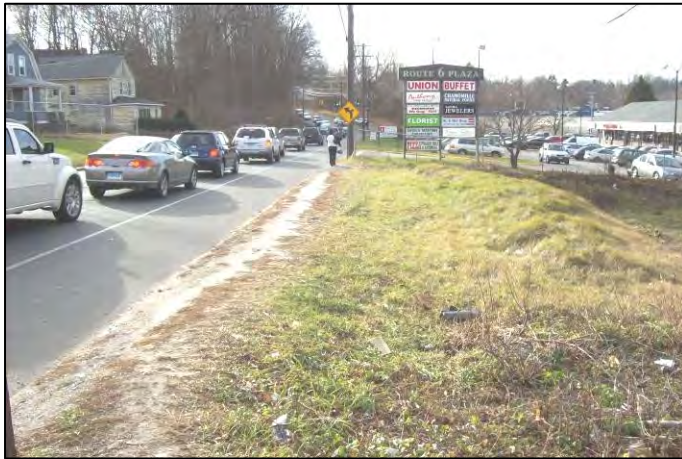
Transition area of Route 806 between Plumtrees Road and Old Newtown Road – Looking to the southwest towards Old Newtown Road

The transition area of Route 806 between Plumtrees Road and Old Newtown Road, and the intersection of Route 806 at Old Newtown Road itself can be considered a single problem due to the close proximity of the two intersections. Vehicles heading southwest on Route 806 through the intersection with Plumtrees Road must quickly merge from two lanes to a single lane.

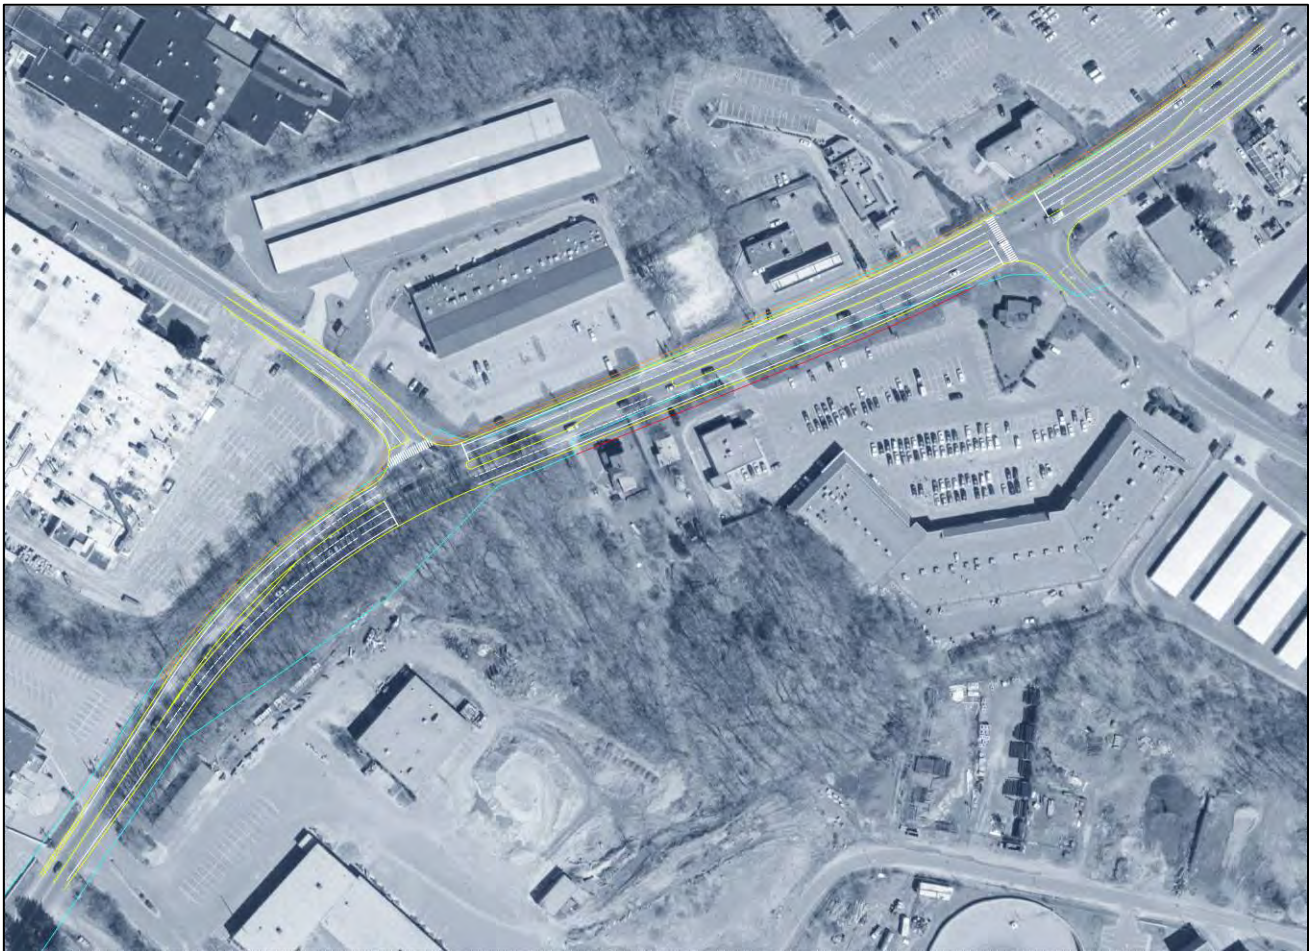
This plan provides two through lanes in each direction on Route 806 with an additional left turn lane. The Old Newtown Road approach would also be widened to provide two separate turn lanes. Moreover, the City of Danbury is seeking to construct a main entrance driveway for the Public Works Complex (DPW) driveway such that it would constitute a fourth leg to the intersection opposite Old Newtown Road. The redesign of the Route 806 at Old Newtown Road intersection is a top priority for the City and HVCEO. It has been indicated by HVCEO that STP-Urban funding is currently available for improvements to this intersection.

Conceptual Improvement for Route 806 at Old Newtown Road. Source: CTDOT, 2010.

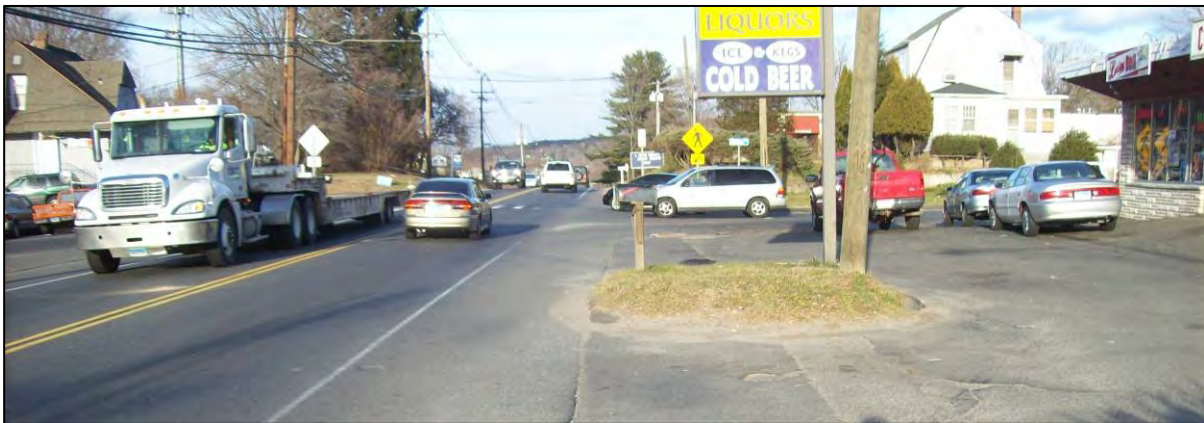
Route 806 at Woodside Avenue – Looking to the Northeast

The separate intersections of Woodside Avenue and Old Shelter Rock Road at Route 806 are closely spaced to one another at 400 feet apart. Local concerns dating back to the 1980s have led to multiple detailed investigations by CTDOT into the potential signalization of one or the other of these intersections^{1 2}. As is common at unsignalized stop controlled approaches to heavily travel roadways such as Route 806, long delays can occur for motorists trying to enter the major roadway. This is especially the case for left turns. The HART 2 bus line provides service along Woodside Avenue (to/from Eden Drive). Inbound buses along this line, for example, must make a difficult left turn from Woodside Avenue onto Route 806³.

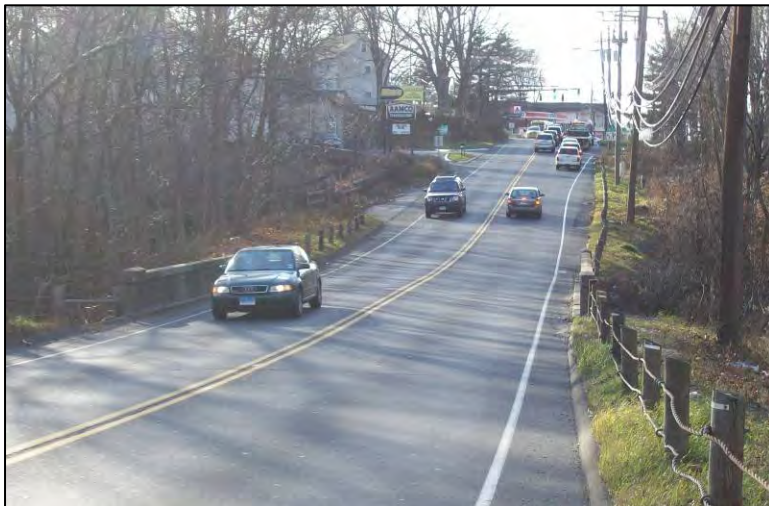
Route 806 Still River Bridge – Looking to the southwest towards White Street

The latter improvement concept was part of an investigation in the mid-1990s into widening the entire western portion of Route 806. The widening would be to increase Route 806 from the existing two travel lanes to a several lane cross section matching the eastern portion of the corridor. As would be expected, such a widening project would likely necessitate takings along the frontages of a number of properties through this stretch of Route 806. Furthermore, widening would require replacement of the bridge over the Still River that is located between White Street and Old Shelter Rock Road. As seen in the picture below, this bridge has narrow roadway shoulders and no dedicated space for pedestrians.

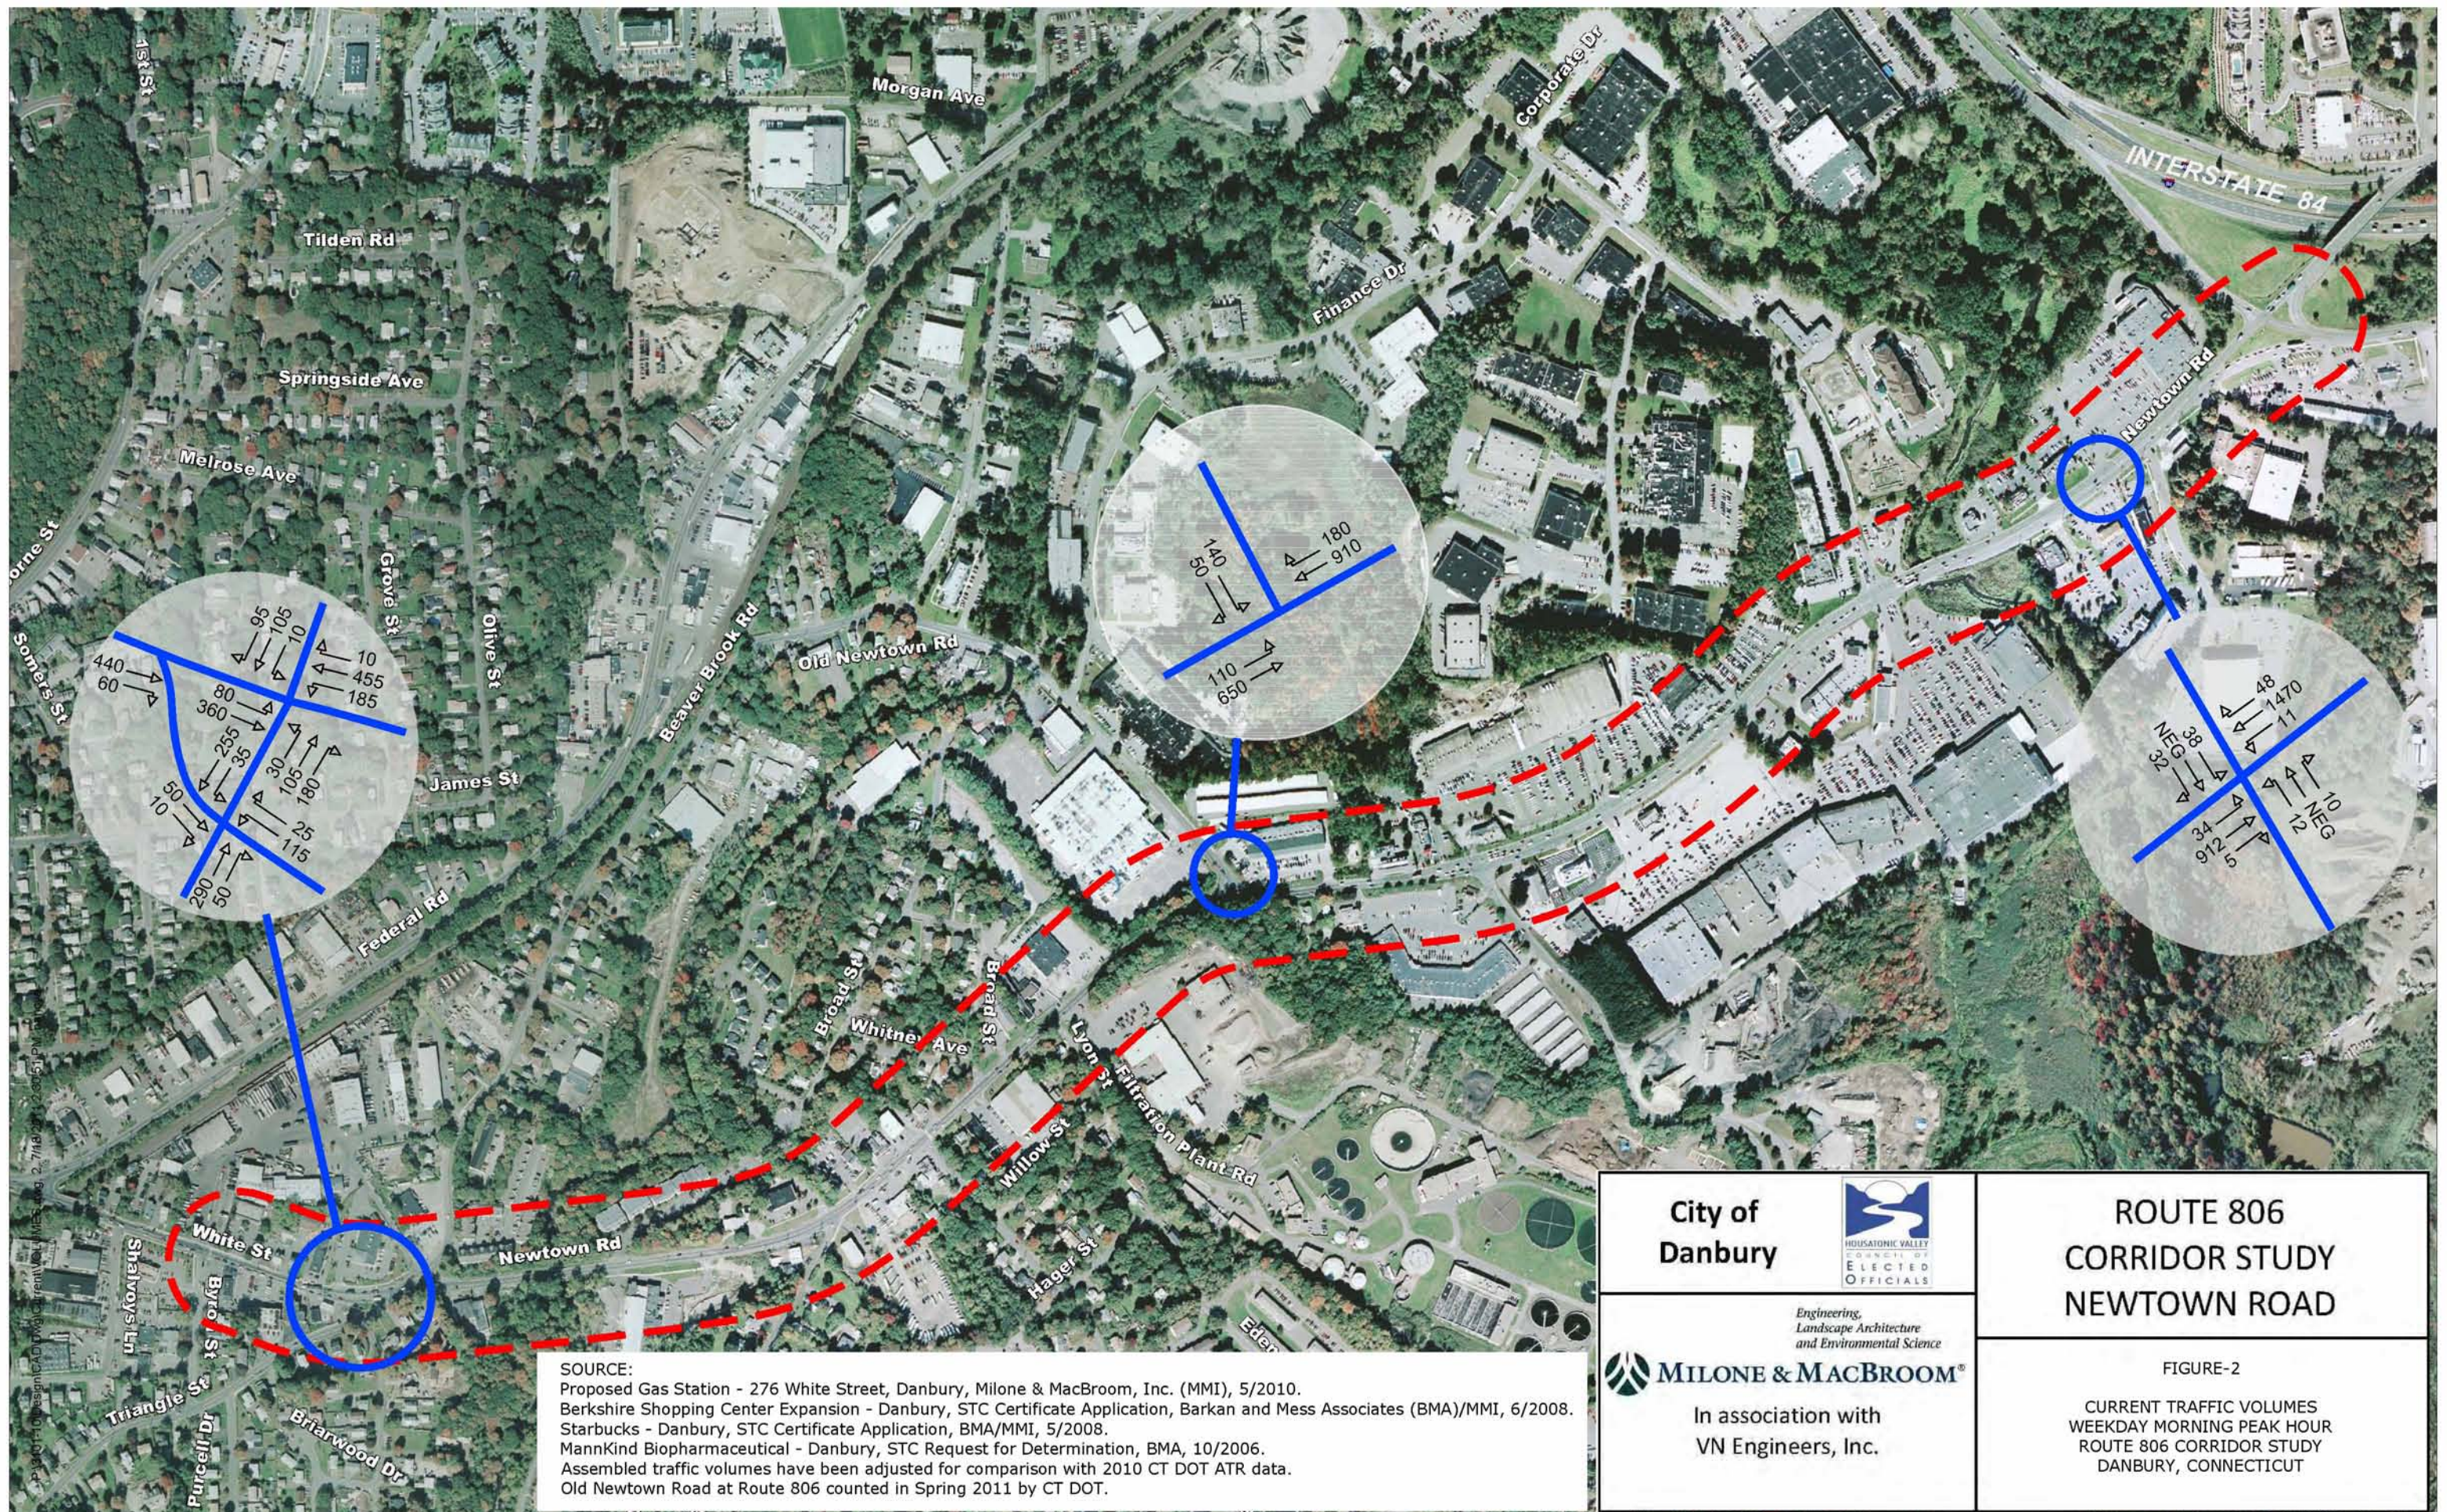
SOURCE:
 Proposed Gas Station - 276 White Street, Danbury, Milone & MacBroom, Inc. (MMI), 5/2010.
 Berkshire Shopping Center Expansion - Danbury, STC Certificate Application, Barkan and Mess Associates (BMA)/MMI, 6/2008.
 Starbucks - Danbury, STC Certificate Application, BMA/MMI, 5/2008.
 MannKind Biopharmaceutical - Danbury, STC Request for Determination, BMA, 10/2006.
 Assembled traffic volumes have been adjusted for comparison with 2010 CT DOT ATR data.
 Old Newtown Road at Route 806 counted in Spring 2011 by CT DOT.

<p>MILONE & MACBROOM</p> <p>In association with VN Engineers, Inc.</p>	
<p>FIGURE-2</p> <p>CURRENT TRAFFIC VOLUMES WEEKDAY MORNING PEAK HOUR ROUTE 806 CORRIDOR STUDY DANBURY, CONNECTICUT</p>

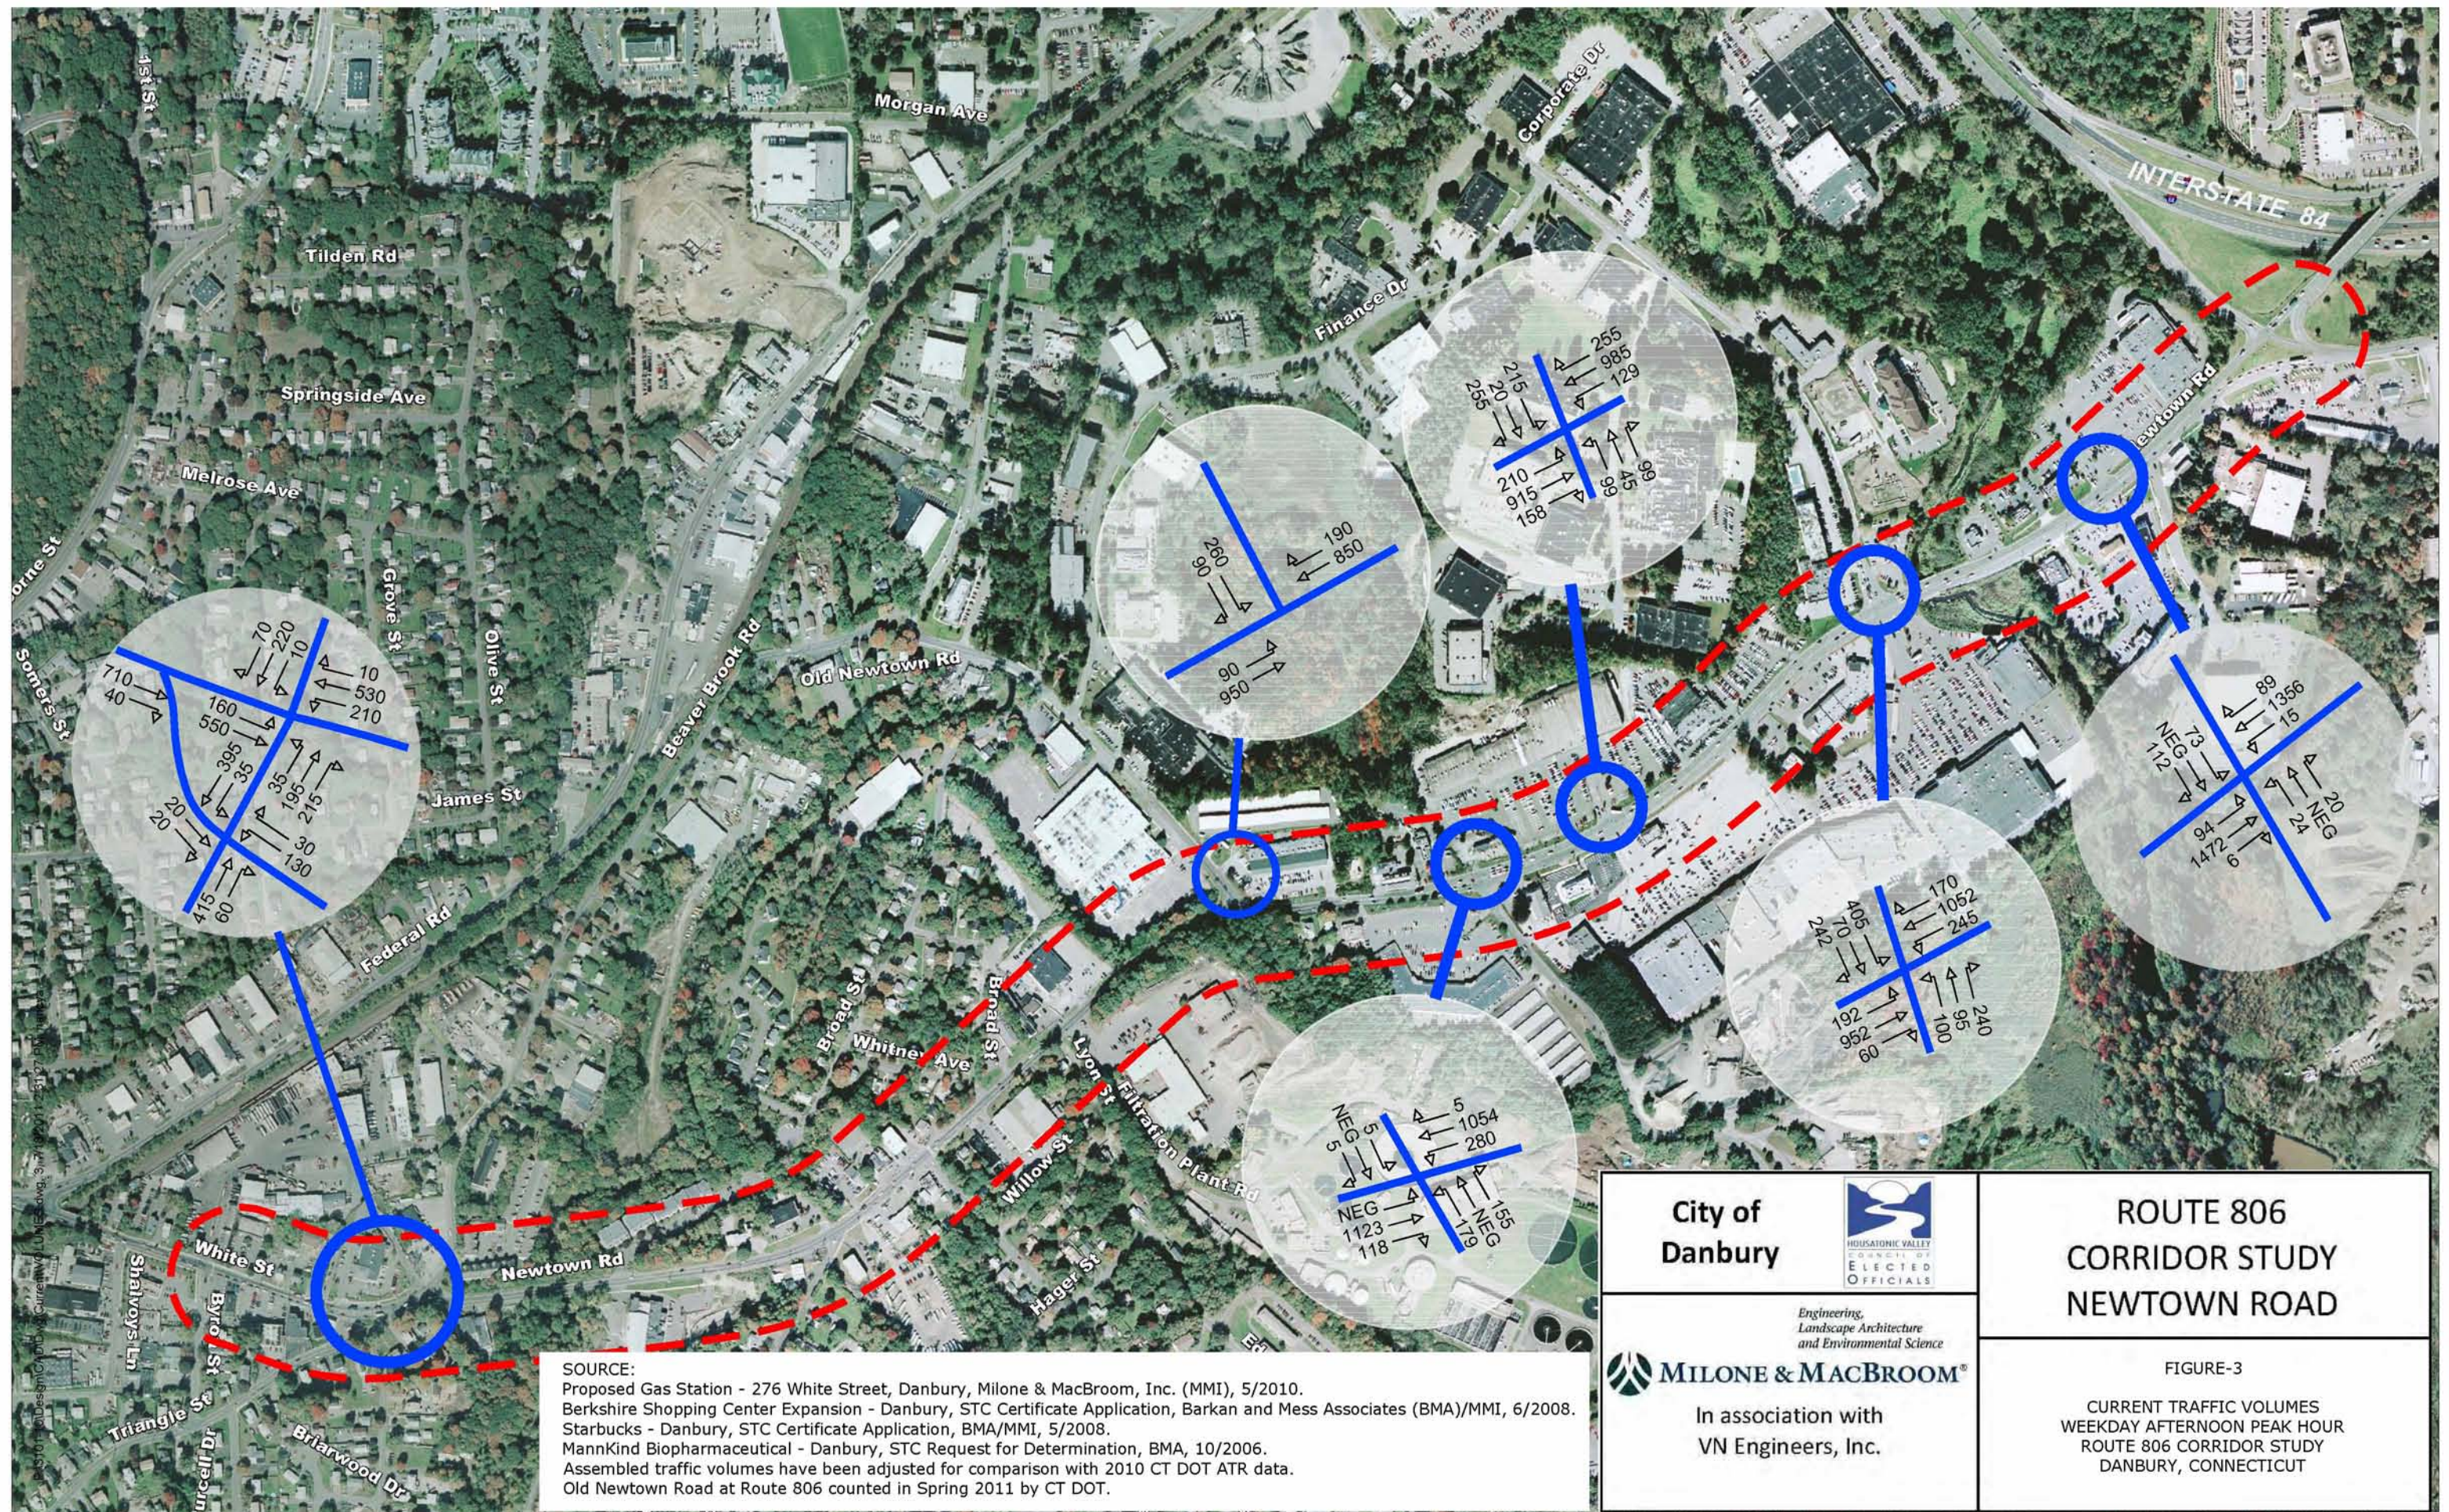
CURRENT TRAFFIC VOLUMES
WEEKDAY AFTERNOON PEAK HOUR
ROUTE 806 CORRIDOR STUDY
DANBURY, CONNECTICUT

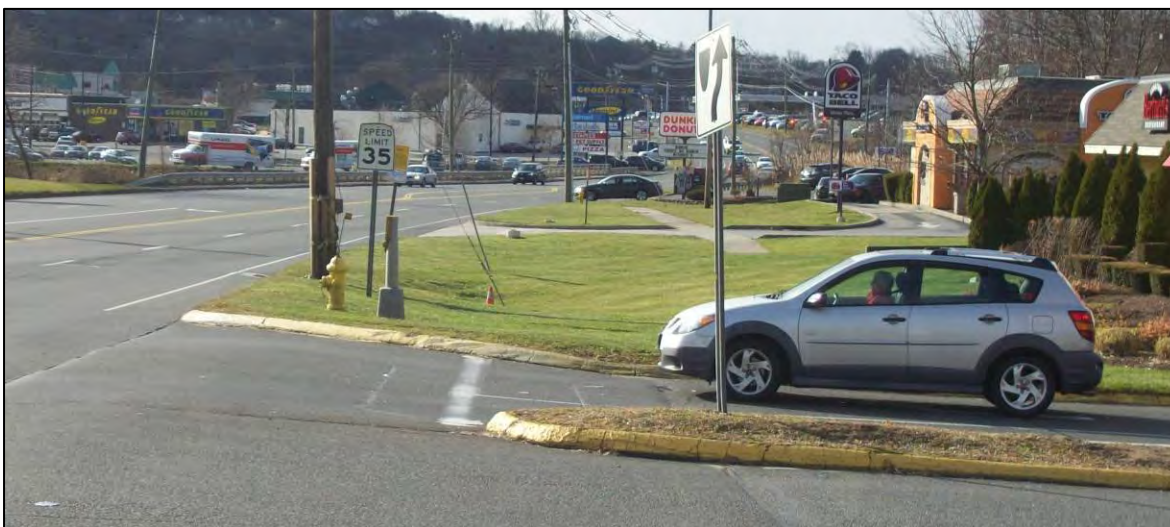
The north side of Route 806 between I-84 eastbound Exit 8 and Eagle Road has only a short sidewalk along the Taco Bell frontage that is less than 200 feet in length. This concrete sidewalk looks to be fairly new and in good condition, but does not connect to the restaurant building itself.

Sidewalk in front of Taco Bell along the north side of Route 806 – looking to the southwest)

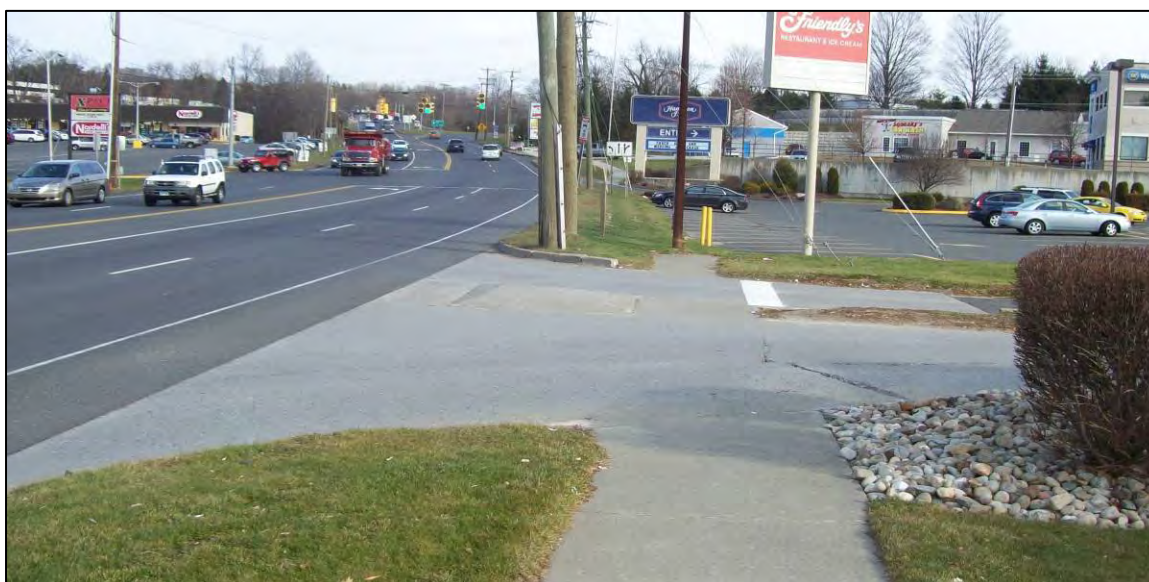
Sidewalks do exist along much of the south side of Route 806 in this area, with the exception of the Friendly's Restaurant frontage. A gap in the network is present here where no sidewalk is provided. The beginnings of a worn foot path are evident along this stretch, indicating that some amount of pedestrian traffic occurs here.

A gap in the sidewalk network in front of Friendly's along the south side of Route 806 – looking to the northeast

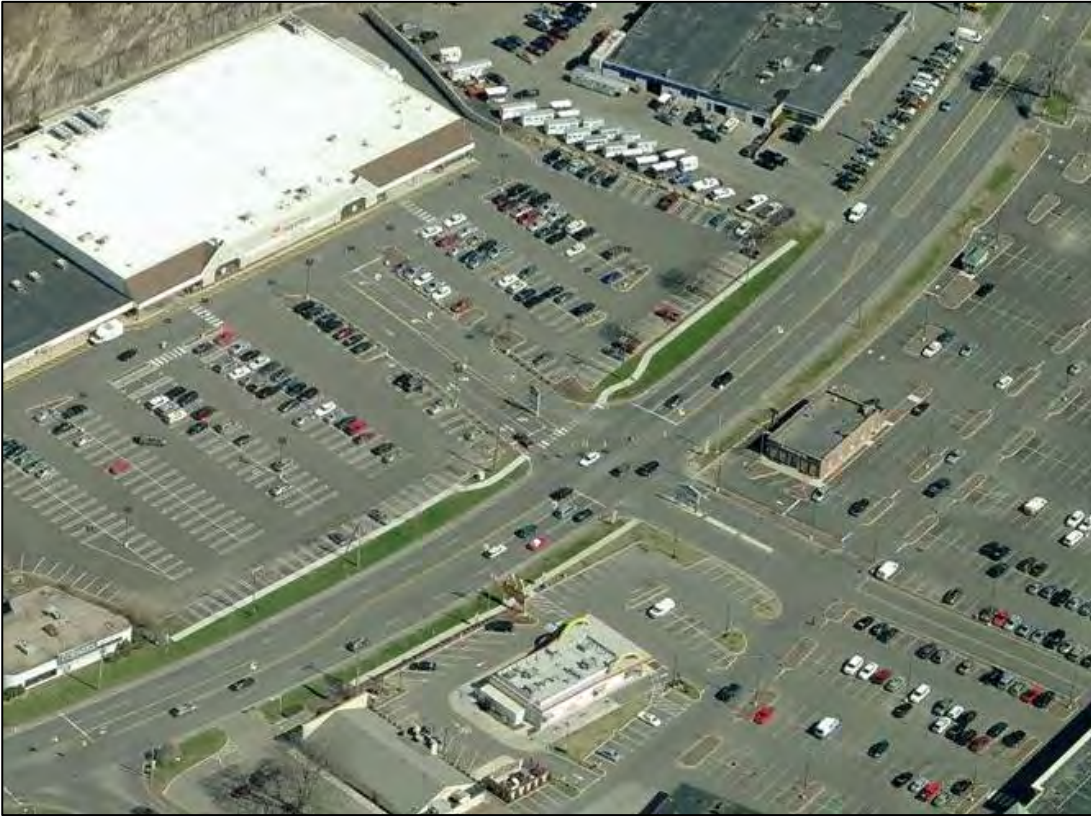
Route 806 at Nutmeg Square Shopping Center and Berkshire Shopping Center. Source: Microsoft Corp.

Two areas of sidewalk exist along Route 806 between Eagle Road and Plumtrees Road. Both concrete and in great condition, these sidewalks are located along the Nutmeg Square shopping center (Stop and Shop) frontage on the north side of Route 806 and in front of the McDonald's Restaurant along the south side of the roadway. Pedestrian buffer space between the sidewalks and the corridor is present.

A single crosswalk is located in this area, traversing the driveway for the Nutmeg Square shopping center. No crosswalks extend across Route 806 in this area between Eagle Road and Plumtrees Road. One bus stop sign is located in this area where no sidewalk exists on the north side of Route 806 approximately 100 feet west of Eagle Road. The beginnings of worn foot paths are evident at locations along this stretch of Route 806 without sidewalks.

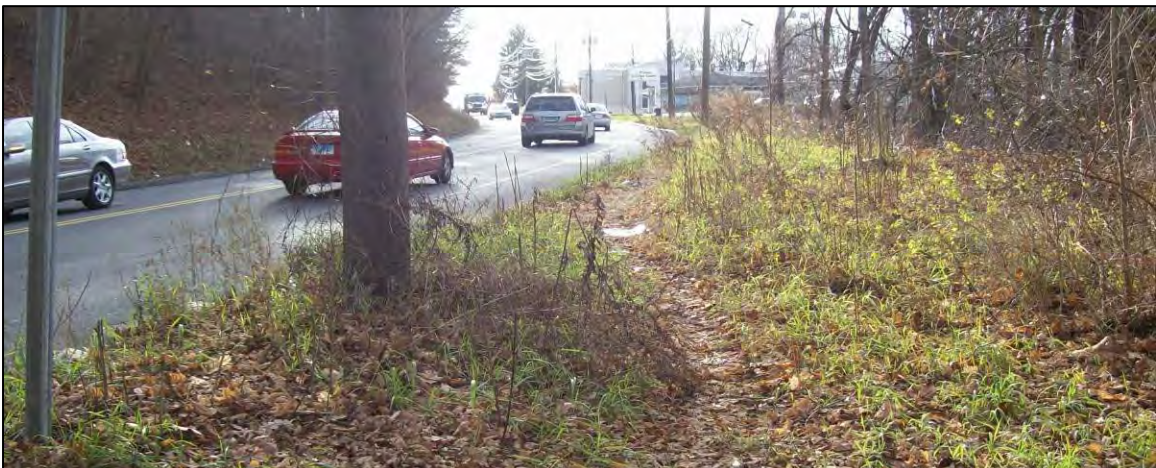
A worn foot path along the north side of Route 806 west of Old Newtown Road – looking to the southwest

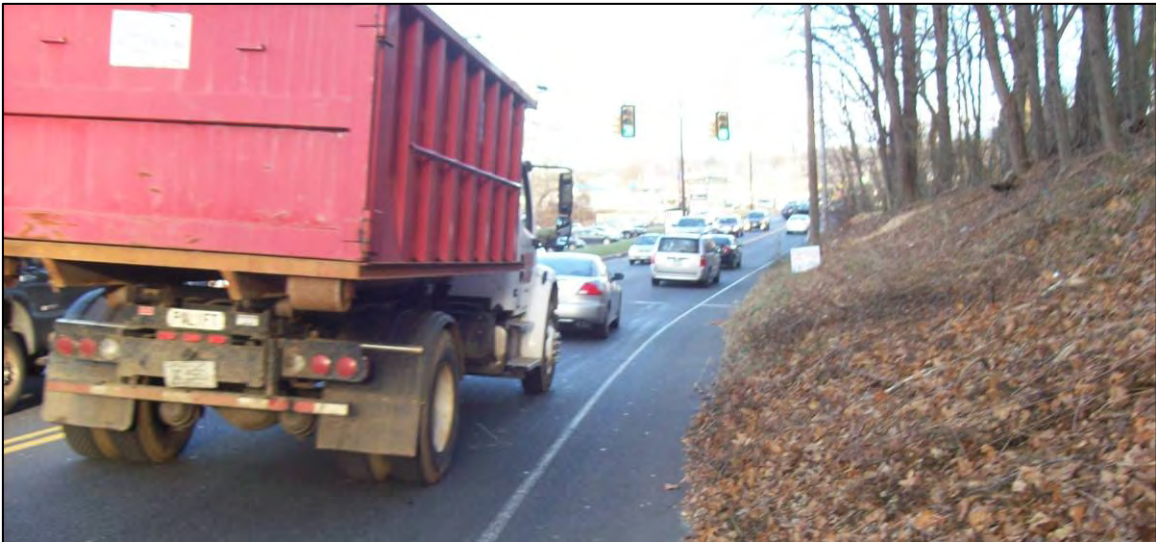
Pedestrians are forced to walk on the roadway shoulder along the south side of Route 806 near Old Newtown Road

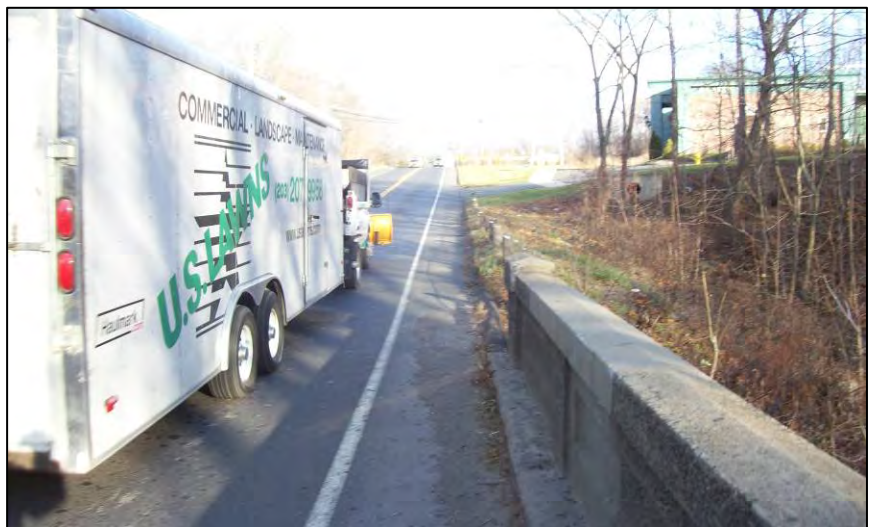
Pedestrians are forced to walk on the Route 806 roadway shoulder on the Still River Bridge

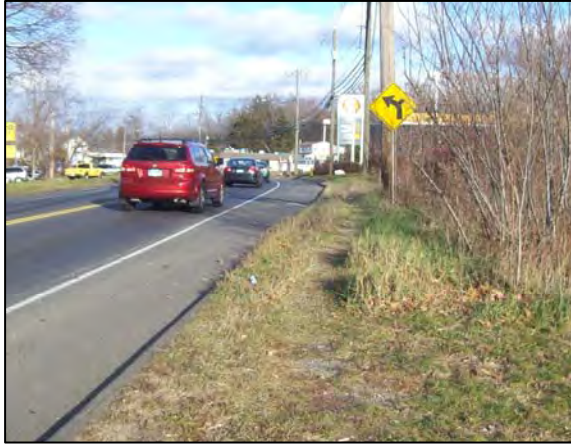
A worn footpath along the south side of Route 806 approaching Old Shelter Rock Road

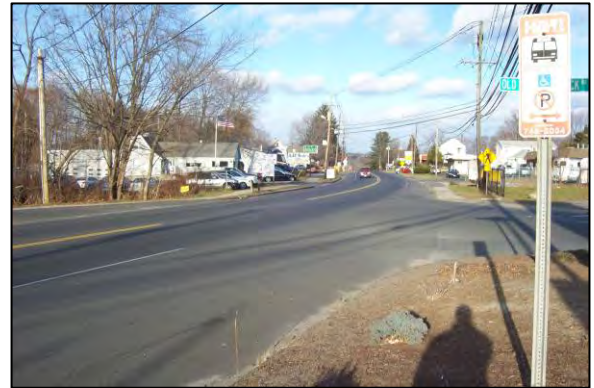
Corner of Old Shelter Rock Rd

The lack of pedestrian facilities at many designated transit stops within the corridor appears to pose some danger to transit riders, as they board and exit on the side of the road. With snow cover, pedestrians would be forced onto the pavement at these sites.

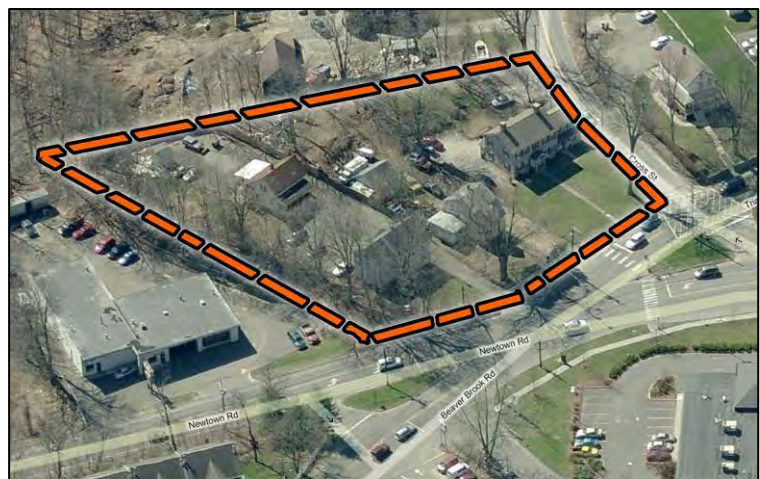
Build Out Analysis Area “A” – Potential for 11,500 sf. of Retail Development

Looking to the future, it is expected that the land use patterns impacting Route 806 will remain relatively unchanged. Figure 6 titled “*Build Out Potential*” presents estimates of potential future development impacting the corridor. This build-out is expressed in terms of

potential gross building square footage. For the purposes of the build out analysis constrained land was deducted from the gross land to compute net buildable land. Based upon existing zoning, it is estimated that an additional 48,600 square feet of commercial development can be accommodated within the corridor.
