TRANSPORTATION MANAGEMENT PLAN
NEWTOWN ROAD (ROUTE 806)
DANBURY, CONNECTICUT

PREPARED FOR:
HOUSATONIC VALLEY COUNCIL OF ELECTED OFFICIALS (HVCEO)
CITY OF DANBURY

BY:
MILONE & MACBROOM, INC.
IN ASSOCIATION WITH
VN ENGINEERS, INC.

JUNE 2011

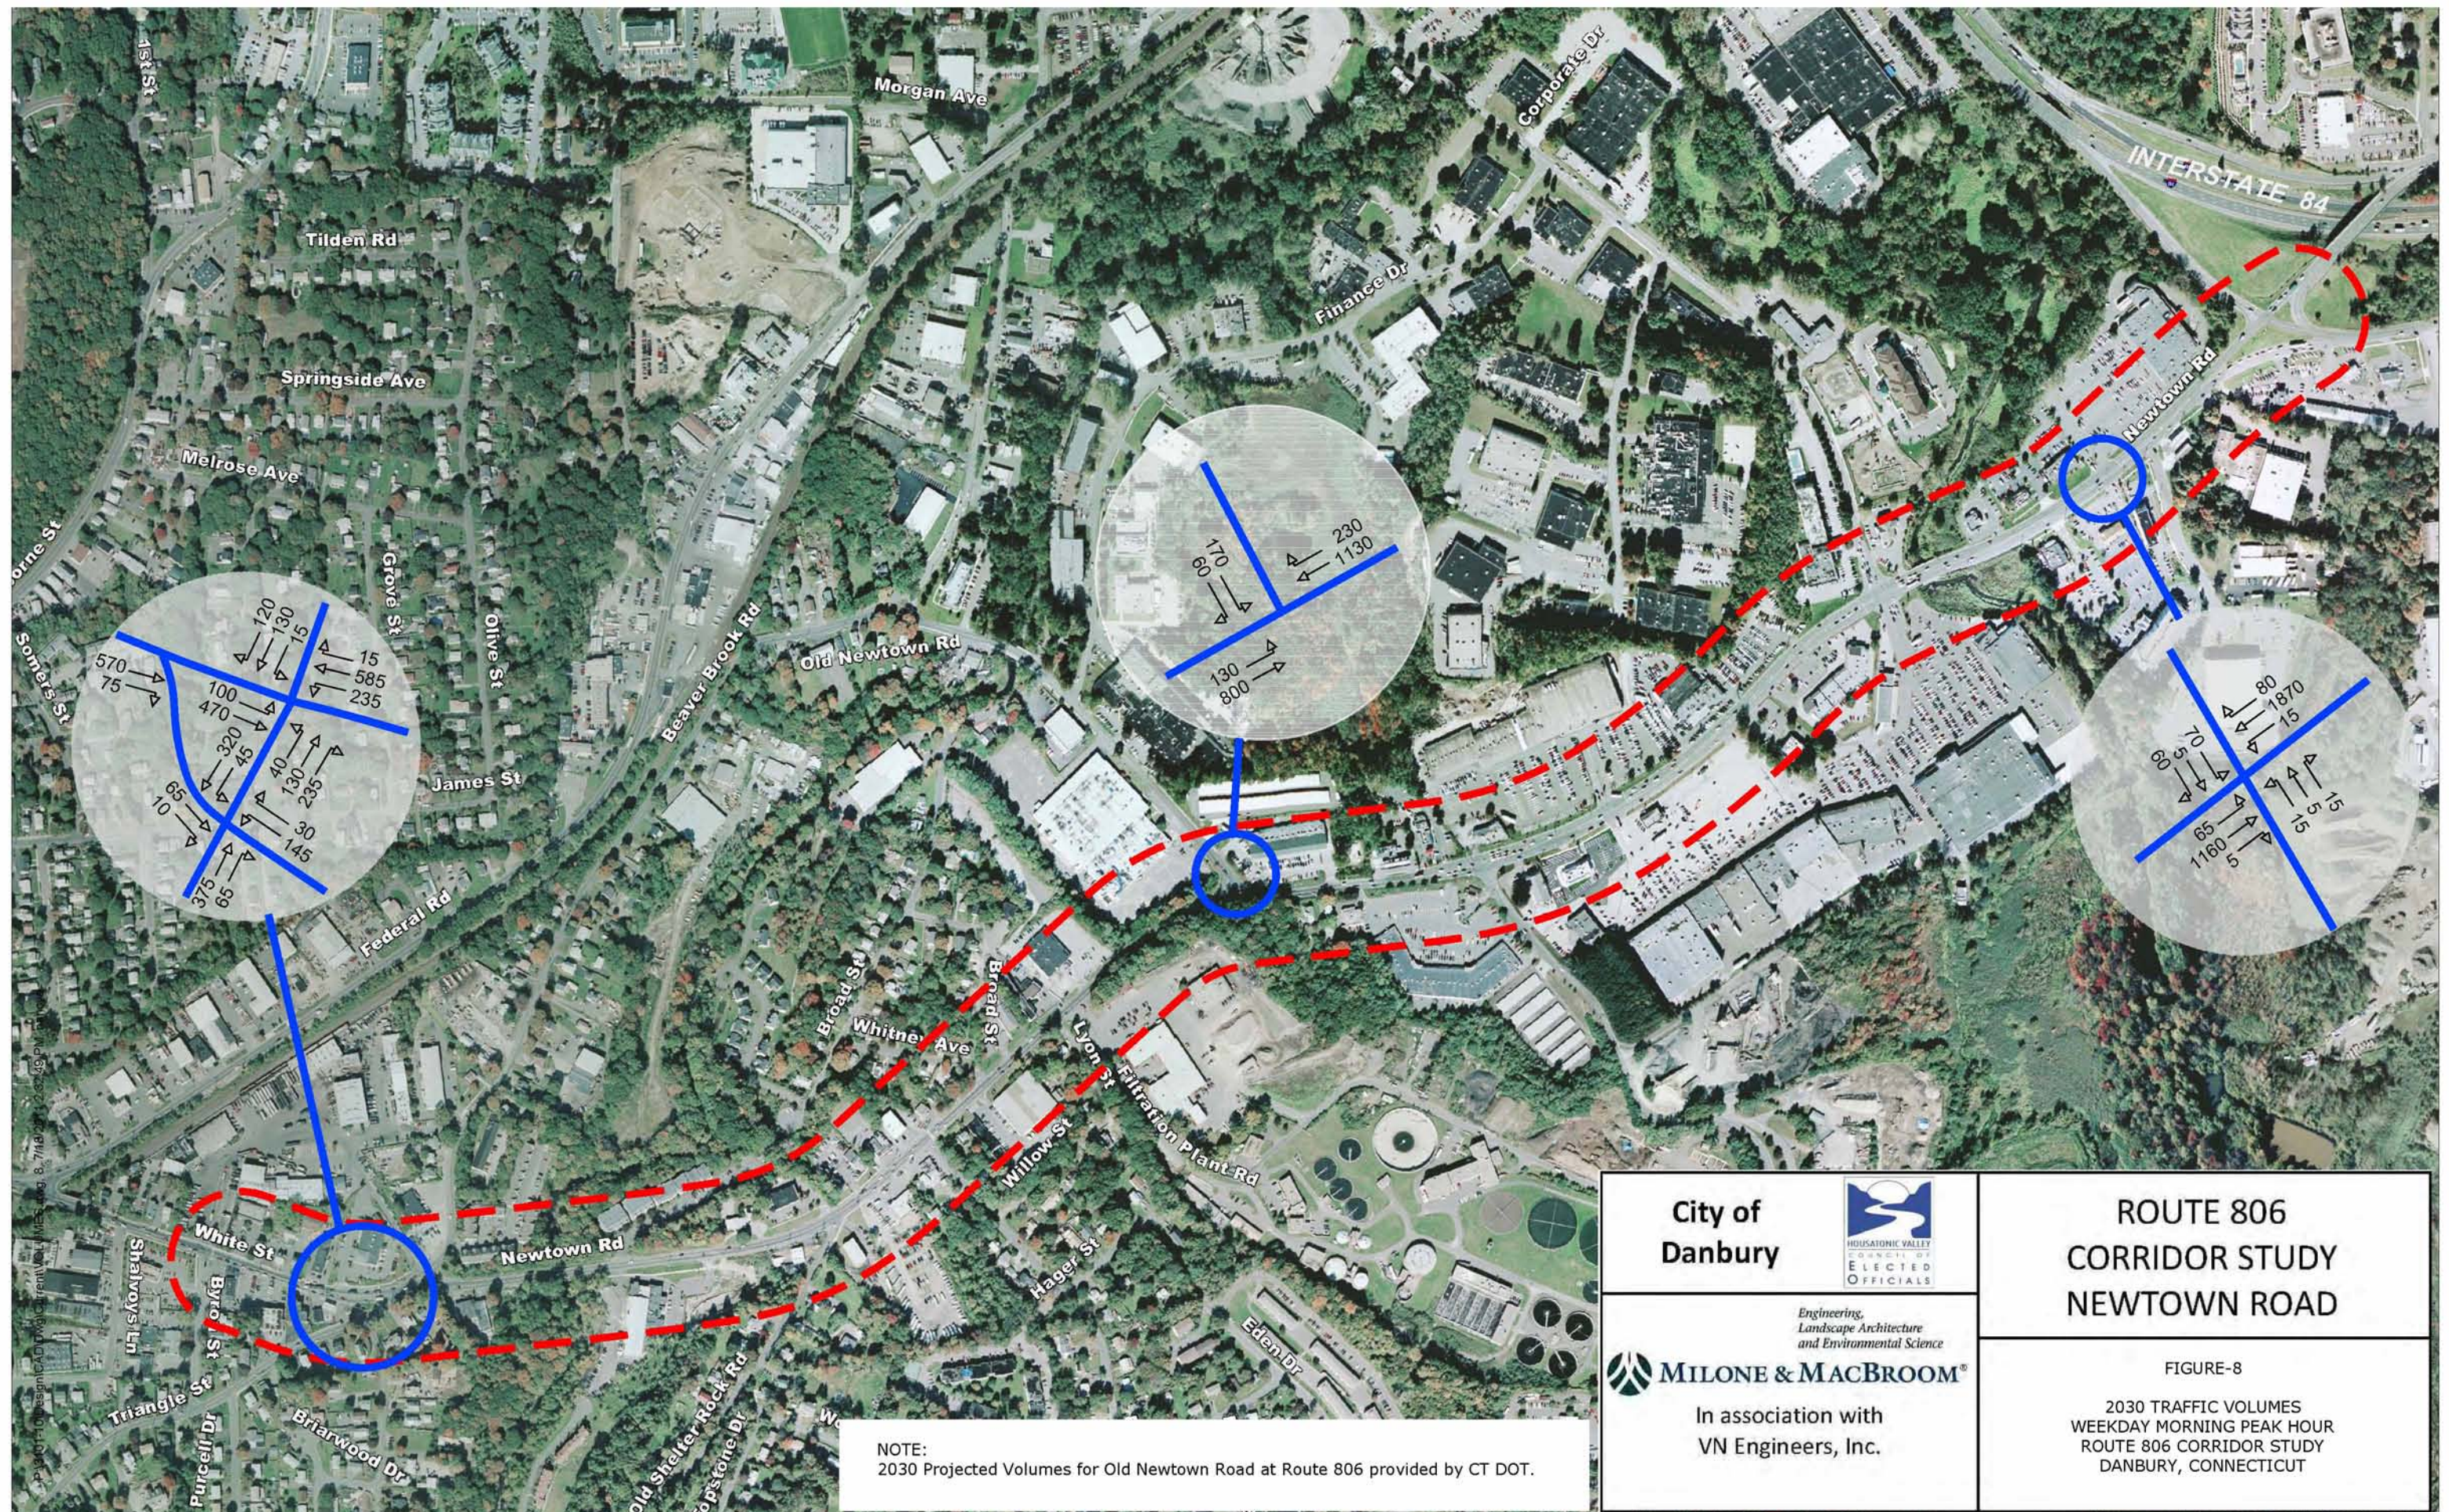
2030 TRAFFIC VOLUMES
WEEKDAY MORNING PEAK HOUR
ROUTE 806 CORRIDOR STUDY
DANBURY, CONNECTICUT

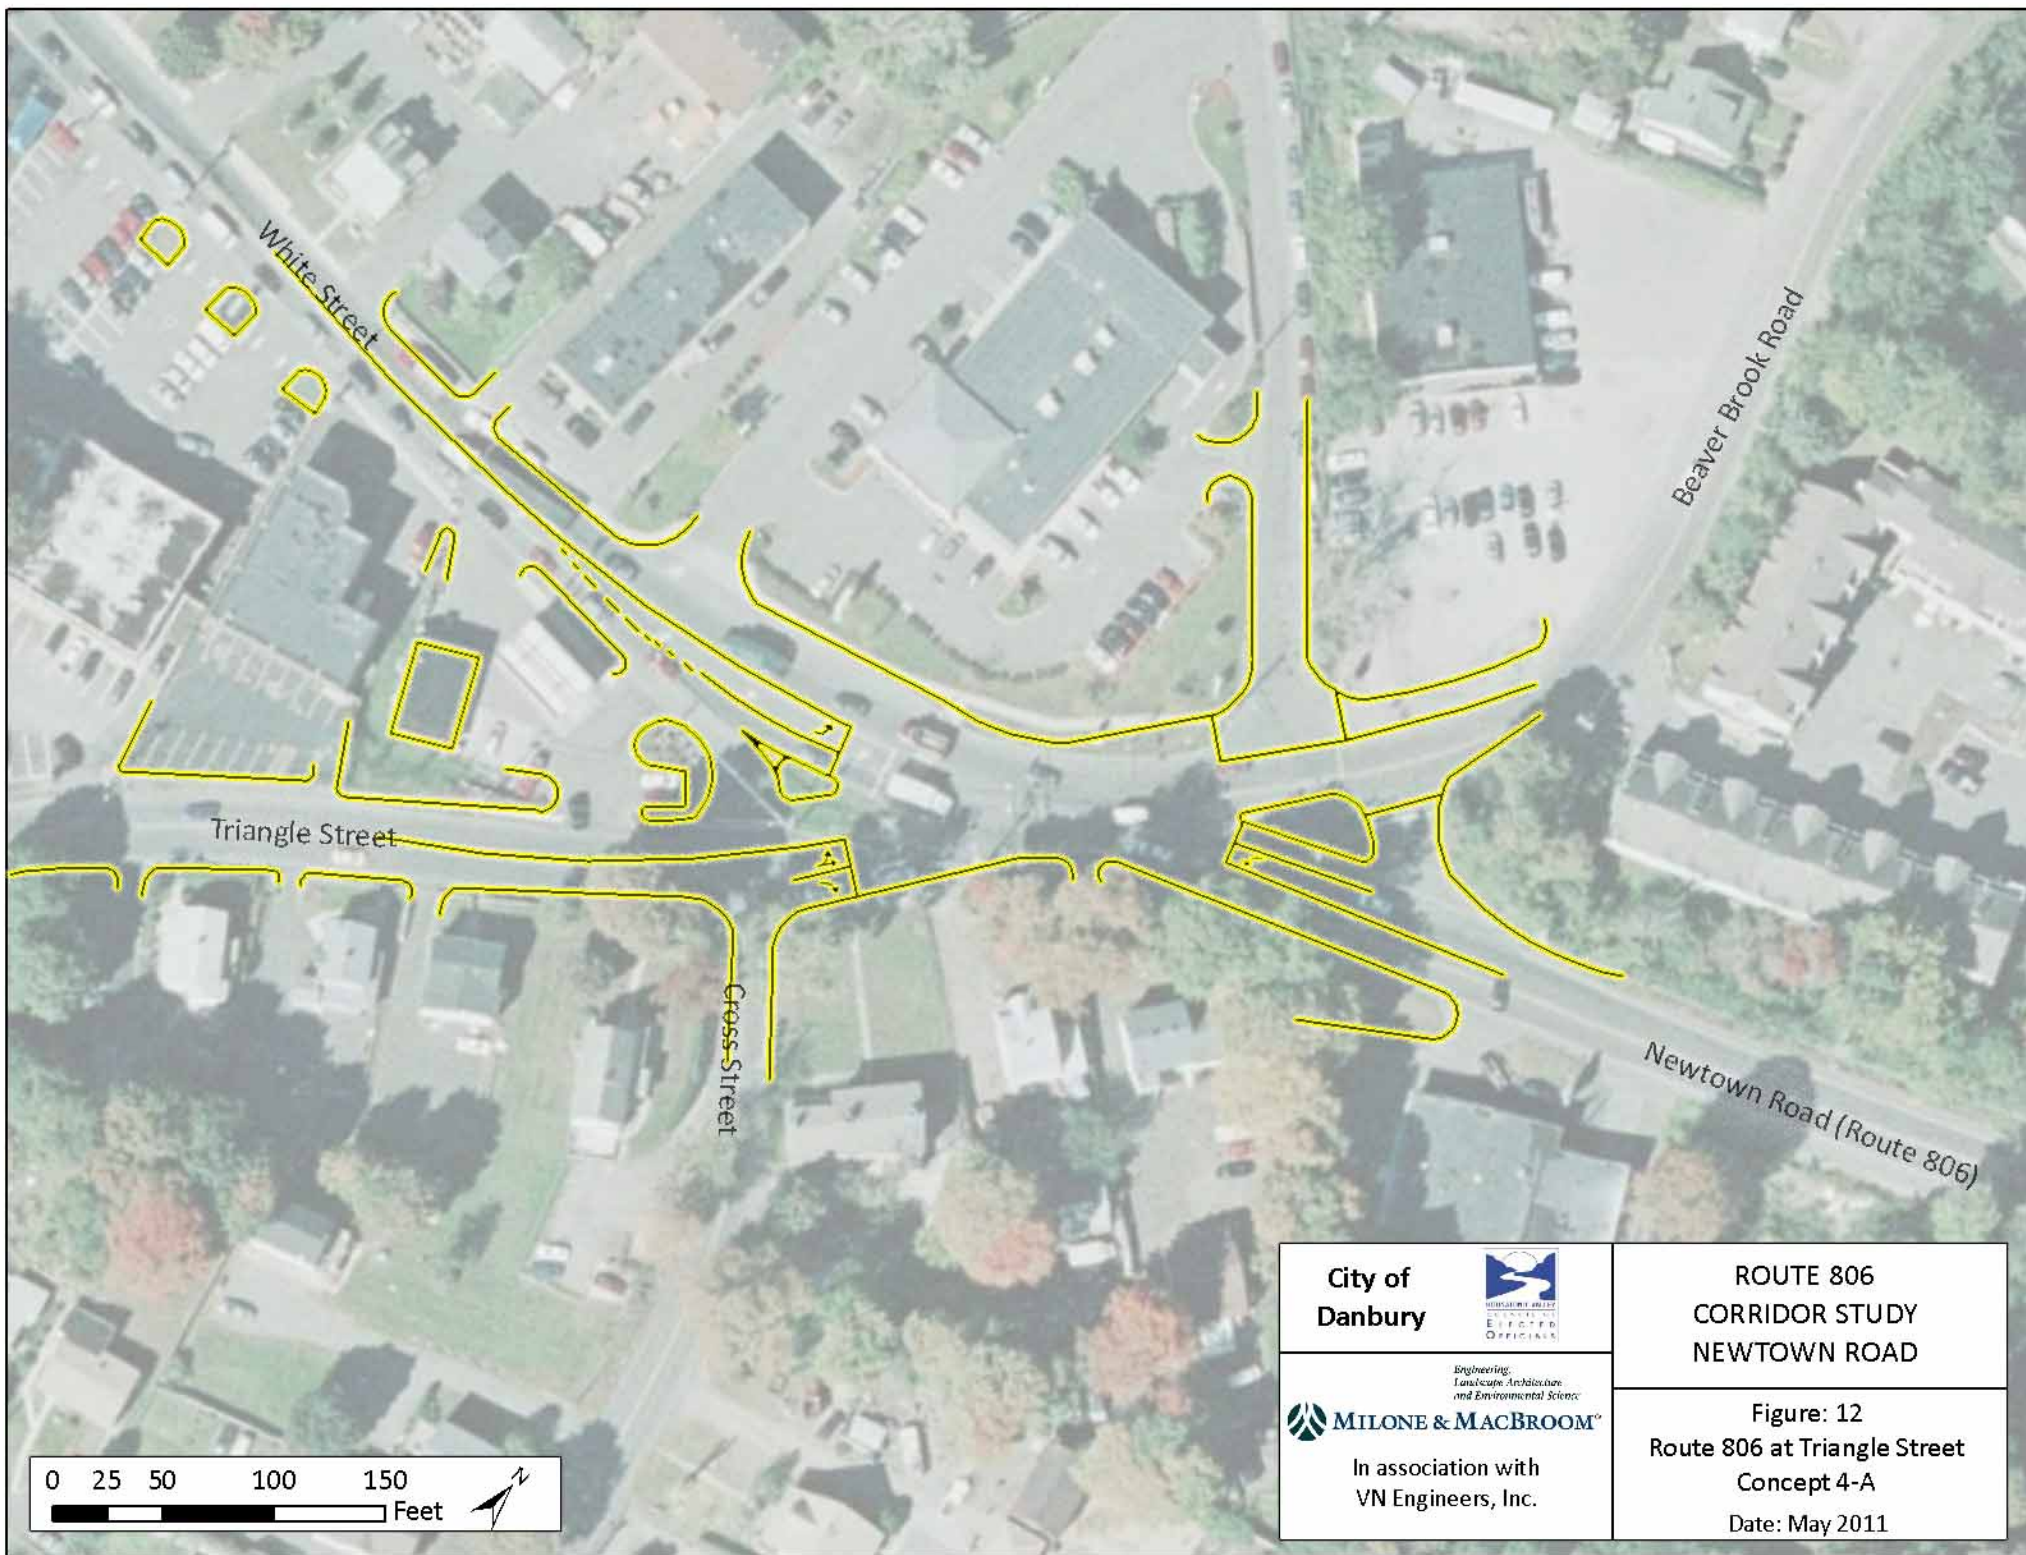
With some widening through the intersection of Route 806 and White Street, this concept would result in improvement of overall LOS from F to E under 2030 conditions, but no significant change to LOS under current conditions.

This concept is to restrict northbound traffic from Triangle Street making Triangle Street one-way southbound from Route 806 to Purcell Drive/Byron Street. As a result, motorists would be diverted to Byron Street or avoid the area and use other streets in the wider geographic area such as Shelter Rock Road and Old Shelter Rock Road.

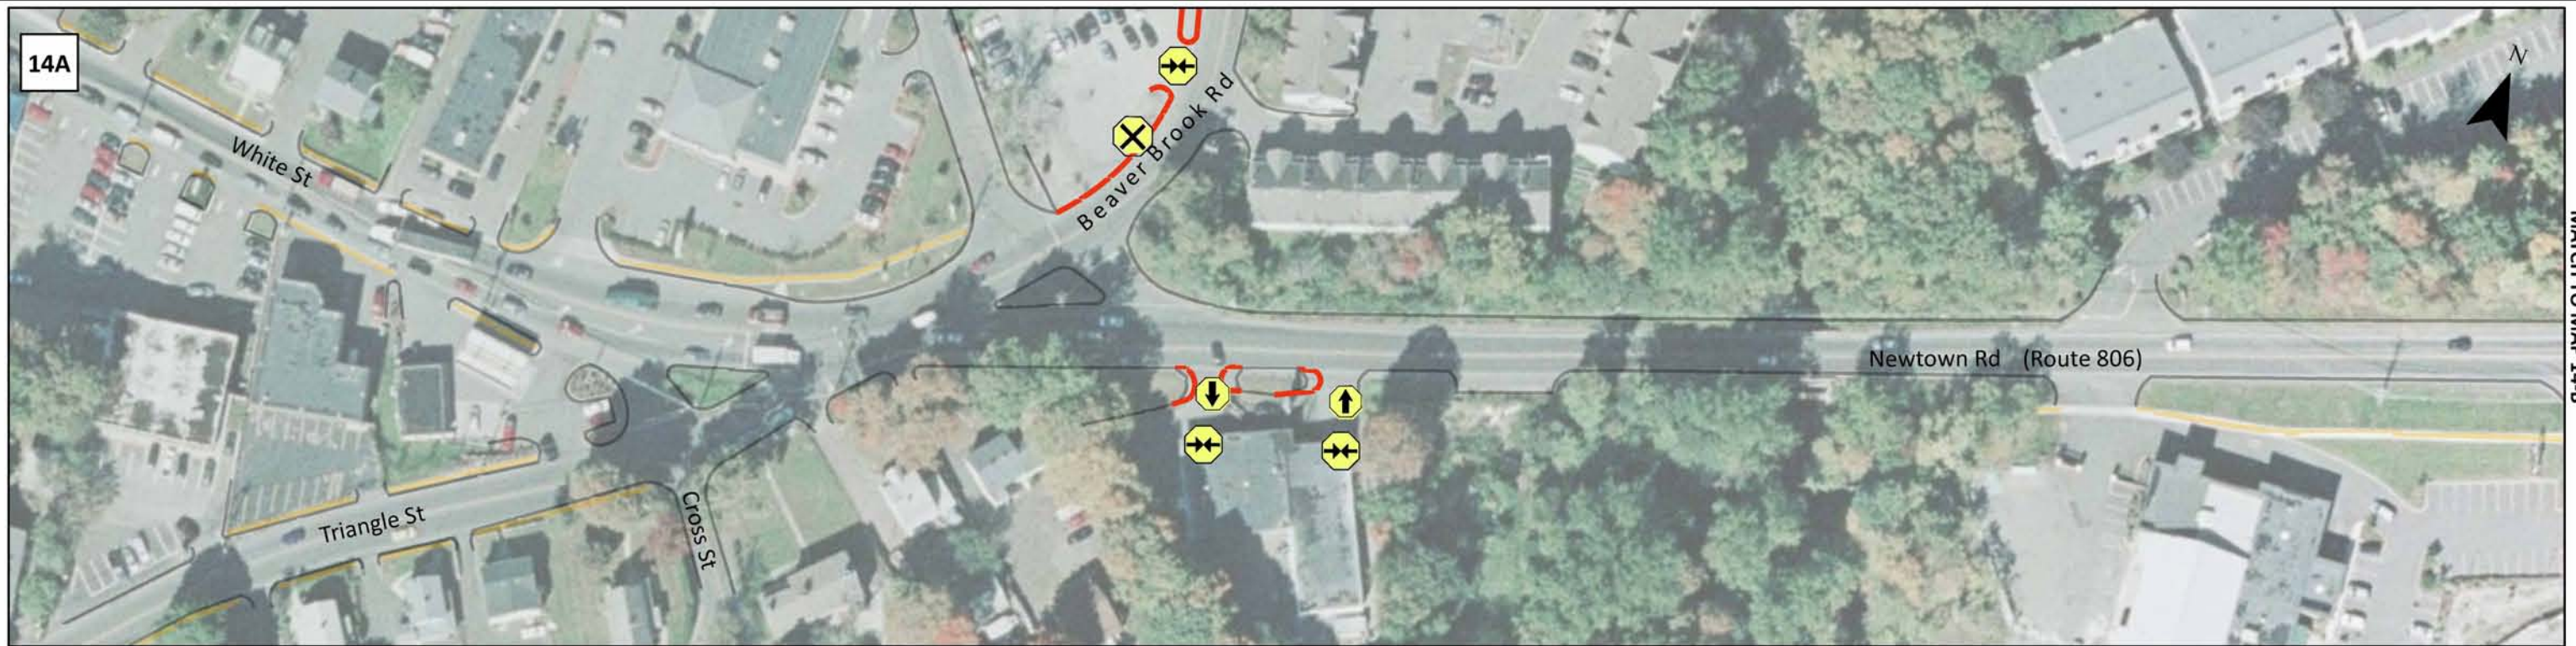
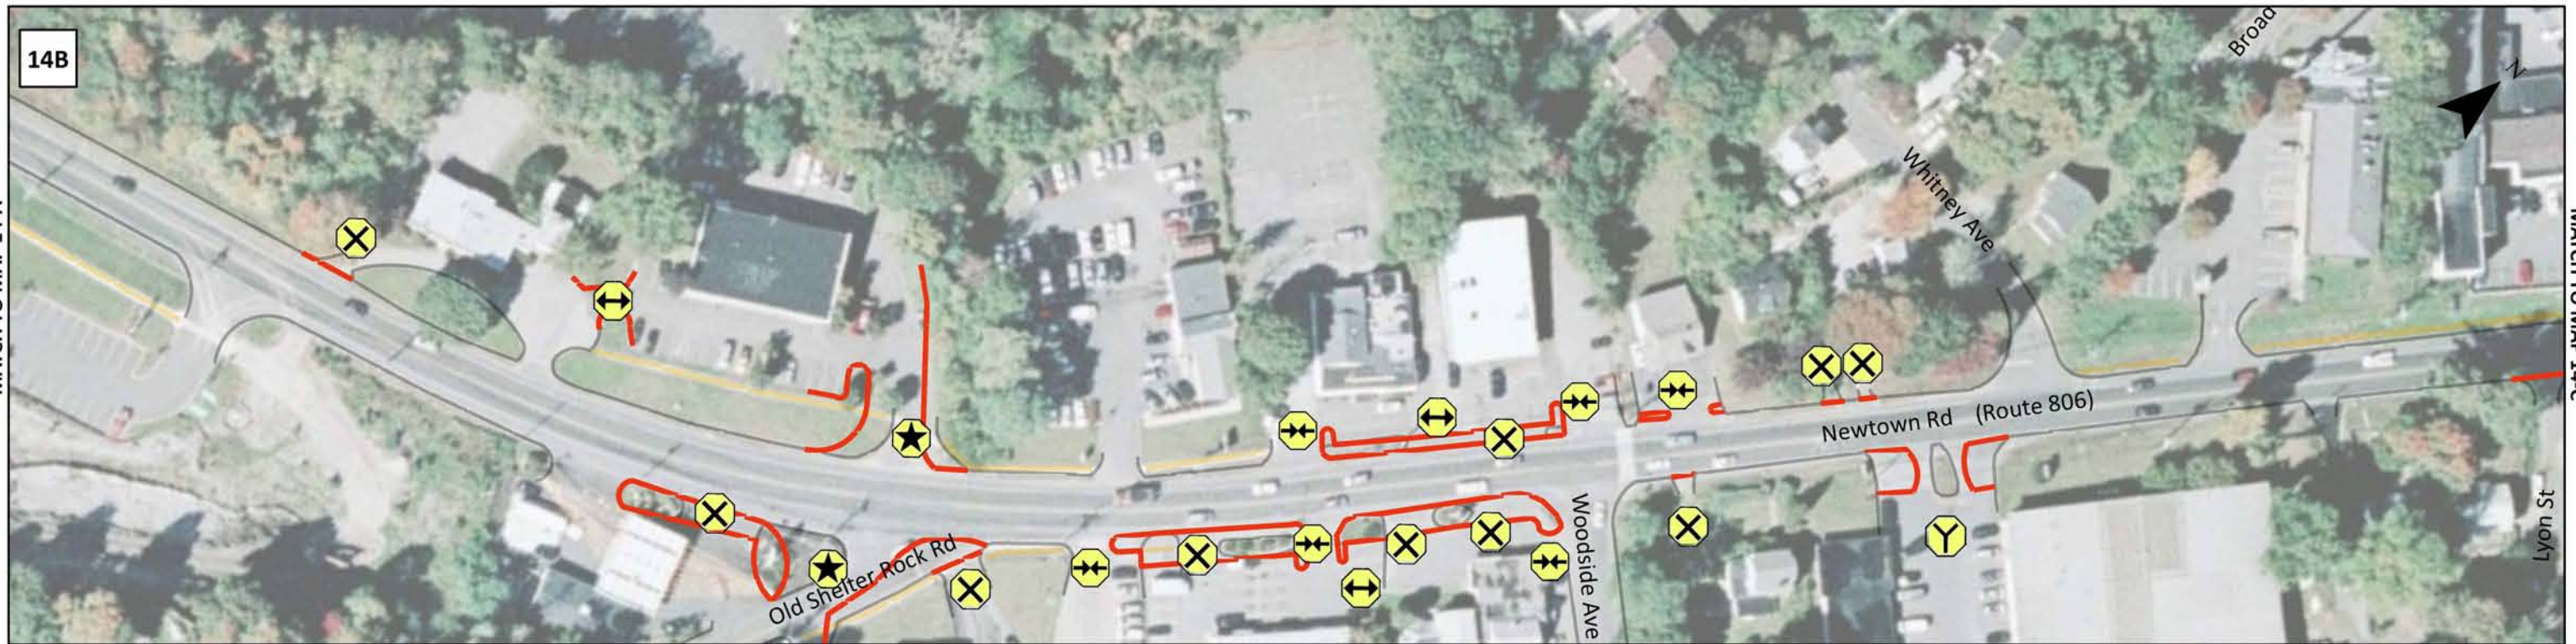
**Figure: 14A & 14B
Curb-Cut Access
Recommendations**

Curb-Cut Access Recommendations			
Legend			
---	Access Modification	Y	Create shared driveway
---	Curb Cuts	★	Relocate/realign access
---	Sidewalk	6'	Maximize sight lines
- - -	Potential Raised Median	↱	Right-Turn-Only
X	Access Closure	→	One-Way
↑	Define Entrance	↔	Provide vehicular Interconnection

A number of curb cut / driveway access management recommendations have been developed for Route 806. These can be seen on Figures 14a through 14f. The driveway access plan recommendations are to serve as a guide for the City of Danbury to begin to consolidate driveways as properties are sold and or redeveloped in the future. Access management recommendations that are agreed upon by property owners, or mutually agreed upon between adjacent property owners, could be completed in the more near-term.

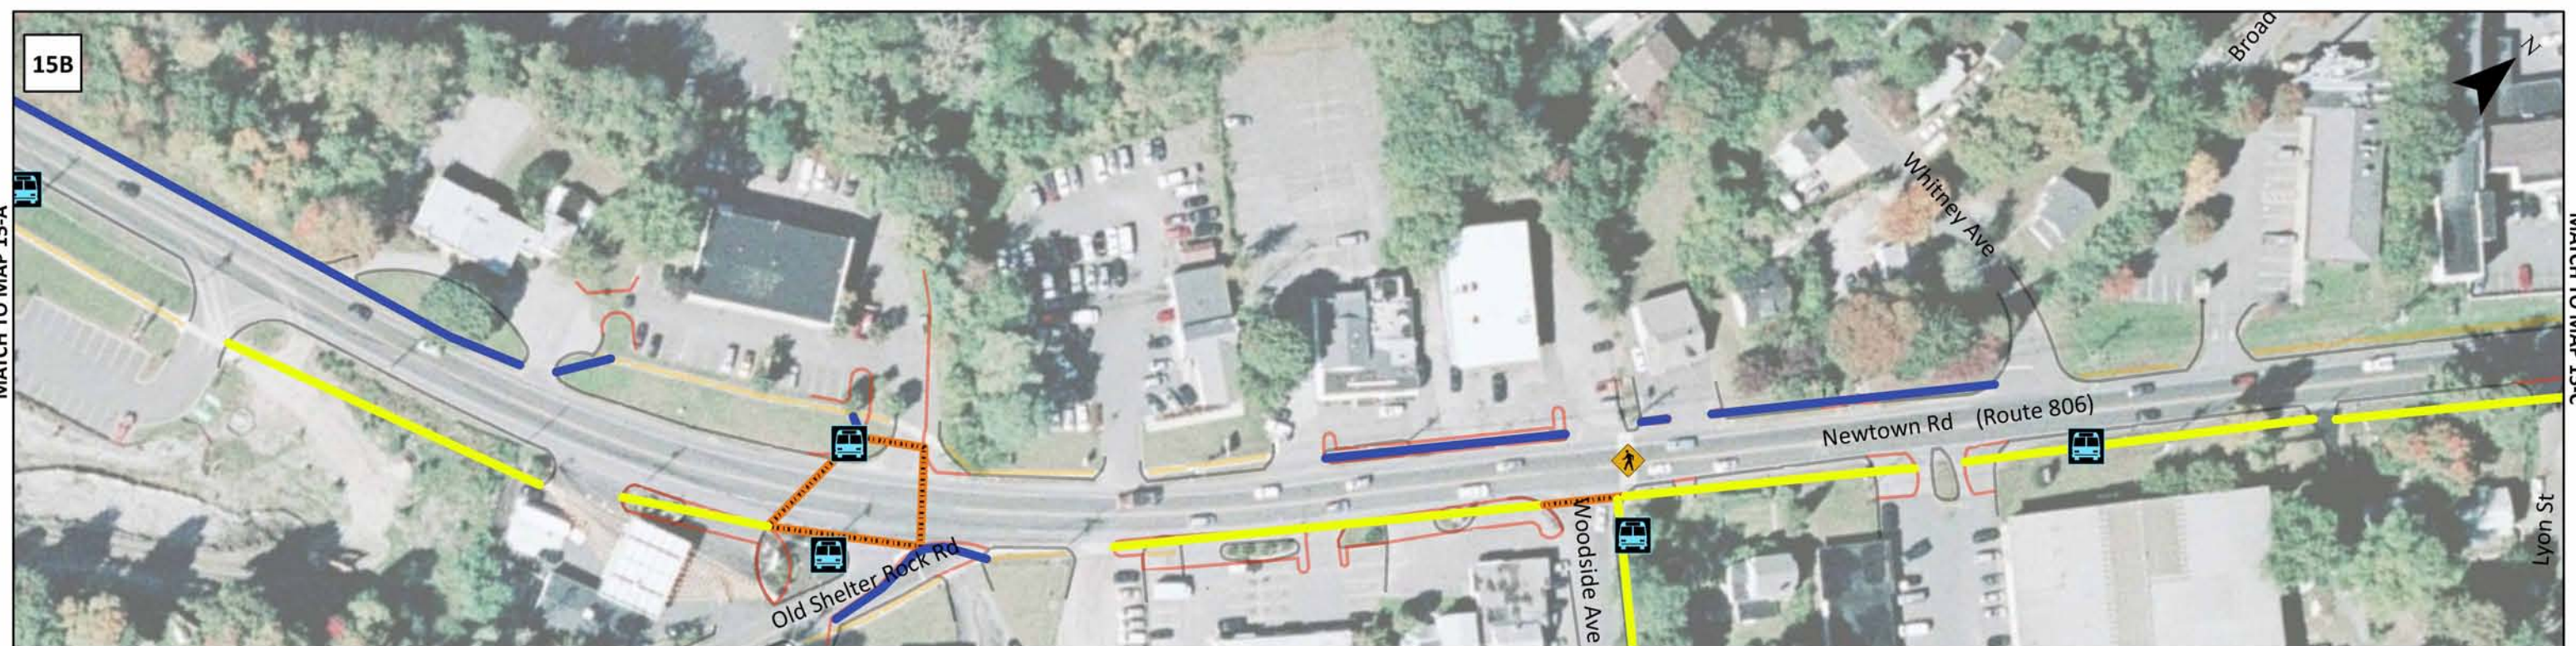
**Figure: 15A & 15B
Pedestrian/Transit
Recommendations**

Pedestrian/Transit Recommendations			
Legend			
	Existing HART Bus Stop		Install HART Bus Shelter
	Existing Crosswalks		Install Crosswalk
	Existing Sidewalks		Install Sidewalk - Short Term
	Existing Curb-Cuts		Install Sidewalk - Long Term
	Access Modification		Bridge Modification

The Pedestrian/Transit Recommendations Map, Figures 15a through 15f contains recommendations for installing numerous sections of sidewalks on both sides of Route 806. The map also contains recommendations for crosswalks at various signalized and non-signalized intersections. Bicycle access is limited along the corridor due to the minimal right-of-way and the speed and volume of the traffic on Route 806.

There are very few existing crosswalks along the Route 806 corridor today. If new exclusive crossings are desired, traffic signal modifications would likely be needed. Upgrades would also need to be made to accommodate ADA requirements. It is recommended that crosswalks be installed in the following locations along the Route 806 corridor as shown on Figures 15a – 15f:

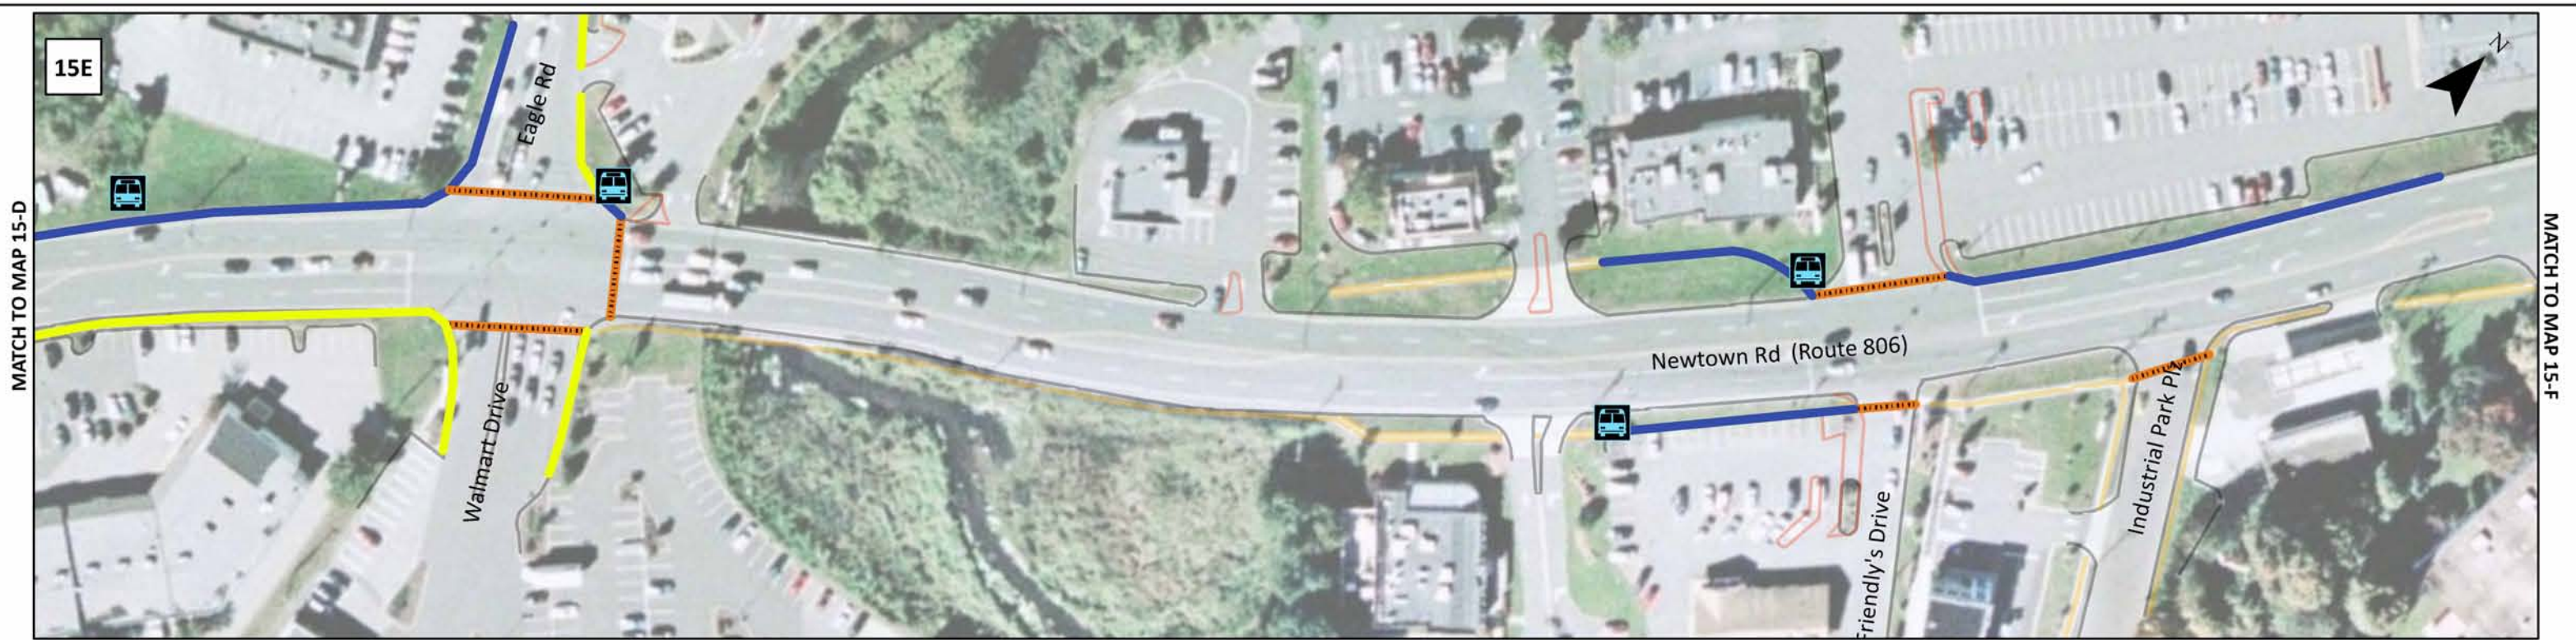
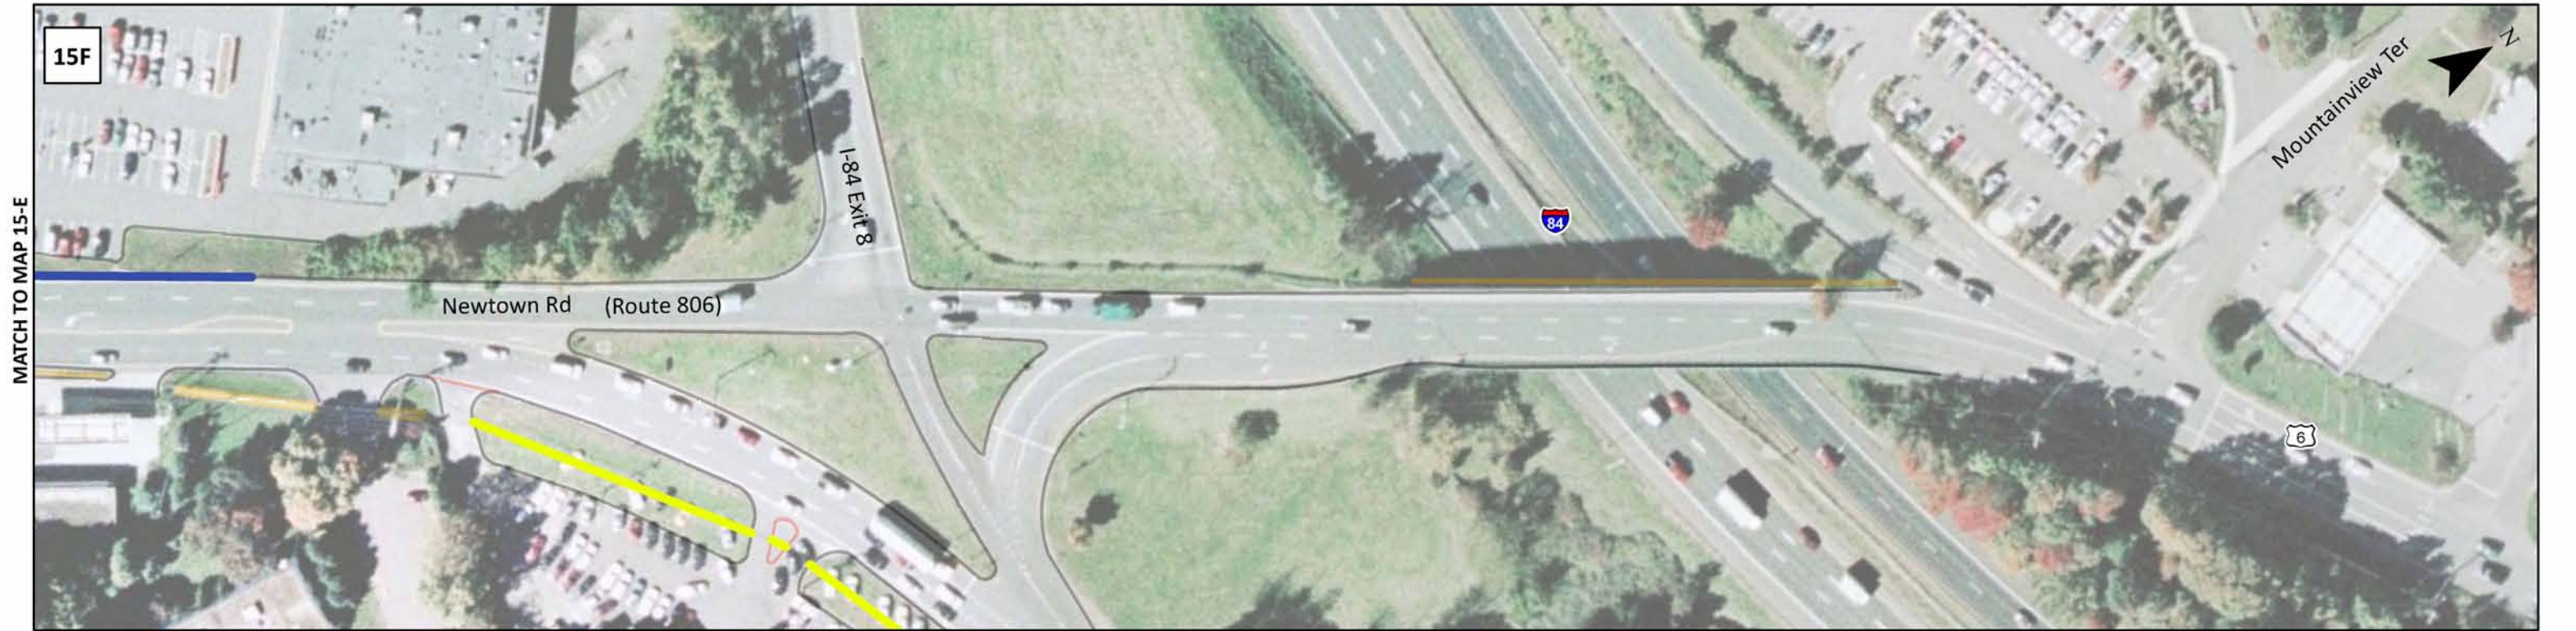
Legend Existing HART Bus Stop Existing Crosswalks Existing Sidewalks Existing Curb-Cuts Access Modification		Pedestrian/Transit Recommendations Install HART Bus Shelter Install Crosswalk Install Sidewalk - Short Term Install Sidewalk - Long Term Bridge Modification		SOURCE: City of Danbury Street Map USA (2009) Milone & MacBroom Field Observations (2010)	SHEET 3 of 3	City of Danbury Engineering, Landscape Architecture and Environmental Science MILONE & MACBROOM® In association with VN Engineers, Inc.	ROUTE 806 CORRIDOR STUDY NEWTOWN ROAD Figure: 15E & 15F Pedestrian/Transit Recommendations Date: May 2011
---	--	--	--	---	-----------------	---	---

It is recommended that the City of Danbury apply for STP-Enhancement funding and STP – Urban funding for the installation of sidewalks and crosswalks as shown on the Pedestrian Access Plans (Figures 15a – 15f). Figure 16 shows a typical pedestrian access plan and renderings of streetscape improvements for one area of the Route 806 corridor that could be incorporated into a funding application.
