Transportation Management Plan Lake Avenue and West Street Danbury, CT

June, 2013

VN Engineers, Inc.
116 Washington Avenue
North Haven, CT 06473
Phone (203) 234-7862

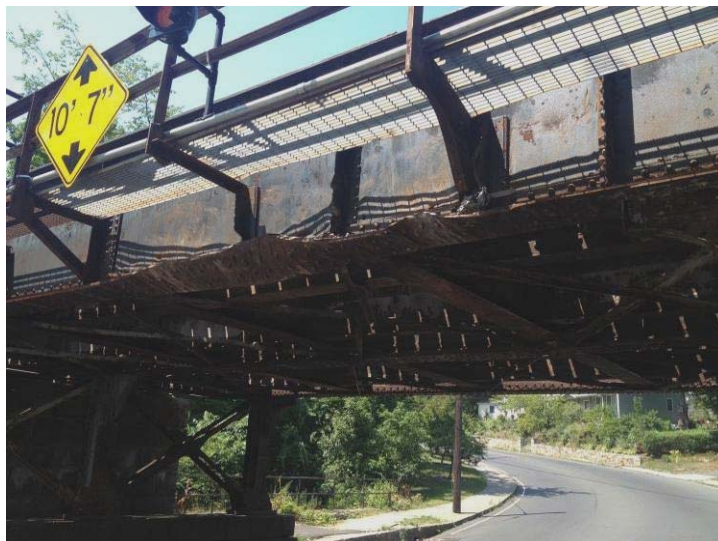
Damage to railroad bridge from vehicle collisions

There is an existing narrow and low clearance (10 feet 7 inches) railroad bridge over West Street between Benedict Avenue and Beaver Street which is negatively impacting traffic safety and operation. There are height sensors linked to advanced warning flashers over Lake Avenue

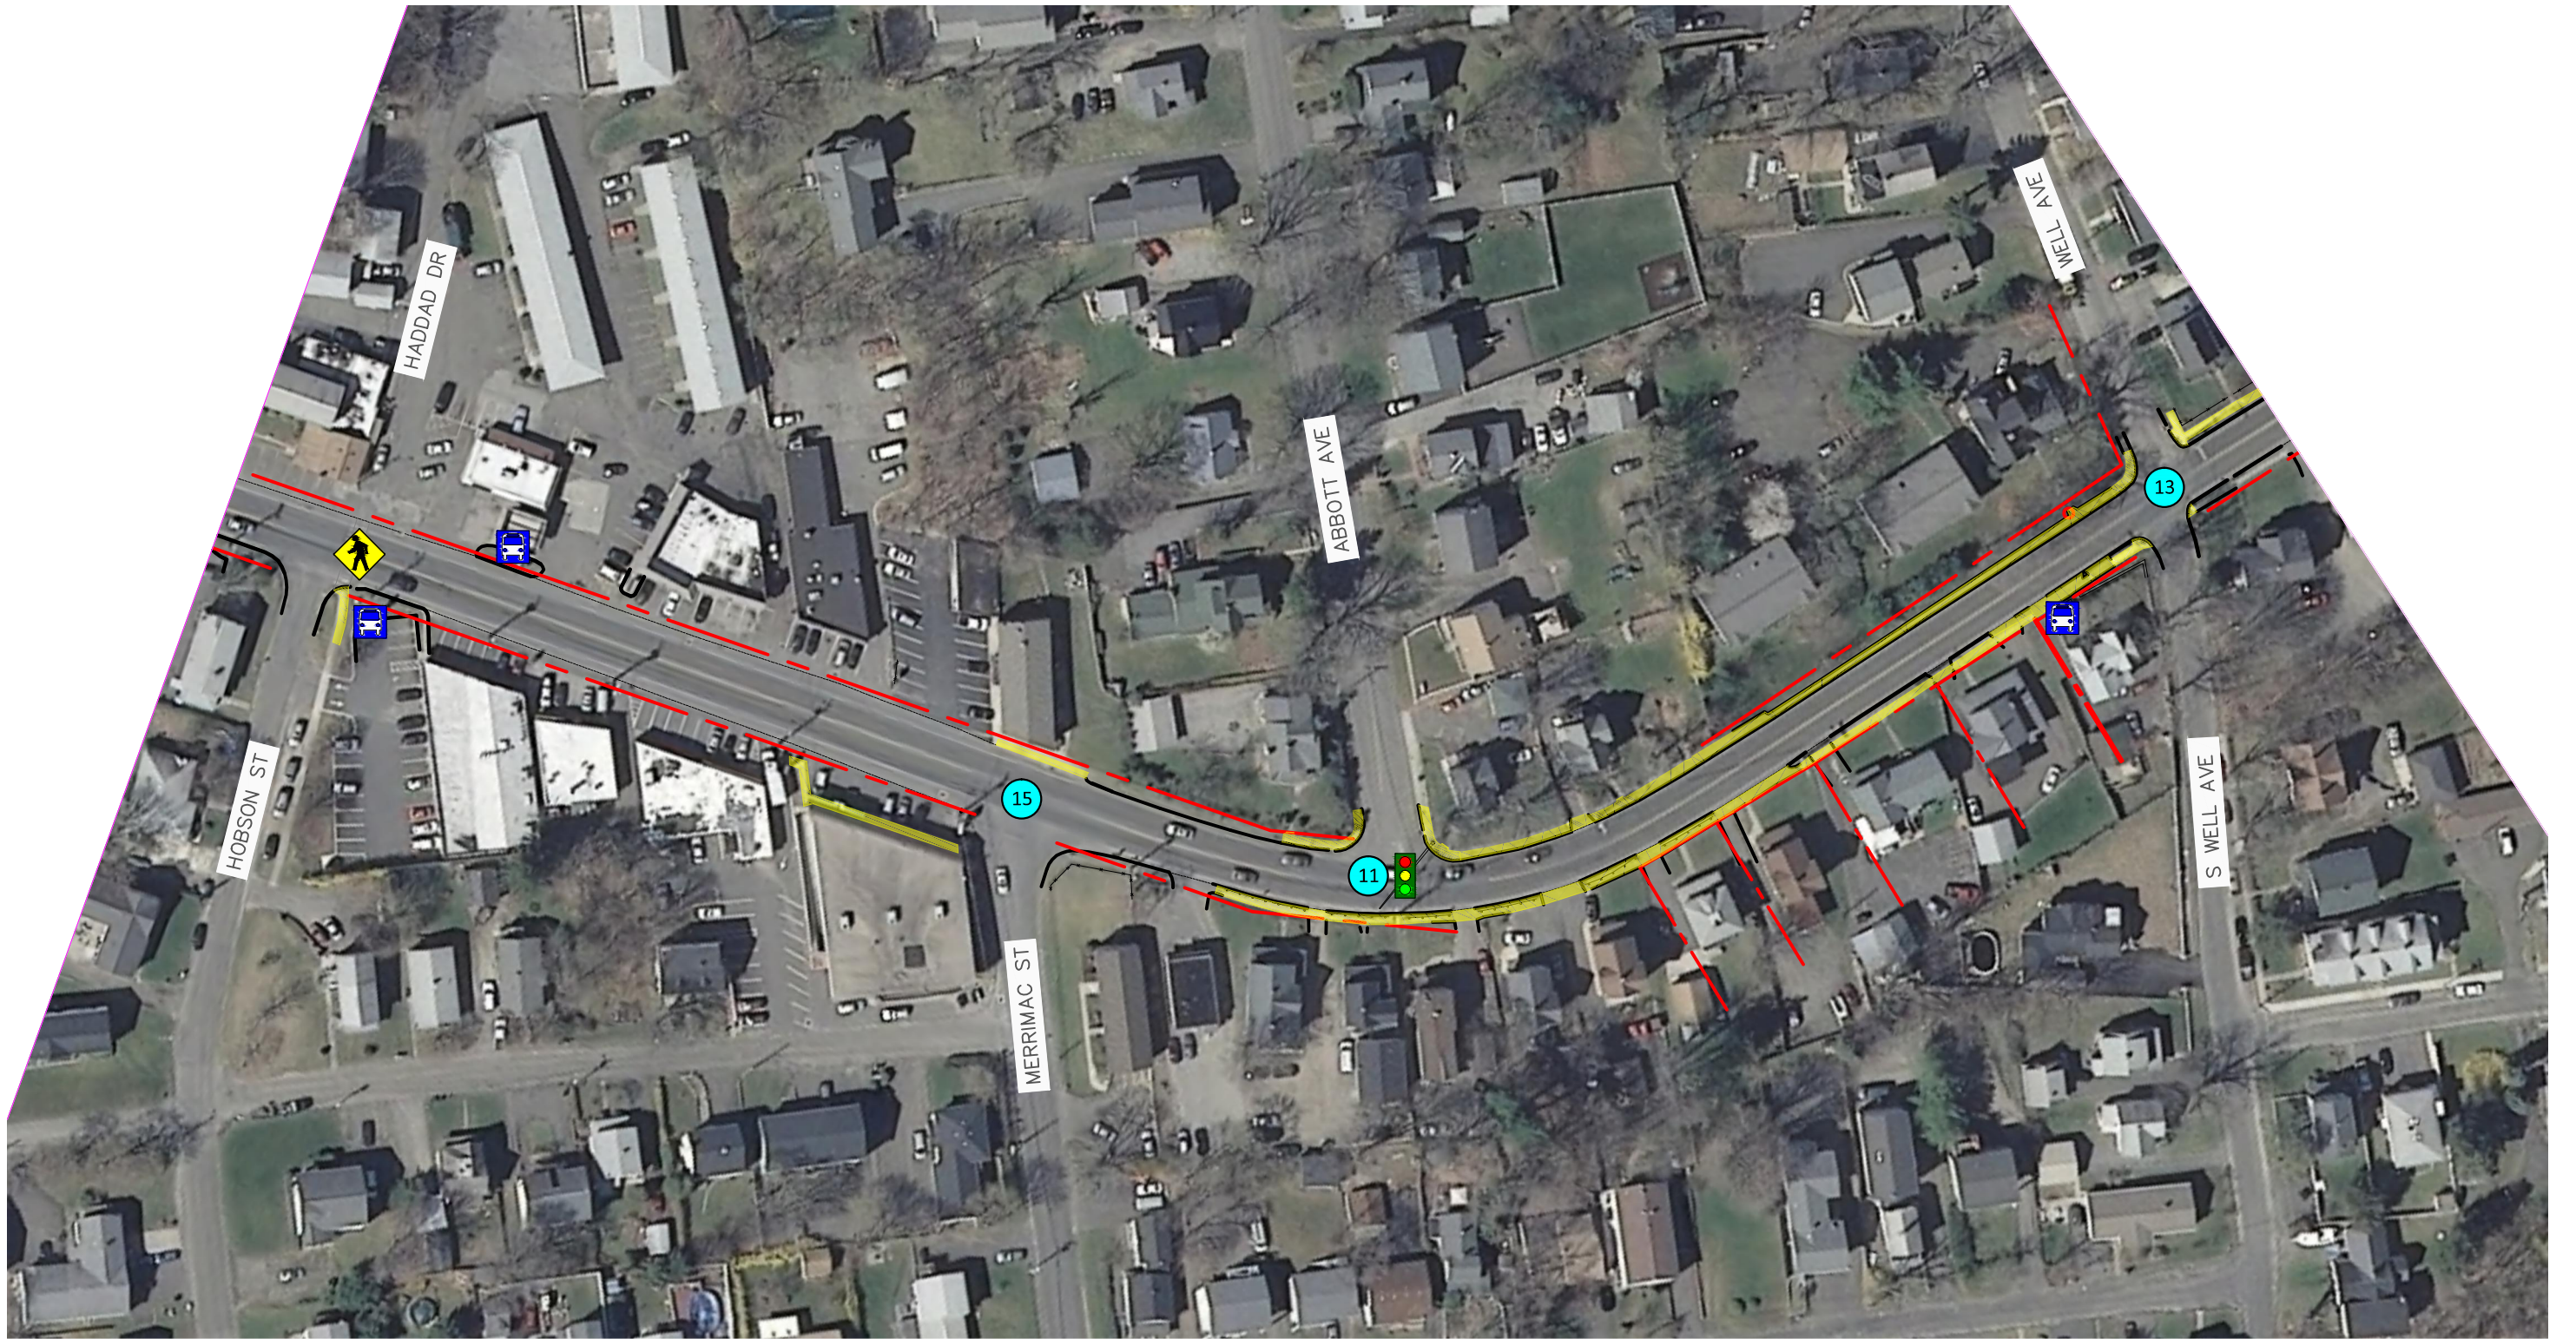
1A

EXISTING CONDITIONS (1 of 6)

There are also a large number of unsignalized intersections with side streets in the corridor in addition to many access driveways. Existing conditions in the Lake Avenue / West Street corridor are illustrated **Figure 1**

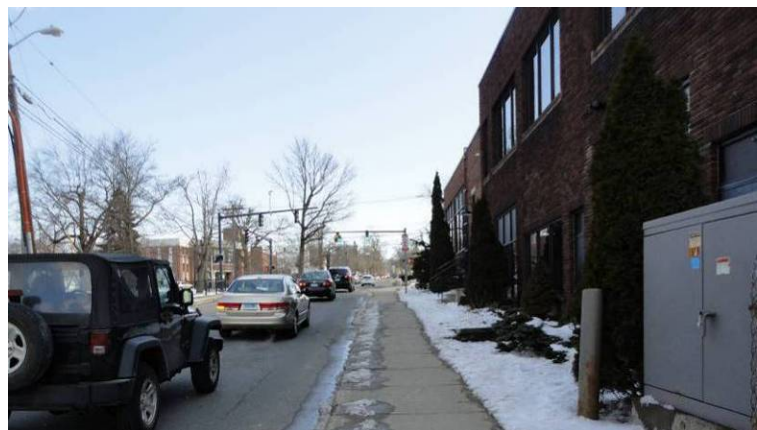
Southbound New Street approach to West Street

review of the individual traffic reports for the intersection, it was found that 13 of the 16 angle crashes occurred while the signal was in flash mode. According to the existing traffic control signal plan, obtained from the City of Danbury, the traffic signal operates in flash mode daily from 10:00 PM to 6:00

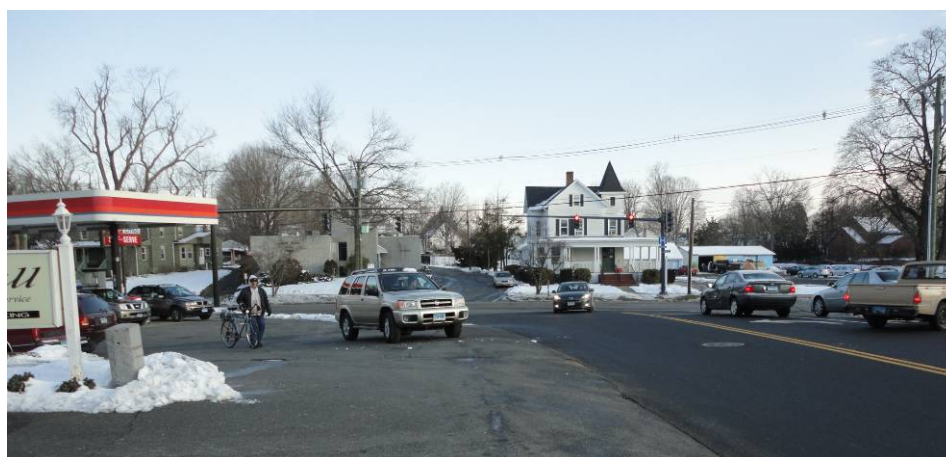
Looking northbound at Citgo access to Division Street

West Street at Division Street - The summary table shows 35 accidents at the intersection of West Street and Division Street over the past three years. On closer review of the accident reports, seventeen of these crashes are associated with nearby access driveways or private property. (Fifteen of these are associated with the Citgo driveways to Division Street or West

Street or occurred within the parking lot itself.) These seventeen accidents include all six of the backing accidents, one of the fixed object accidents, and ten of the turning accidents listed in the table.

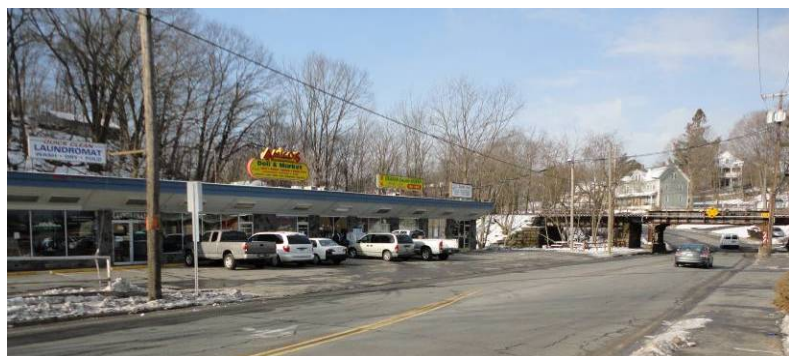
Continuous access at 130 West Street

West Street at Beaver Street - The intersection of West Street and Beaver Street had 36 accidents in the three-year period considered. Upon closer review of the accident records, only 17 of these were located at the intersection itself, while the other 19 were at nearby driveways and unsignalized intersections. A collision diagram of this location depicting the 17 accidents at the intersection is shown in **Figure 4**. Of the 19 other accidents that occurred at other nearby locations, there were several associated with the access to 130 West Street, including four rear end accidents and three turning accidents. This location is particularly hazardous because of the continuous access with front in parking along West Street which allows for many conflict points between through traffic and vehicles pulling in or out of the driveway. The continuous access also creates a large area where friction can occur along West Street as vehicles stop or slow for others turning in or out. There were also accidents which occurred at the intersection with Pleasant Street (including a pedestrian accident) and the intersection with Stevens Street. Both of these unsignalized intersection locations are in very close proximity to Beaver Street. Eighteen of the 36 accidents in the vicinity of the West Street at Beaver Street intersection were rear end crashes. Three of these occurred on the southbound approach, eight occurred on the westbound approach, and seven occurred on the eastbound approach. Only eight of the 18 were directly associated with the West Street at Beaver Street intersection. It is

likely that there are several factors that are contributing to crashes in this area including the proximity and layout of nearby driveways and intersections, as well as sharp horizontal curves

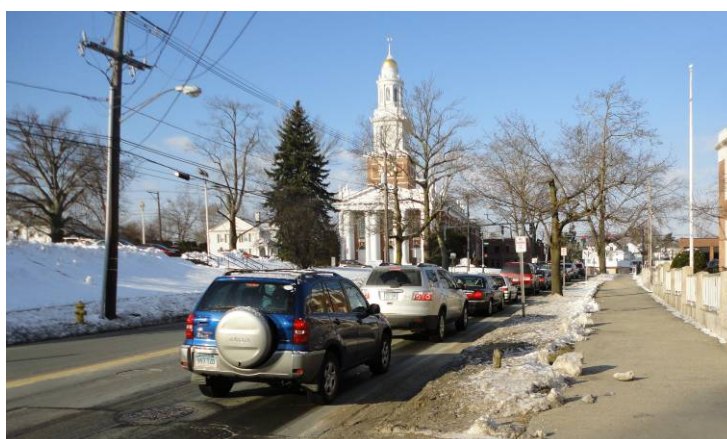
Westbound West Street approach to the New Street / Deer Hill Avenue intersection during the PM peak hour

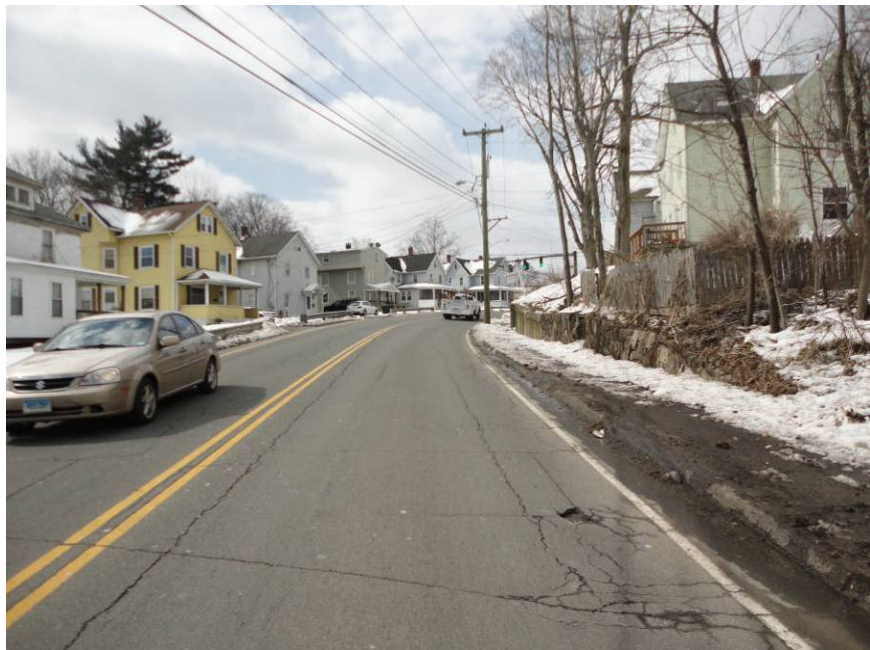
Westbound approach to the Lake Avenue at Abbott Avenue intersection

intersection. On the north side of the roadway there is a retaining wall as well as some large trees. During summer months when the trees are overgrown it appears that site lines to the traffic signal heads could be obstructed. Per AASHTO guidelines, with a design speed of 30 miles per hour the stopping sight distance for a 9% upgrade is 179 feet. During field observations the site lines appeared adequate,

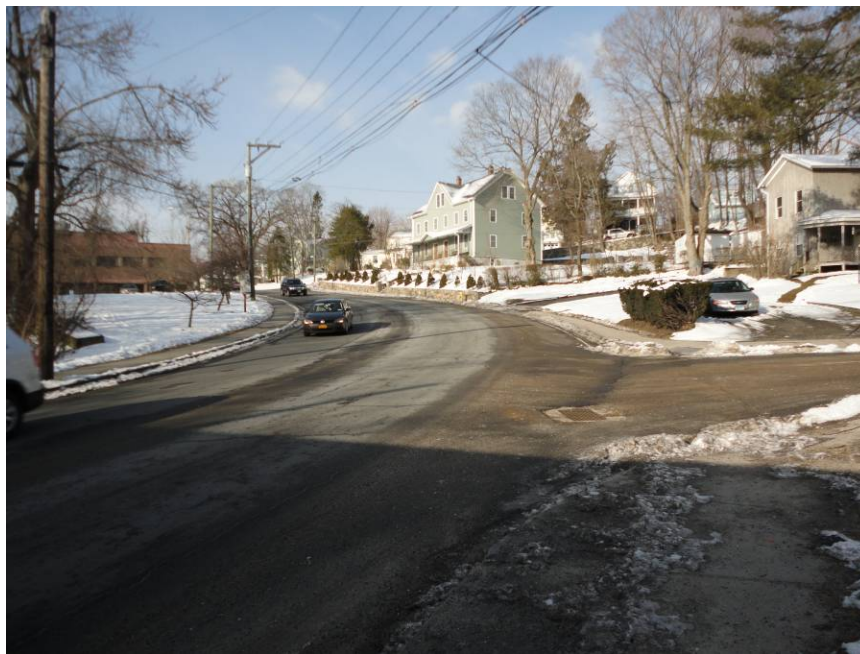
Westbound approach to the West Street at Benedict Avenue intersection

A review of the accident history near the intersection of West Street at Benedict Avenue and the railroad bridge revealed that there were two collisions that involved eastbound vehicles impacting the bridge piers on the north side of the road. There is a sharp horizontal curve on West Street between Morris Street and the railroad bridge, where the intersection of Benedict

Avenue is located. The CTDOT Highway Design Manual requires a minimum radius of 275 feet for a horizontal curve with a 30 mile per hour design speed. The existing curve at Benedict Avenue does not meet the minimum standard set by the state. A desktop review actually has the radius less than 200 feet. This design feature, along with the steep slope downhill on

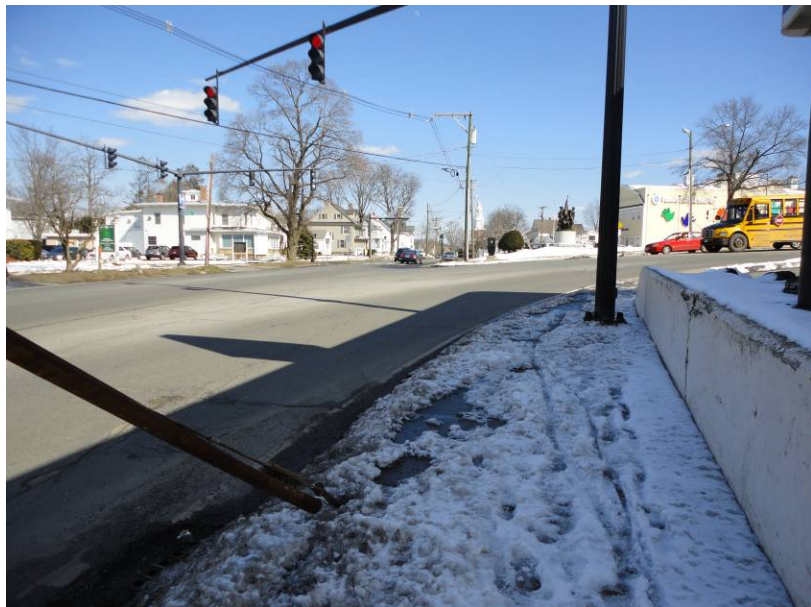
Eastbound approach to West Street at Division Street intersection

The Division Street intersection is another priority location within the corridor for addressing operational and safety issues. SYNCHRO analysis indicates that there are no major operational issues at this intersection. There are a large number of accidents that have occurred in the vicinity of the intersection, approximately half of which were related to driveways for nearby properties (the vast majority of those involved the Citgo property). Another access issue is the two unsignalized driveways (at 91 and 93 West Street) on the north side of West Street within the intersection limits. The driveways are approximately 80 feet apart and not centered in the intersection. Additionally, stop bars for the eastbound and westbound West Street approaches are set far back from the intersection to accommodate the near-side signal head placement as well as to limit encroachment over the centerline of turning trucks and transit buses. The stop bar for the northbound Division Street approach is also set far back to accommodate turning movements of large vehicles. This makes the intersection excessively large and difficult for pedestrians to move through. The crosswalk over the east leg of the intersection is also set back from the intersection, just in front of the stop bar. The pedestrian phase for this crossing is concurrent with the northbound signal phase. On observation in the field, this is particularly dangerous since visibility of the crosswalk from the northbound approach is limited. The eastbound approach is another reason the intersection is so large. The eastbound right-turn lane is flared and the curb radius on the southwest corner is very large (approximately 100 feet). These issues would probably cause more problems for pedestrians if pedestrian volumes were higher at this intersection. However, due to the lack of accommodations, pedestrians seem to be seeking alternate routes around this intersection. Note that in general there are issues with profile grades and cross slopes within this intersection that have required the placement of the high curbing and retaining walls on the southerly side of the intersection. During intersection redesign, grading issues

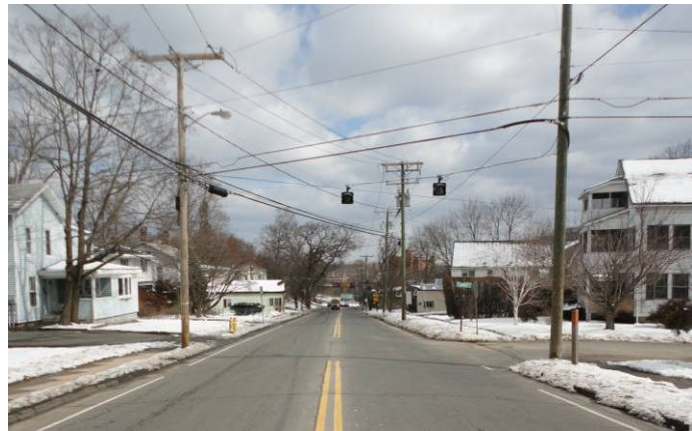
Existing warning flashers on eastbound approach to railroad bridge

1. Mounted overhead with warning flashers on the approach to Division Street
2. Post-mounted on the approach to Stevens Street
3. On the mast arm at the Beaver Street intersection
4. Mounted on a utility pole in advance of the driveway to 131 West Street.

There is also a W12-2 sign mounted on the bridge itself with warning flashers.

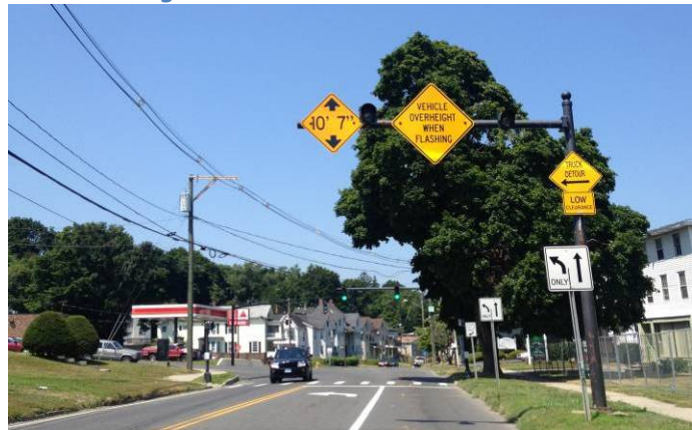
Existing warning flashers on westbound approach to railroad bridge

- Add signage to accompany the warning flashers on the eastbound approach to the bridge similar to what is shown on the westbound approach (“Vehicle overheight when flashing” “Truck Detour” “Low Clearance”).

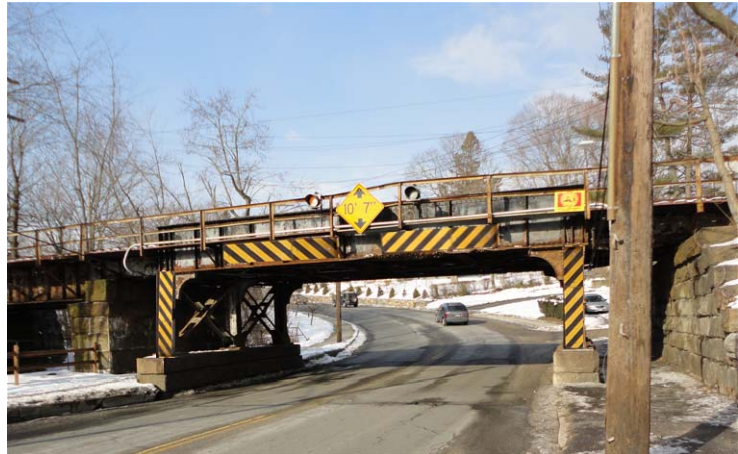
Westbound approach to bridge with object markers added

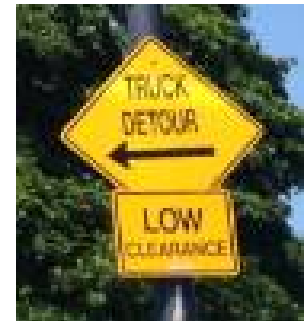
Truck detour signage

- Replace or repair damaged signs, such as the W12-2 on the eastbound approach to the bridge, which is crooked. Consider replacing existing W12-2 signs on the bridge with horizontal type signs with legend “LOW CLEARANCE 10 feet 7 inches.”

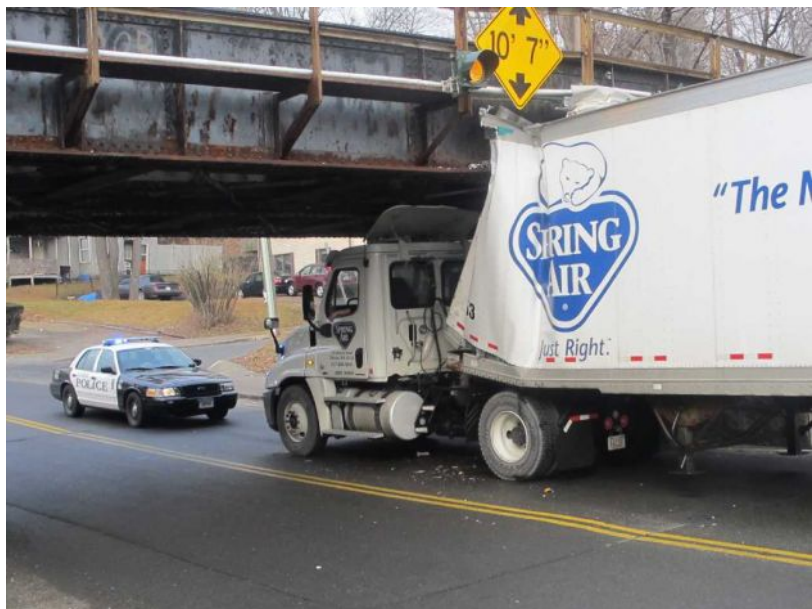
Truck collision with railroad bridge in February, 2012

eliminates that option as a possible solution. Elevation of the rail line and replacement of the bridge is another option that has been considered. However, the responsibility for bridge replacement would typically fall on the bridge owner, the Housatonic Railway Company, but since the bridge over West Street adequately serves their needs at this time its replacement is not a priority.

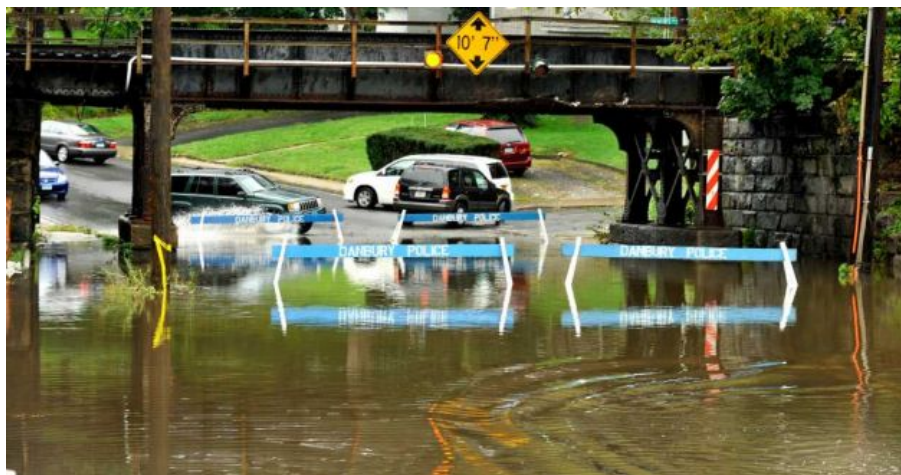
Flooding under railroad bridge in September, 2011
Source: CTPost.com

In addition to traffic operational issues at the crossing, this location is also subject to periodic flooding due to two issues 1) the inadequate roadway drainage system and 2) the outfall to the adjacent Still River that becomes submerged when the River is in a flood stage. Although this corridor serves as an important part of the City's transportation network, when the roadway is

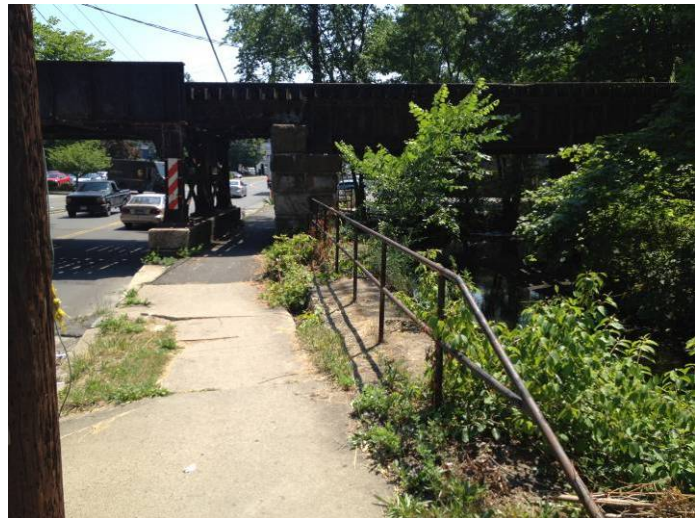
Sidewalk failure above box culvert outfall to Still River

The existing drainage system does not appear to function satisfactorily as evidenced by the damage at the existing

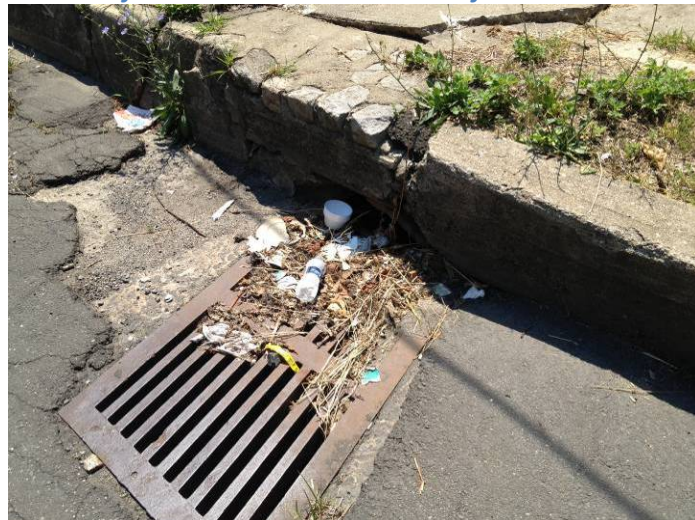
Existing catch basin at outfall

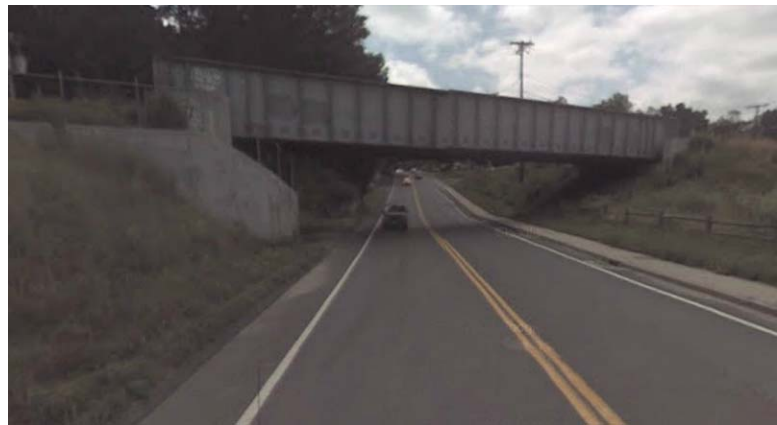
Recently replaced Housatonic Railway Bridge over Route 6 (Church Hill Road) in Newtown

Replacing the railroad bridge is a long-term solution to the operational and safety problems caused by the existing structure. This solution has not had much traction to date for a number of reasons, one of which is ownership. Infrastructure and operations for Class I freight railway lines are funded almost entirely by the freight railway company with income from its operations. Improvements to smaller lines and regional railroads, such as the Class III Housatonic Railway Company, are often funded privately, but are also more commonly funded with state and local funds. Since the State of Connecticut does not own the railroad bridge over West Street or West Street itself, options for using State funds are more limited. In speaking with members of several groups within the Connecticut Department of Transportation, no specific funding options could be identified for replacing the West

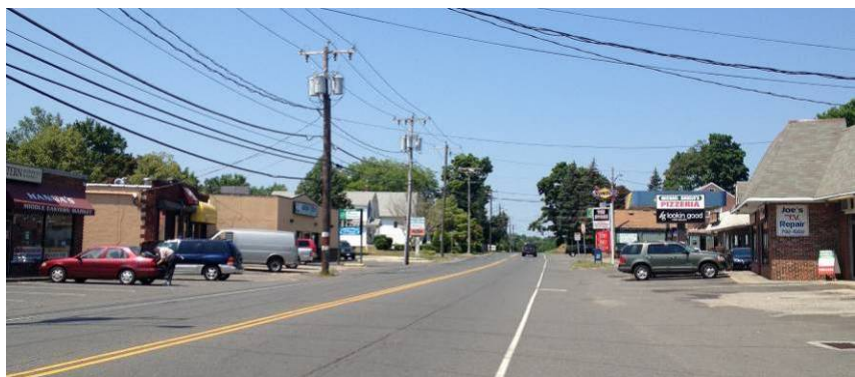
Lake Avenue commercial area between Lawncrest Road and Merrimac Street

Safety risks and traffic friction for all road users increase in areas with closely spaced driveways, continuous access, and / or angle parking. Traffic can flow more smoothly and conflict points are reduced when access management

strategies are implemented. Access management is a systematic effort to organize access to adjacent properties along a corridor in order to reduce impacts to traffic flow and safety. Access management strategies that address driveways include identifying optimal locations, specifying appropriate spacing, providing standards for design, and limiting operations to specific movements. Access management strategies for the roadway include properly locating and designing traffic signals, auxiliary lanes, and medians. These strategies are used to provide a balance between adjacent properties and mobility on the transportation system that is appropriate for the roadway classification and land use. Access management can also be used to support local community goals for development or redevelopment. In addition to the engineering design, implementation of an access management plan requires planning and regulatory involvement. Goals should be reinforced in the Danbury's Plan of Conservation and Development, the Danbury Transportation Plan, zoning regulations, development codes, and local ordinances.

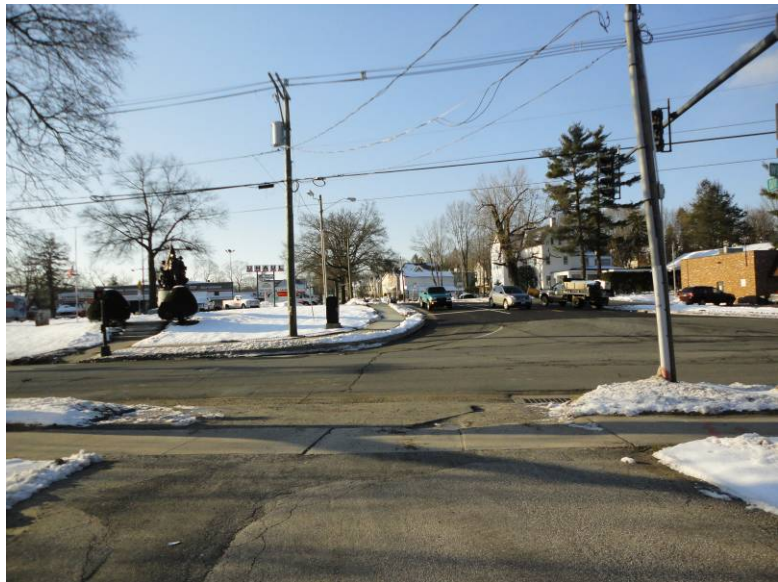
Unsignalized access driveway in the West Street at Division Street intersection

As was documented in the accident history section of this report, driveway locations and configurations in the corridor have been a contributing factor to many accidents in the corridor, including turning and rear end collisions in particular.

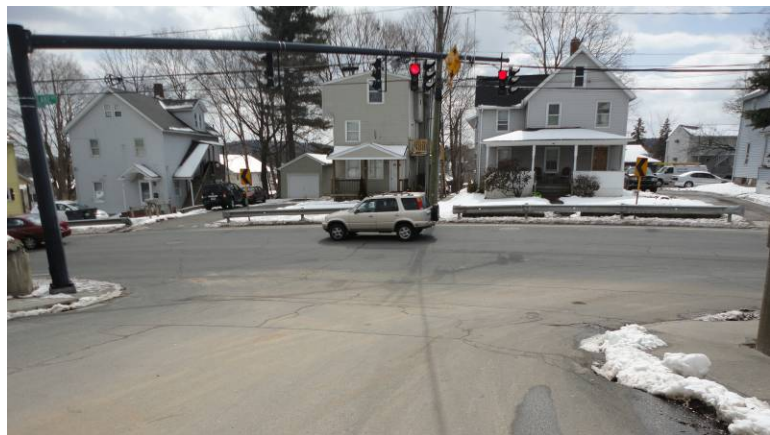
Absence of pedestrian accommodations at Lake Avenue at Abbott Avenue intersection

- **Large crossing distances.** Multiple, wide travel lanes, turning lanes, and large curb-return radii contribute to uncomfortably large crossing distances at many locations. This is a hazard for pedestrians who often share the crossing phase with turning vehicles. The long crossing distances also require longer phases, which contribute to vehicular delay at some locations. The curb radius on the southwest corner of the West Street at Division Street intersection is particularly large. Crossing distances over West Street are particularly large, since there are wide travel lanes as well as on street parking lanes,

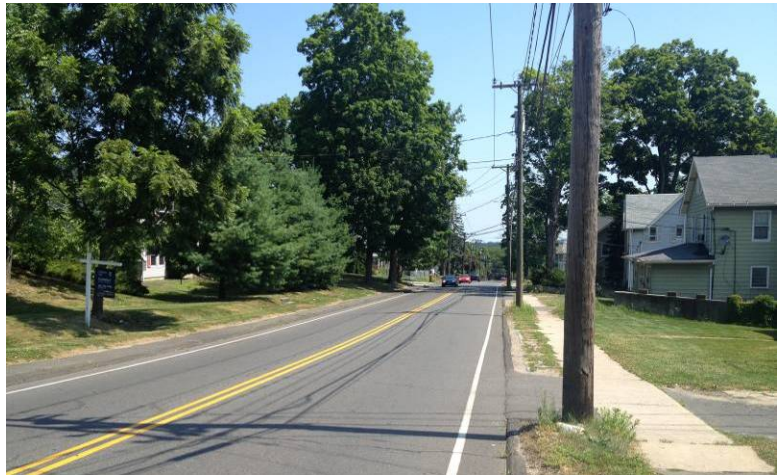
Sidewalk on south side of Lake Avenue

- **Incomplete sidewalk networks.** Pedestrian exposure to vehicles is increased where sections of sidewalk are missing. In many of these locations, pedestrians use landscaped areas, private property, or off-street parking areas to travel along a corridor. There are a number of areas along Lake Avenue where sidewalks are discontinuous between the western limit of the study corridor and Abbott Avenue. There is also no sidewalk along the south side of West Street between Division Street and Orchard Street.

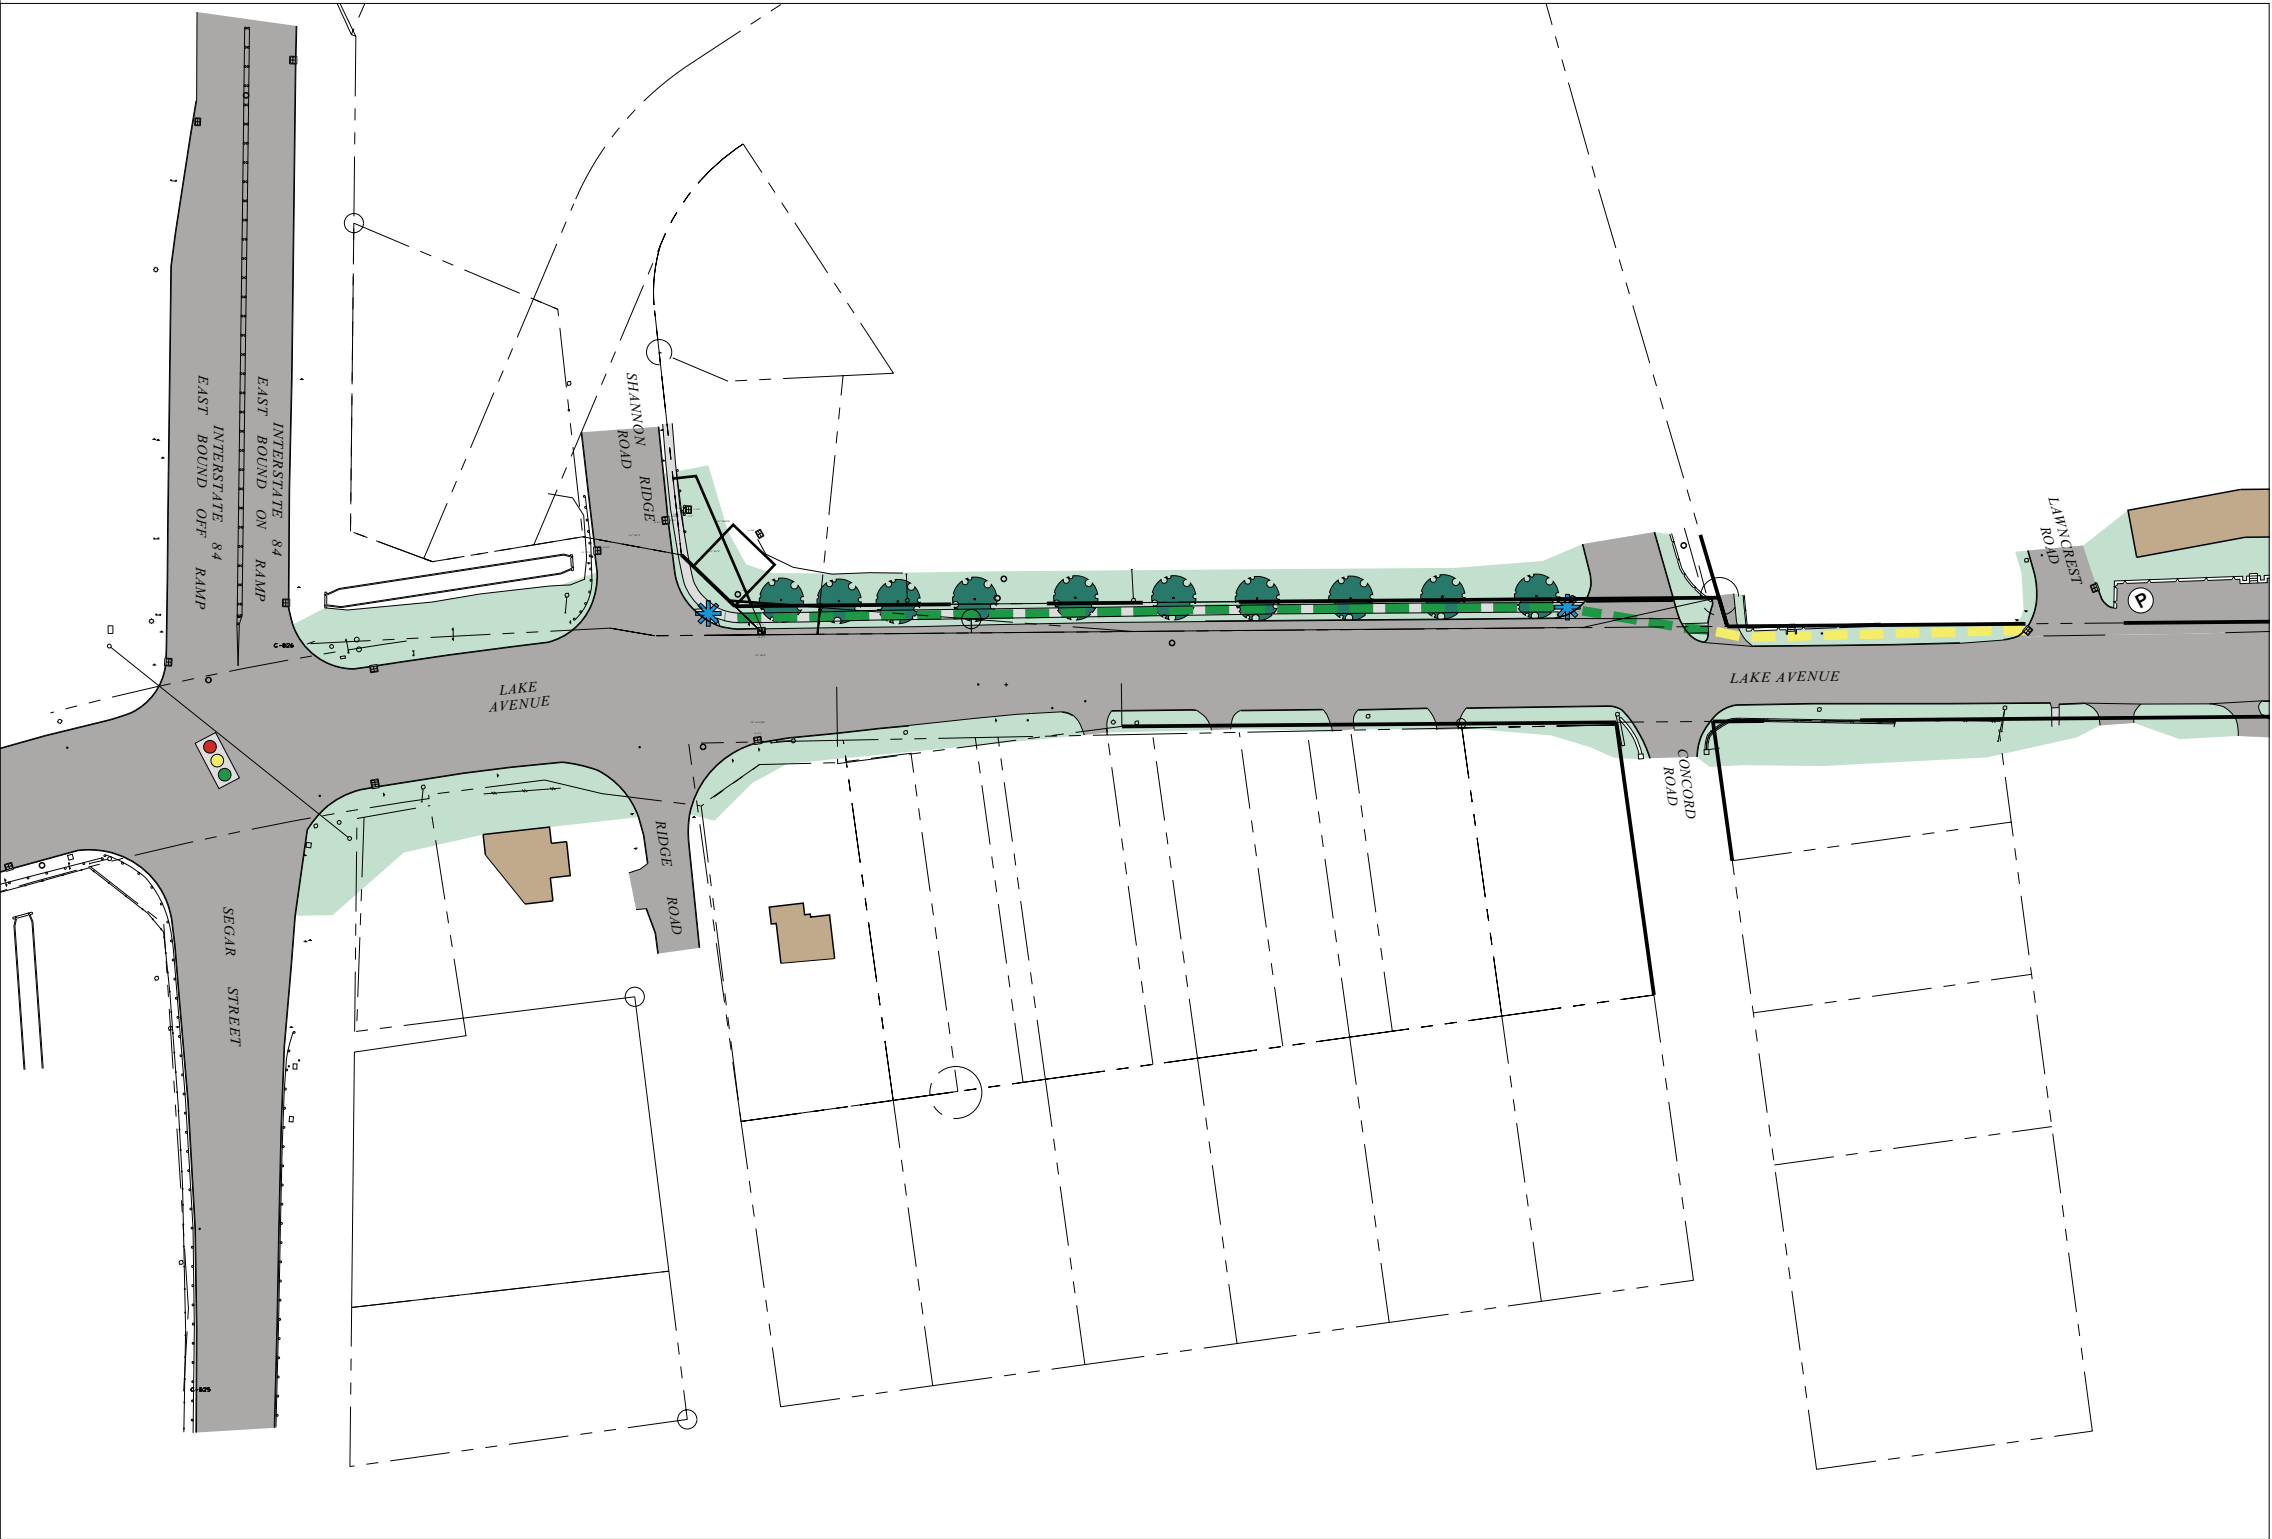
Project Title:	
TRANSPORTATION PLAN FOR LAKE AVENUE AND WEST STREET	
Location:	
DANBURY, CT	
Figure Title:	Figure Number:
EXISTING SIDEWALK CONDITIONS ANALYSIS I84 RAMP/LAWNCREST ROAD AREA	10A

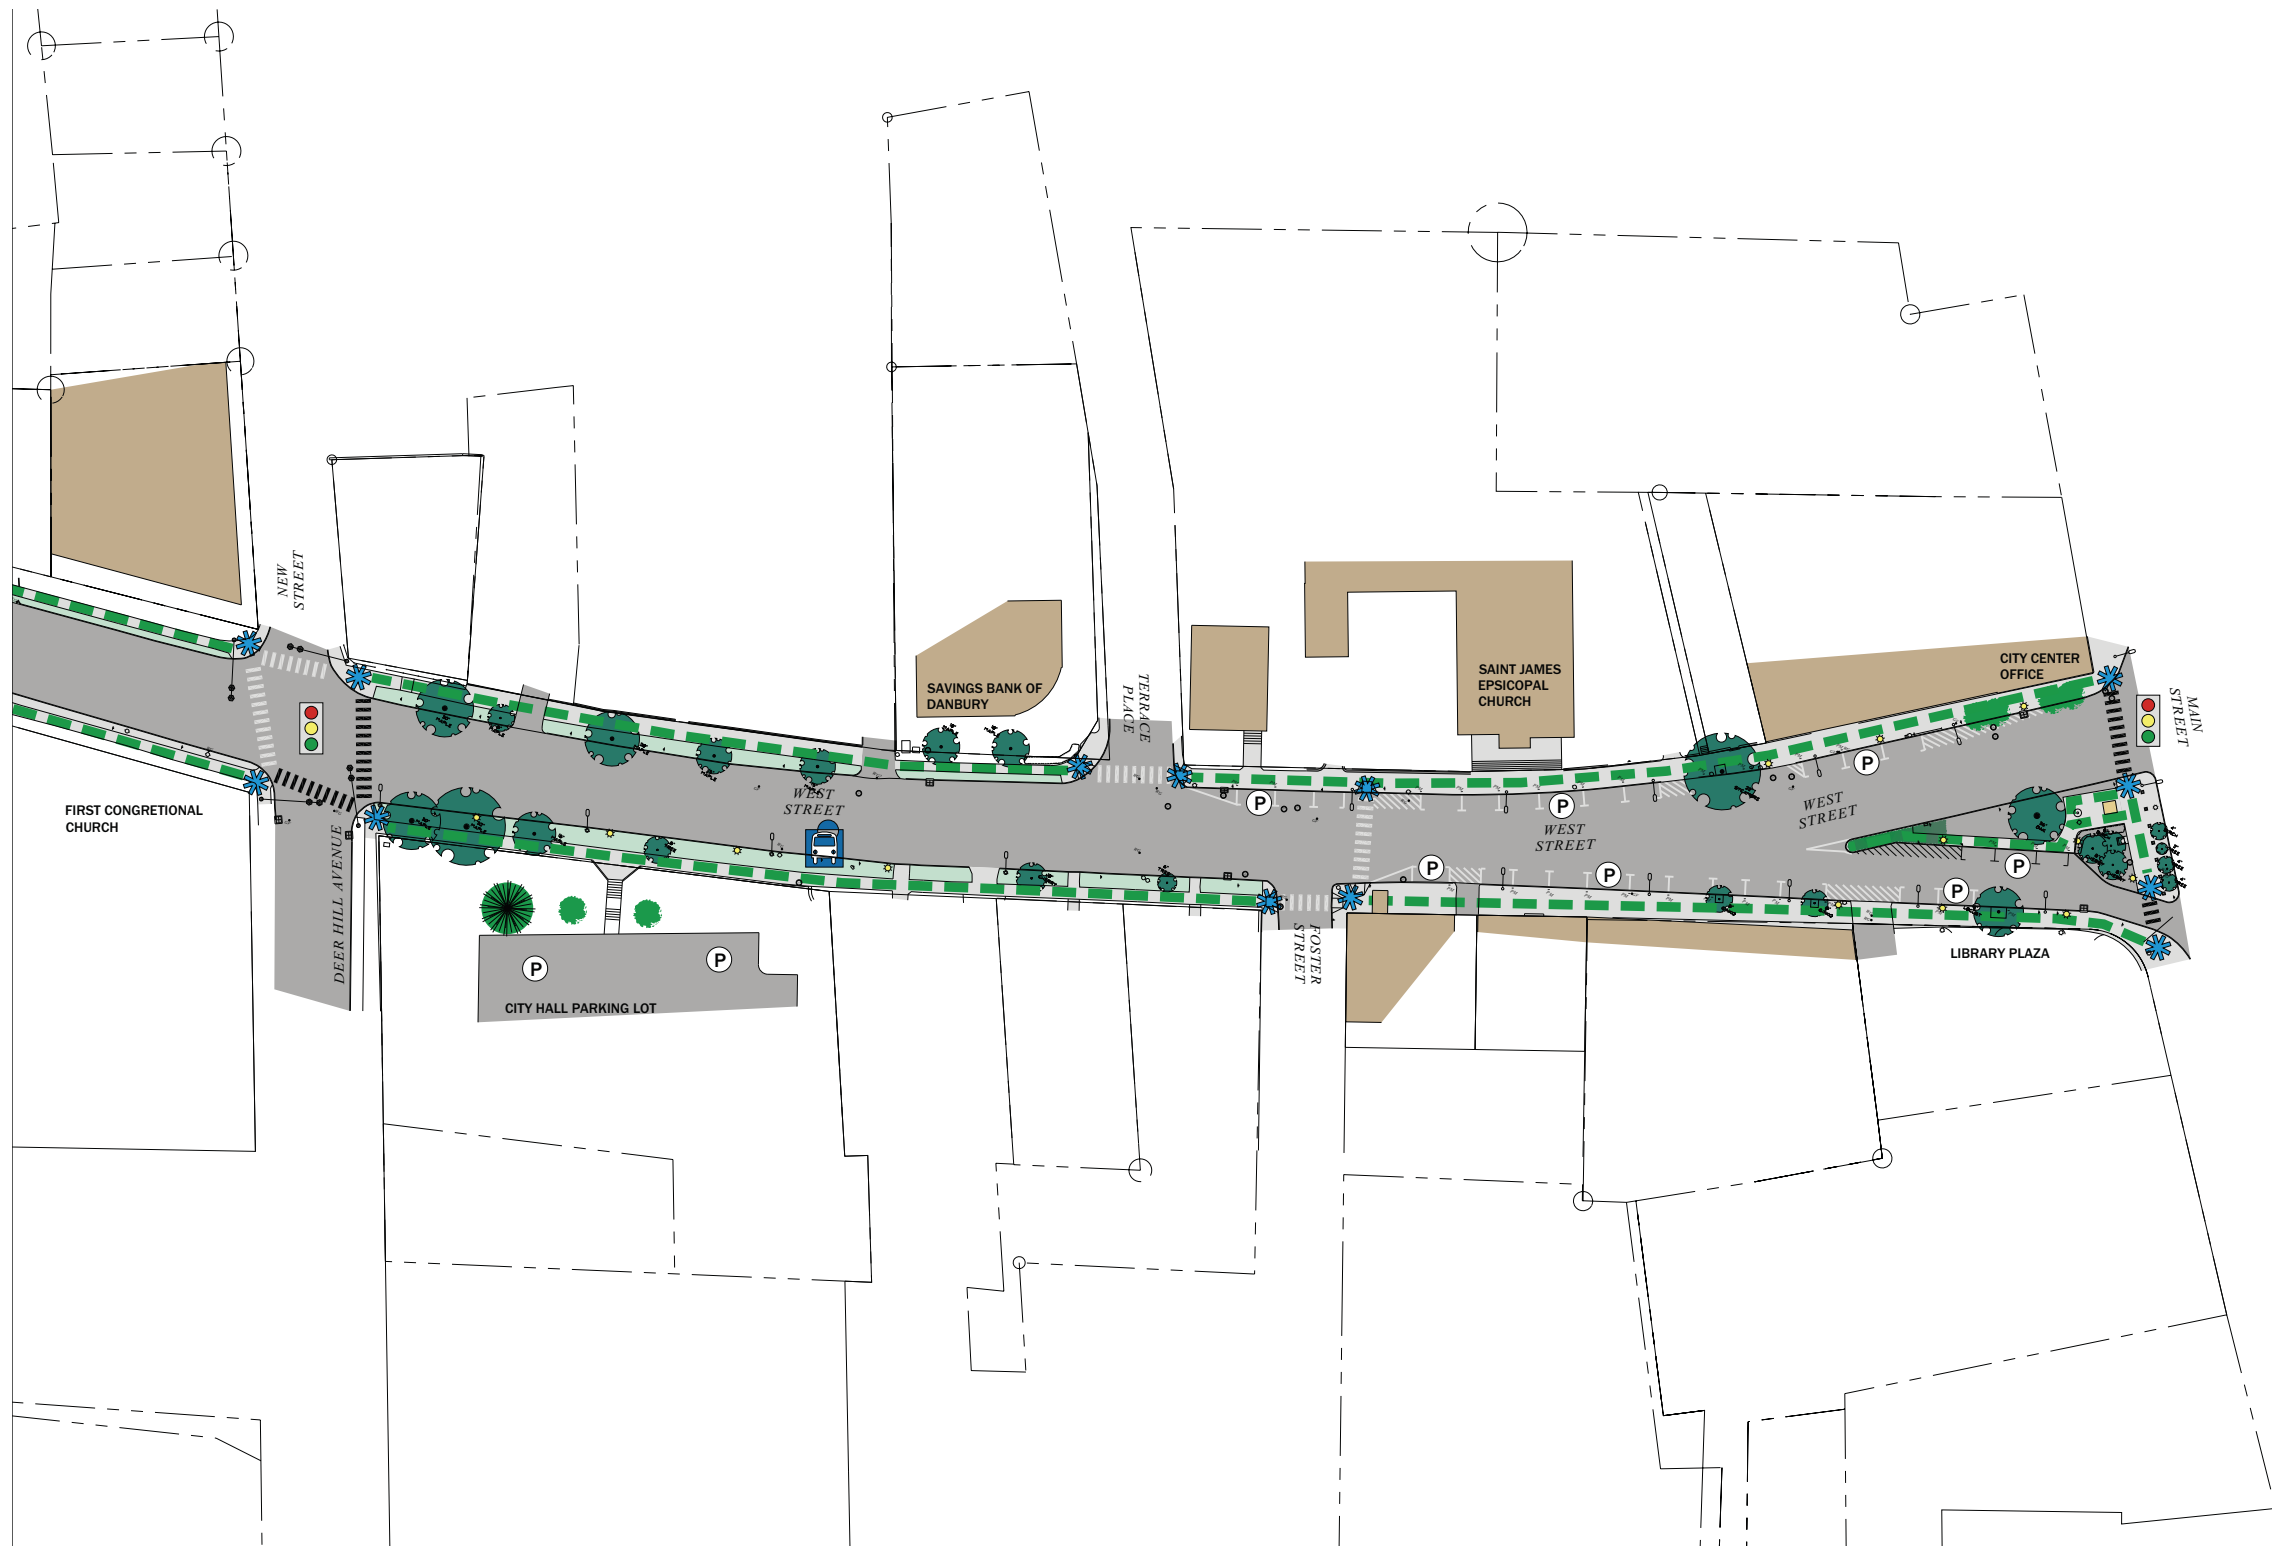
Project Title: TRANSPORTATION PLAN FOR LAKE AVENUE AND WEST STREET	
Location: DANBURY, CT	
Figure Title: EXISTING SIDEWALK CONDITIONS ANALYSIS DIVISION ST./MONTGOMERY ST. AREA	Figure Number: 10E

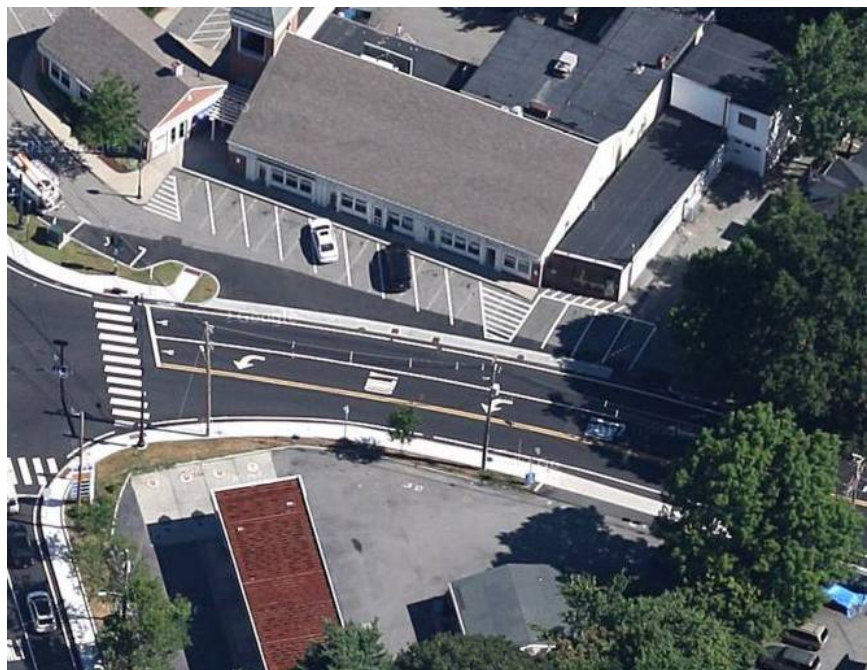
Example pedestrian improvements at continuous access
