Transportation Management Plan Lake Avenue and West Street Danbury, CT

June, 2013

VN Engineers, Inc.
116 Washington Avenue
North Haven, CT 06473
Phone (203) 234-7862

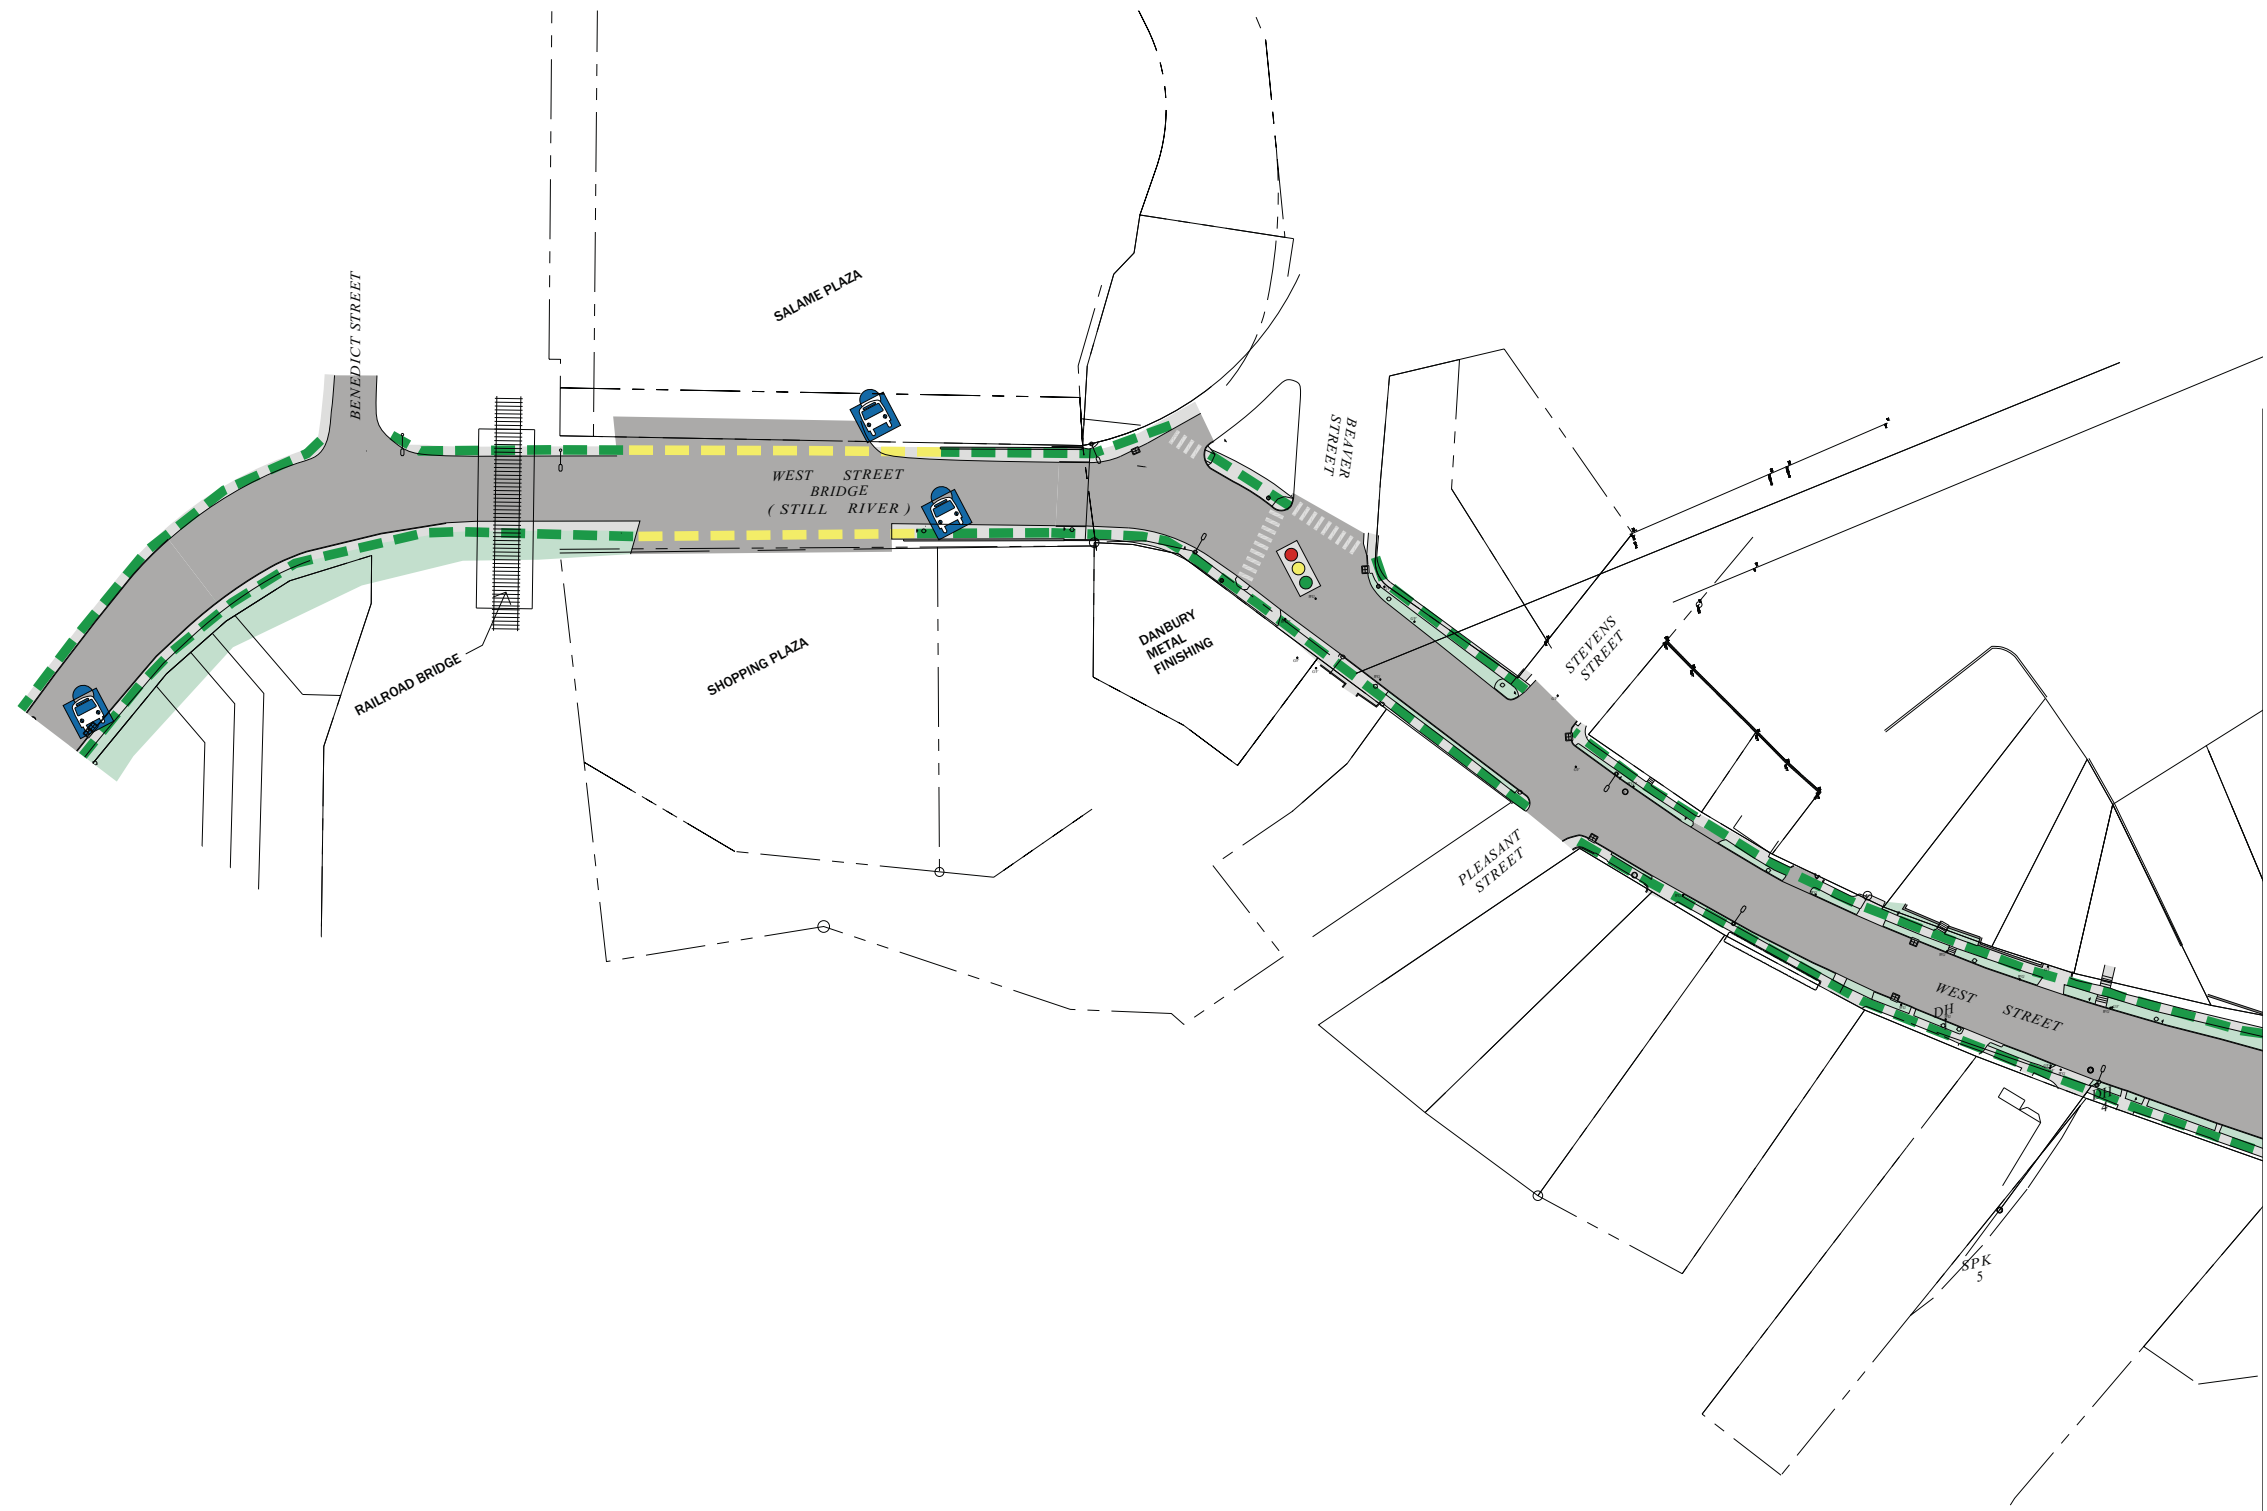
11C

- Legend:
- HOUSATONIC AREA REGIONAL TRANSIT BUS STOP
 - SIGNALIZED INTERSECTION
 - GOOD SUITABILITY FOR STREETScape
 - FAIR SUITABILITY FOR STREETScape
 - POOR SUITABILITY FOR STREETScape
 - EXISTING LAWN
 - EXISTING BUILDING

An important criterion for the development or redevelopment of sidewalk facilities is the suitability of the corridor for pedestrian use. Items to take into account are adequate space, pedestrian safety, conflicts between different user types (pedestrian, vehicular, commercial, and residential, etc.) and need for pedestrian facilities. Almost the entire project corridor is well suited for sidewalk installation with the exceptions being the few areas of storefront parking between Lawncrest Road and Merrimac Street and also the shopping plaza and Salame Plaza just east of the railroad bridge. While both of these areas are suitable for sidewalks from a topographic and infrastructure standpoint, the storefront parking does create some safety issues that need to be addressed in the design. Refer to **Figure 11** for more detailed suitability analysis.

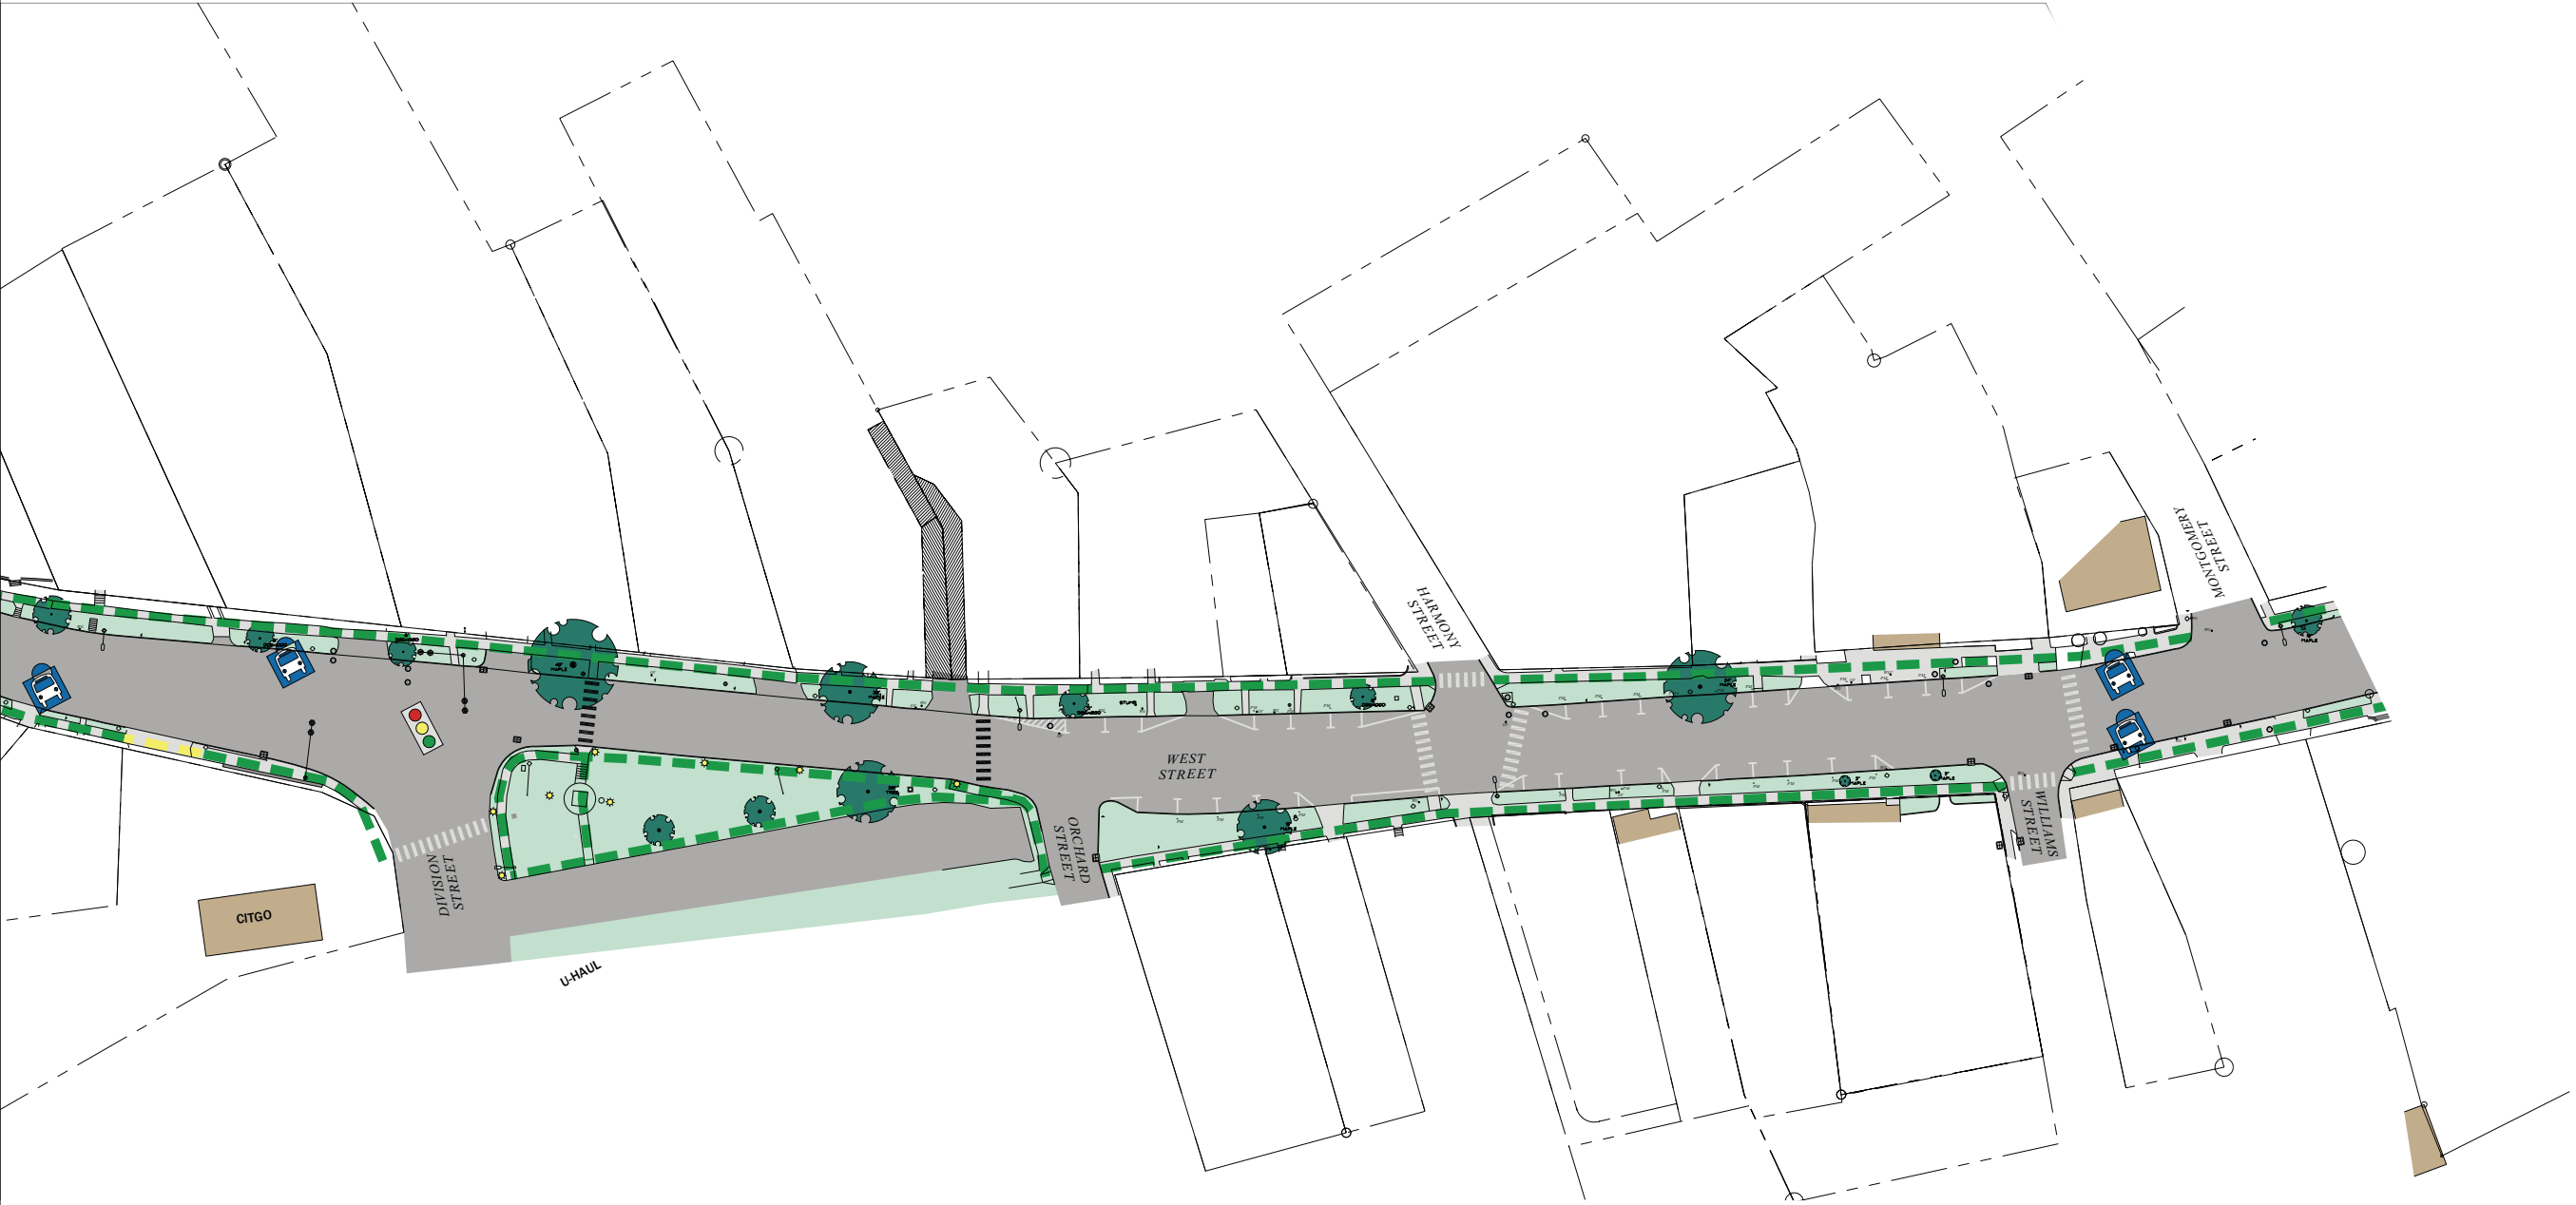
11D

- HOUSATONIC AREA REGIONAL TRANSIT BUS STOP
- SIGNALIZED INTERSECTION
- GOOD SUITABILITY FOR STREETScape
- FAIR SUITABILITY FOR STREETScape
- POOR SUITABILITY FOR STREETScape
- EXISTING LAWN
- EXISTING BUILDING

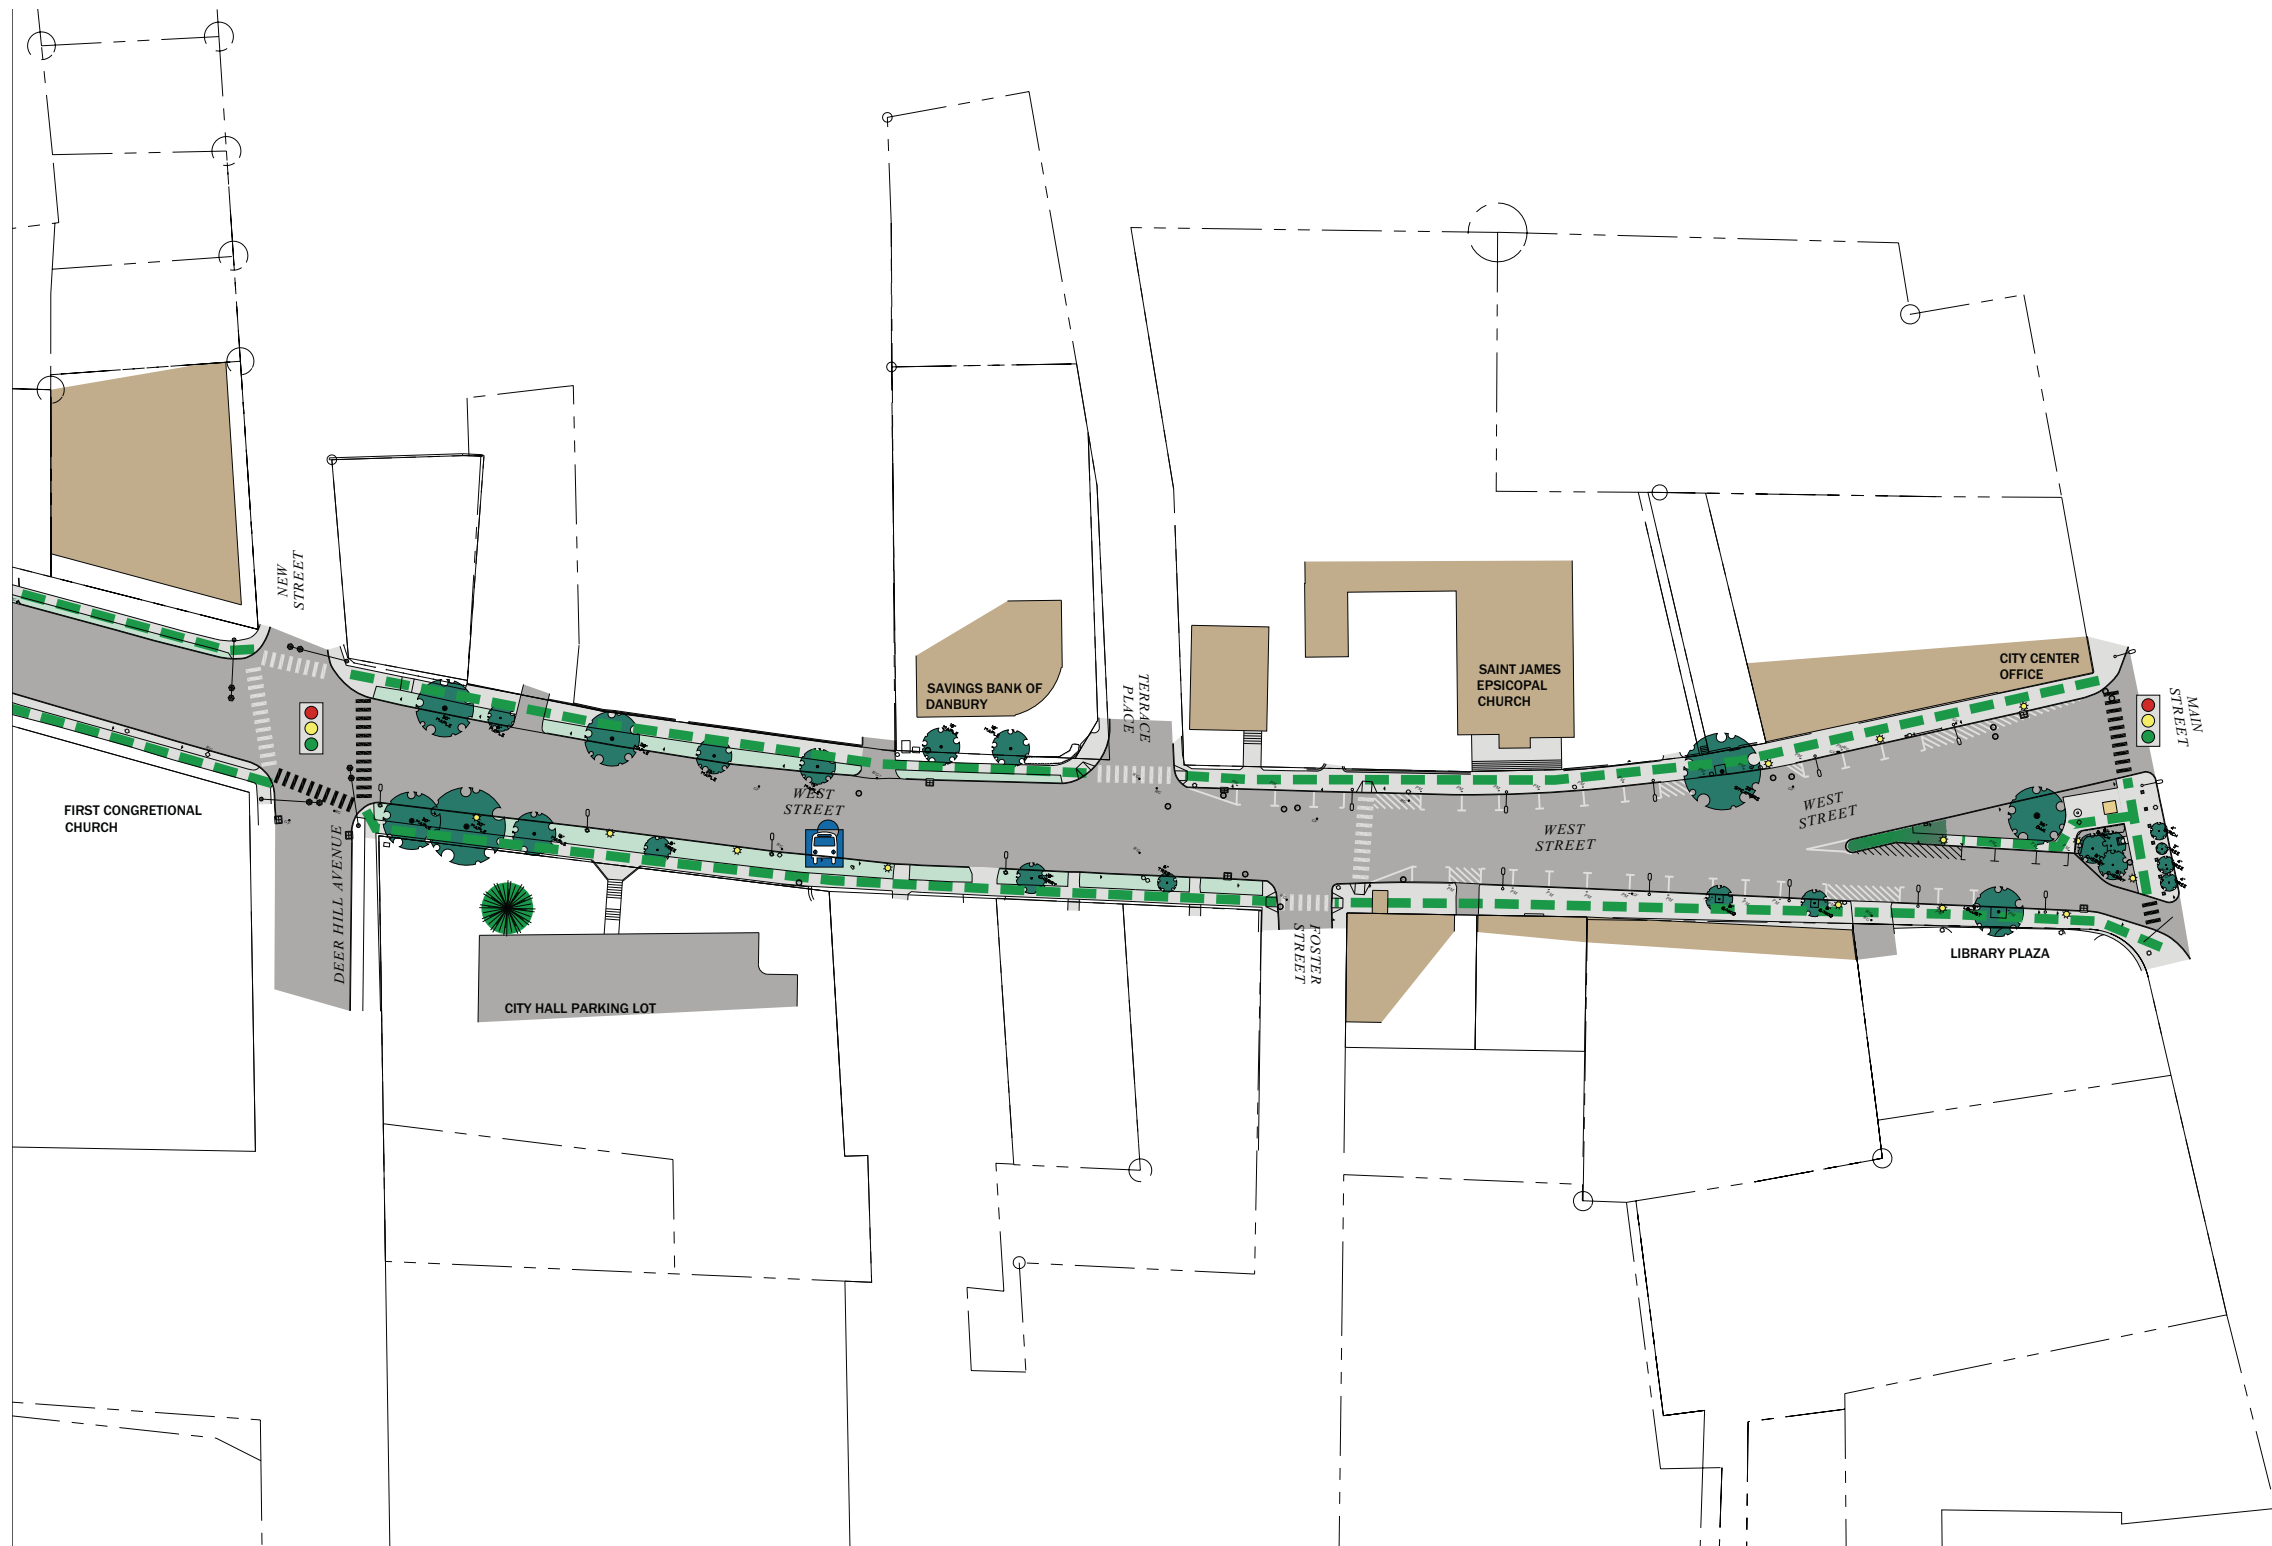
11E

HOUSATONIC AREA REGIONAL TRANSIT BUS STOP		EXISTING LAWN
	SIGNALIZED INTERSECTION		EXISTING BUILDING
	GOOD SUITABILITY FOR STREETScape		
	FAIR SUITABILITY FOR STREETScape		
	POOR SUITABILITY FOR STREETScape

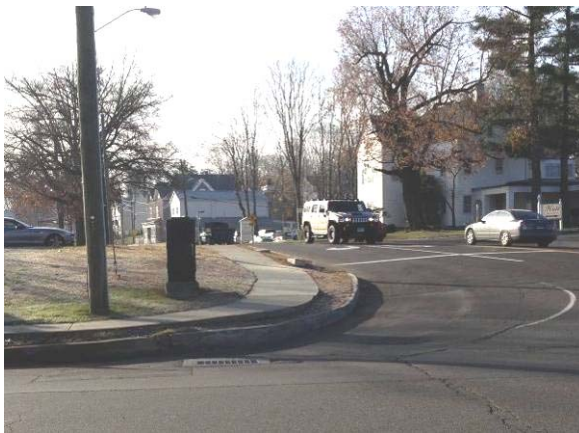
Curbing at southeast corner of West Street at Division Street

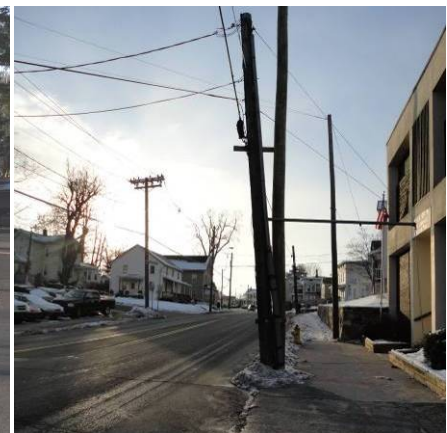
Existing utility pole just east of the Beaver Street intersection

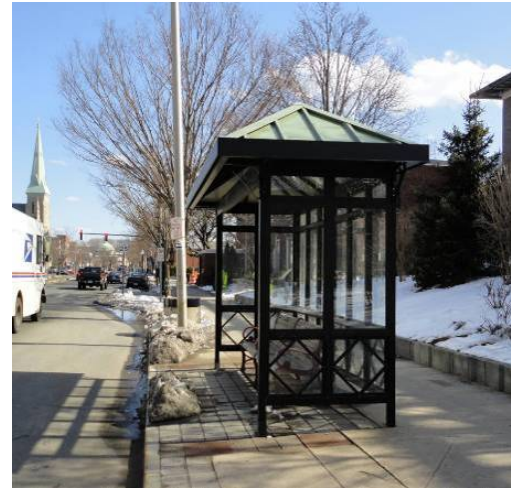
Figure 12: Existing Transit Shelter on Main Street in Front of the Library

That being said, transit shelters can address various needs and provide services beyond creating a safe, comfortable place to access public transit. **Figure 12** shows an existing transit shelter on Main Street just south of West Street. A transit shelter can include space for public notices or information regarding upcoming events, either on the shelter itself or with the inclusion of a separate, standalone kiosk. High use transit shelters are well suited to the kiosk model as they typically have more space available and are also located in areas of high activity where a kiosk will be seen by more users (pedestrians, cyclists, etc.) who may not realize that the information posted directly on the shelter may not be exclusively for transit users. Space for public artwork is also a possibility at transit stops that are located on larger parcels of property. The artwork can create a sense of place at the transit shelter and help to integrate it into the local neighborhood and provide a comfortable gathering space for residents to meet and form community bonds. Although transit shelters have many benefits, currently there are no staff members at HARTransit or the City that can install or maintain a new shelter. It would be beneficial if a management plan could be developed to determine how shelters would be constructed and maintained. Or, alternatively, a structure requiring less maintenance, such as a bench or a roof / cover (with no sides) could be considered.

HARTransit has indicated that the current stop locations are adequate throughout the corridor, however we have identified several locations where transit shelters could be installed based on available area. These locations are the two existing stops on West Street near Williams Street and Montgomery Street and on West Street at the east corner of the City Hall property. As installation and maintenance issues are resolved and transit use increases in the corridor, HARTransit should consider the installation of shelters or other amenities at some stops along West Street to benefit transit users and the greater community.

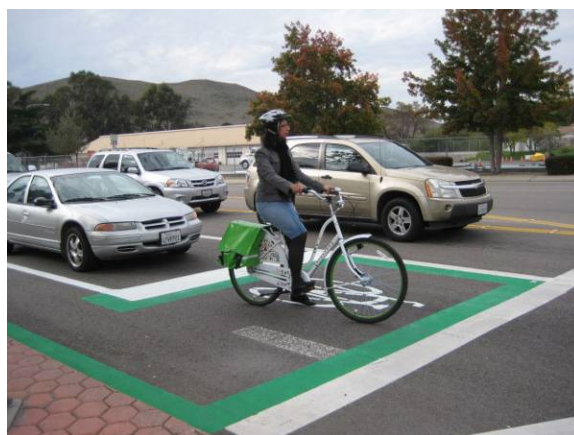
- Establishing bike facilities at signalized intersections such as bike boxes and detection equipment that can detect bicycles. Bike boxes help improve visibility of cyclists, confirm their appropriate location waiting for a red light, and improve safety for bicyclists

Bikebox

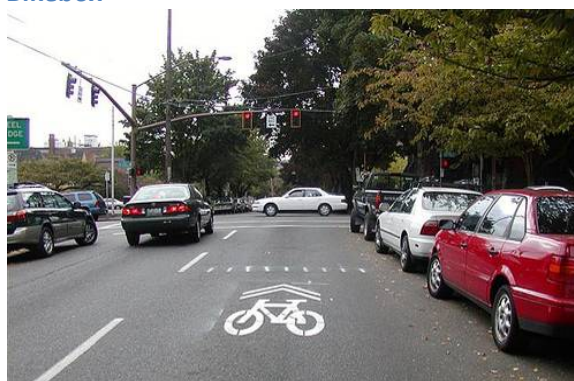
Sharrows

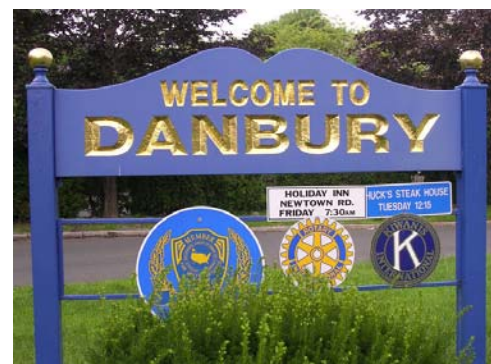
- Gateway sign
- Planting
- Lighting

Example Gateway Signage

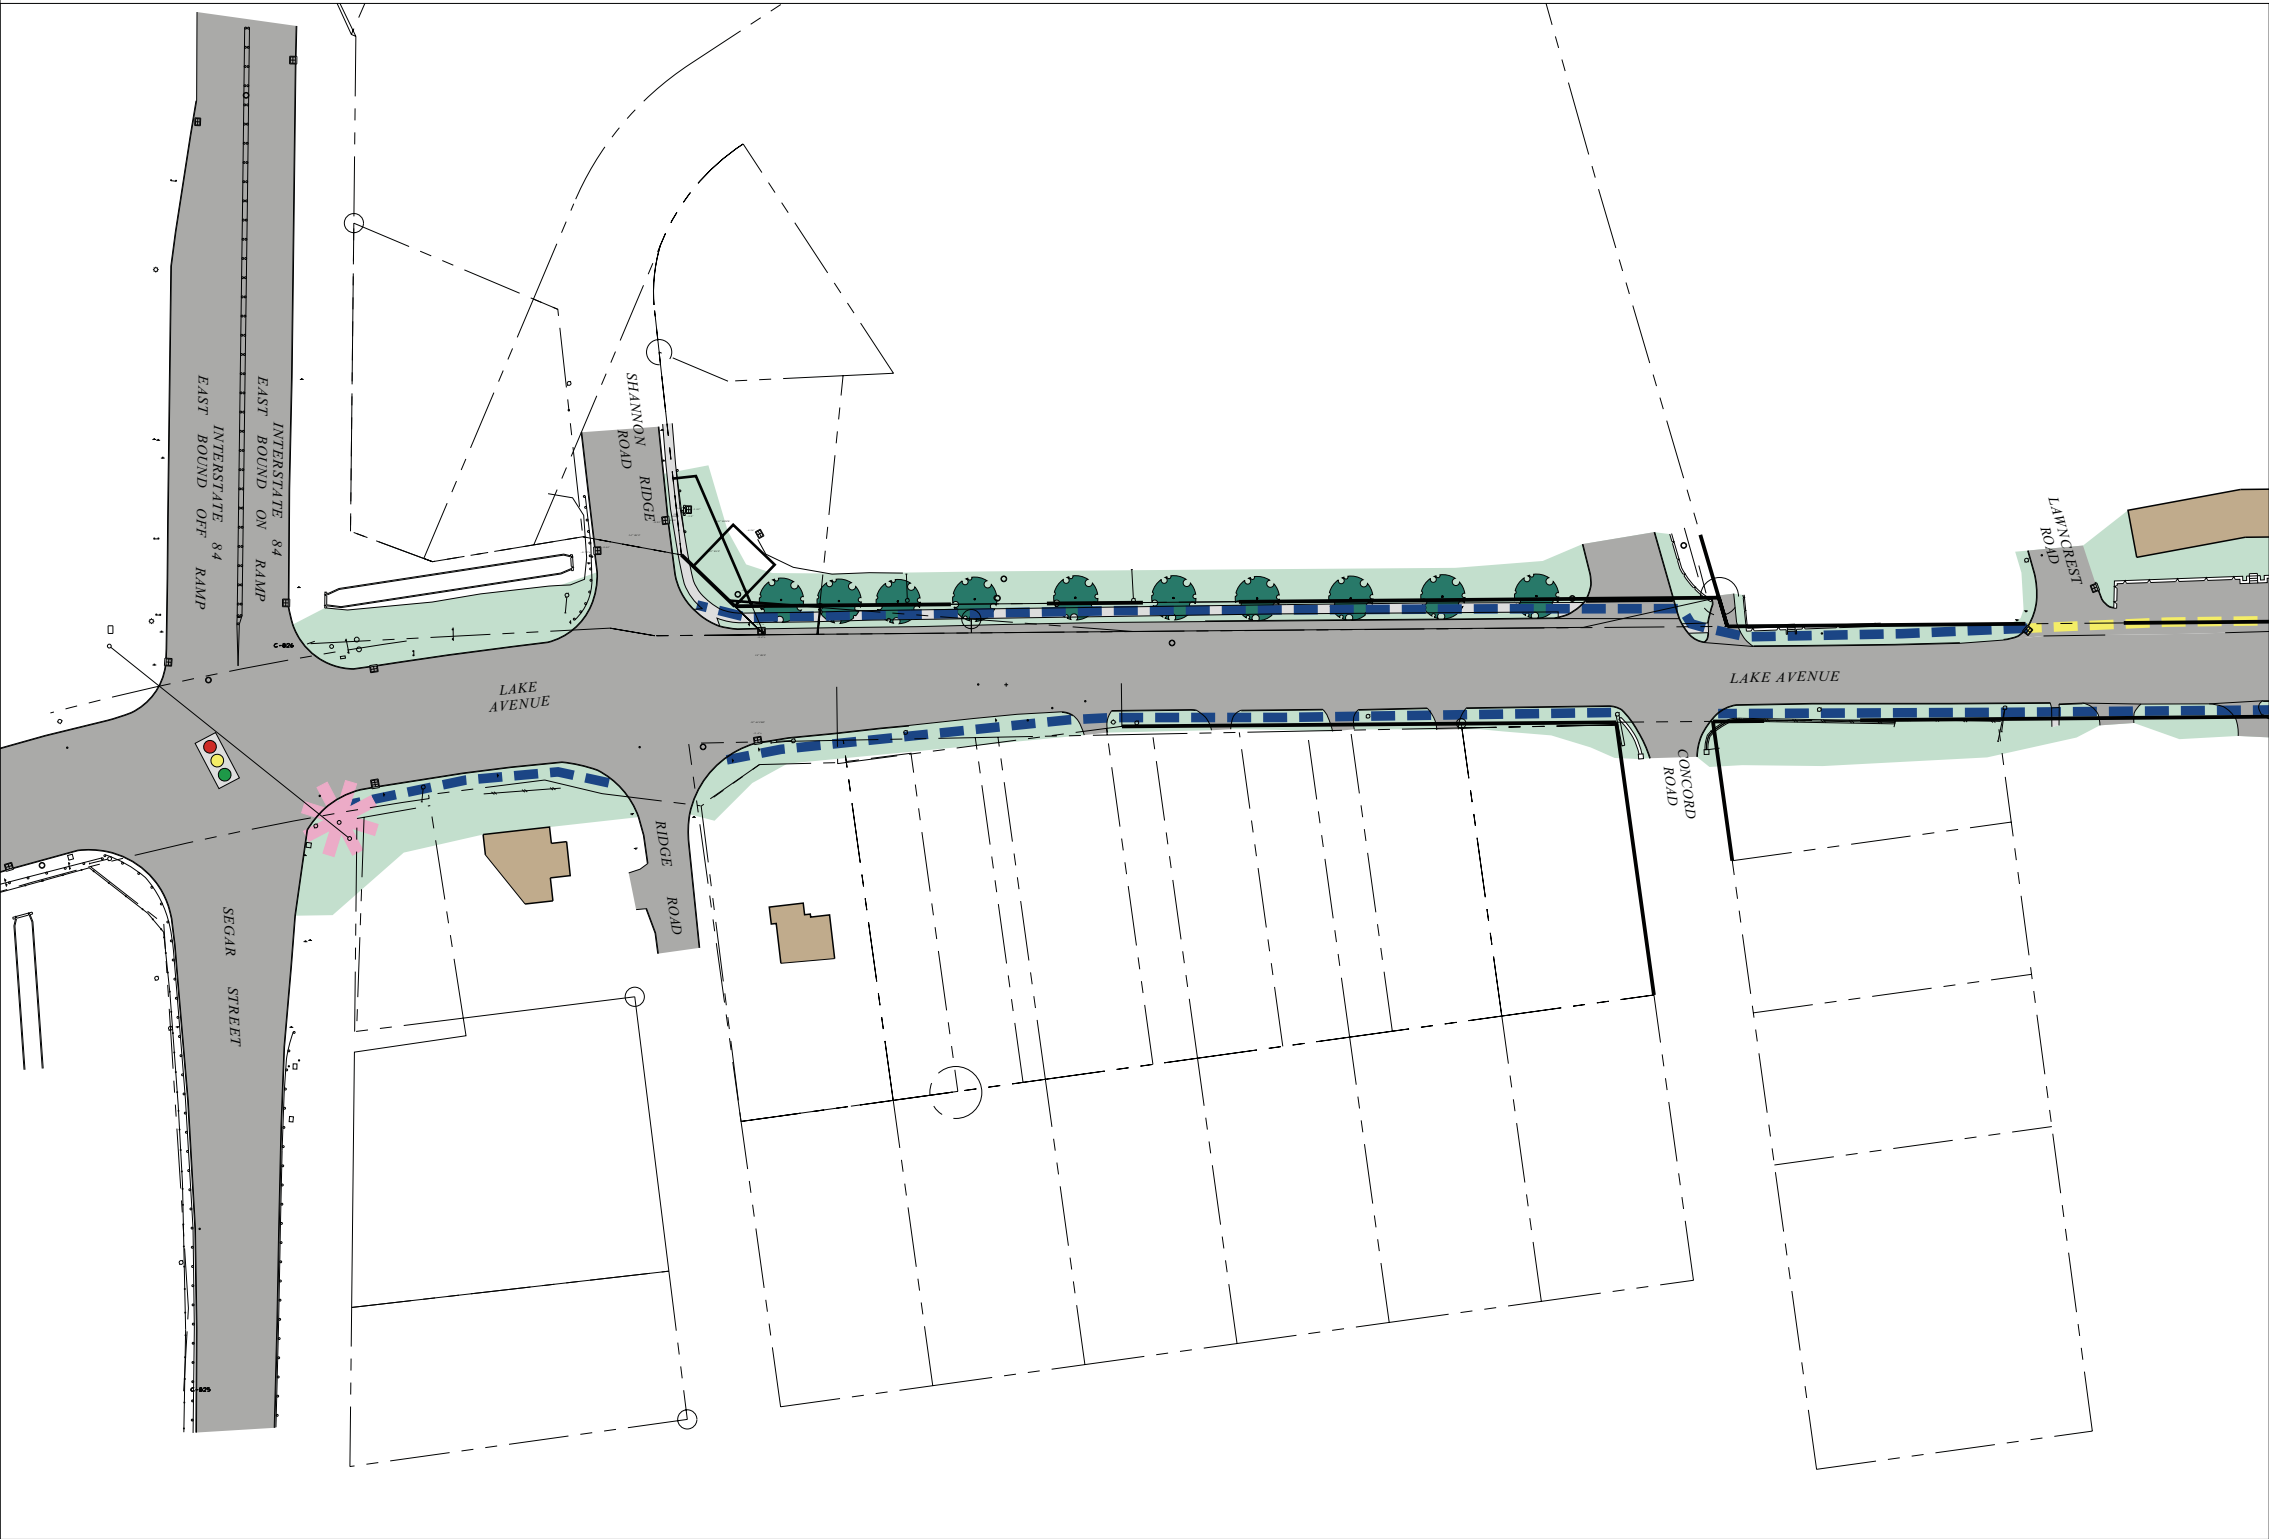
PROPOSED STREETScape STYLE	STREETScape ELEMENTS
<u>NEIGHBORHOOD STREETScape</u> 	<ul style="list-style-type: none">• CONCRETE WALK PAVEMENT WITH 5' PANEL SCORE PATTERN - HEAVY DUTY PAVEMENT AT DRIVEWAY CROSSINGS• LAWN STRIP BETWEEN WALK AND ROAD WHERE POSSIBLE• STREET TREES• PAINTED CROSSWALKS
<u>STREETScape AT STORE FRONT PARKING</u> 	<ul style="list-style-type: none">• HEAVY DUTY CONCRETE WALK PAVEMENT WITH 5' PANEL SCORE PATTERN• PAINTED CROSSWALKS
<u>GATEWAY AREA</u> 	<ul style="list-style-type: none">• GATEWAY SIGN• PLANTING• LIGHTING

The project corridor from the I-84 ramps to Lawncrest Road and Hudson Street are well suited to the “Neighborhood Streetscape” model. From these points east to Merrimac Street is the location of the first group of storefront parking areas. As previously noted, there are some safety concerns for pedestrian facilities in these areas, however with proper design these could be addressed. These areas have been keyed out to be the “Streetscape at Store Front Parking” design. The next section of the project corridor, from Merrimac Street to Division Street consists primarily of residential uses with some small areas of commercial use mixed throughout. As such, it is recommended that the “Neighborhood Streetscape” model be installed along this section with the exception of the small shopping plaza and Salame Plaza, just east of the railroad bridge, which would be constructed per the “Streetscape at Store Front Parking” model.

Just east of Division Street is the first of two pocket parks in the corridor. This park currently has several statues, a perimeter walkway, and several old trees. All of the elements of the “Pedestrian Park” model could be installed here and would recreate this park as a gathering space for the neighborhood and increase its prominence in the proposed streetscape. Division Street marks the beginning of the downtown / Main Street area and here is where the streetscape designs become more detailed. The concrete walk pavement will now be an 18 inch x 18 inch score pattern, decorative street lighting and waste receptacles along with street trees and permeable paver tree pits. The corridor from Division Street to Terrace Place / Foster Street would be constructed per the “Downtown Streetscape with Lawn” model and the rest of the corridor up to Main Street would be the “Downtown Streetscape” model. The last piece of the

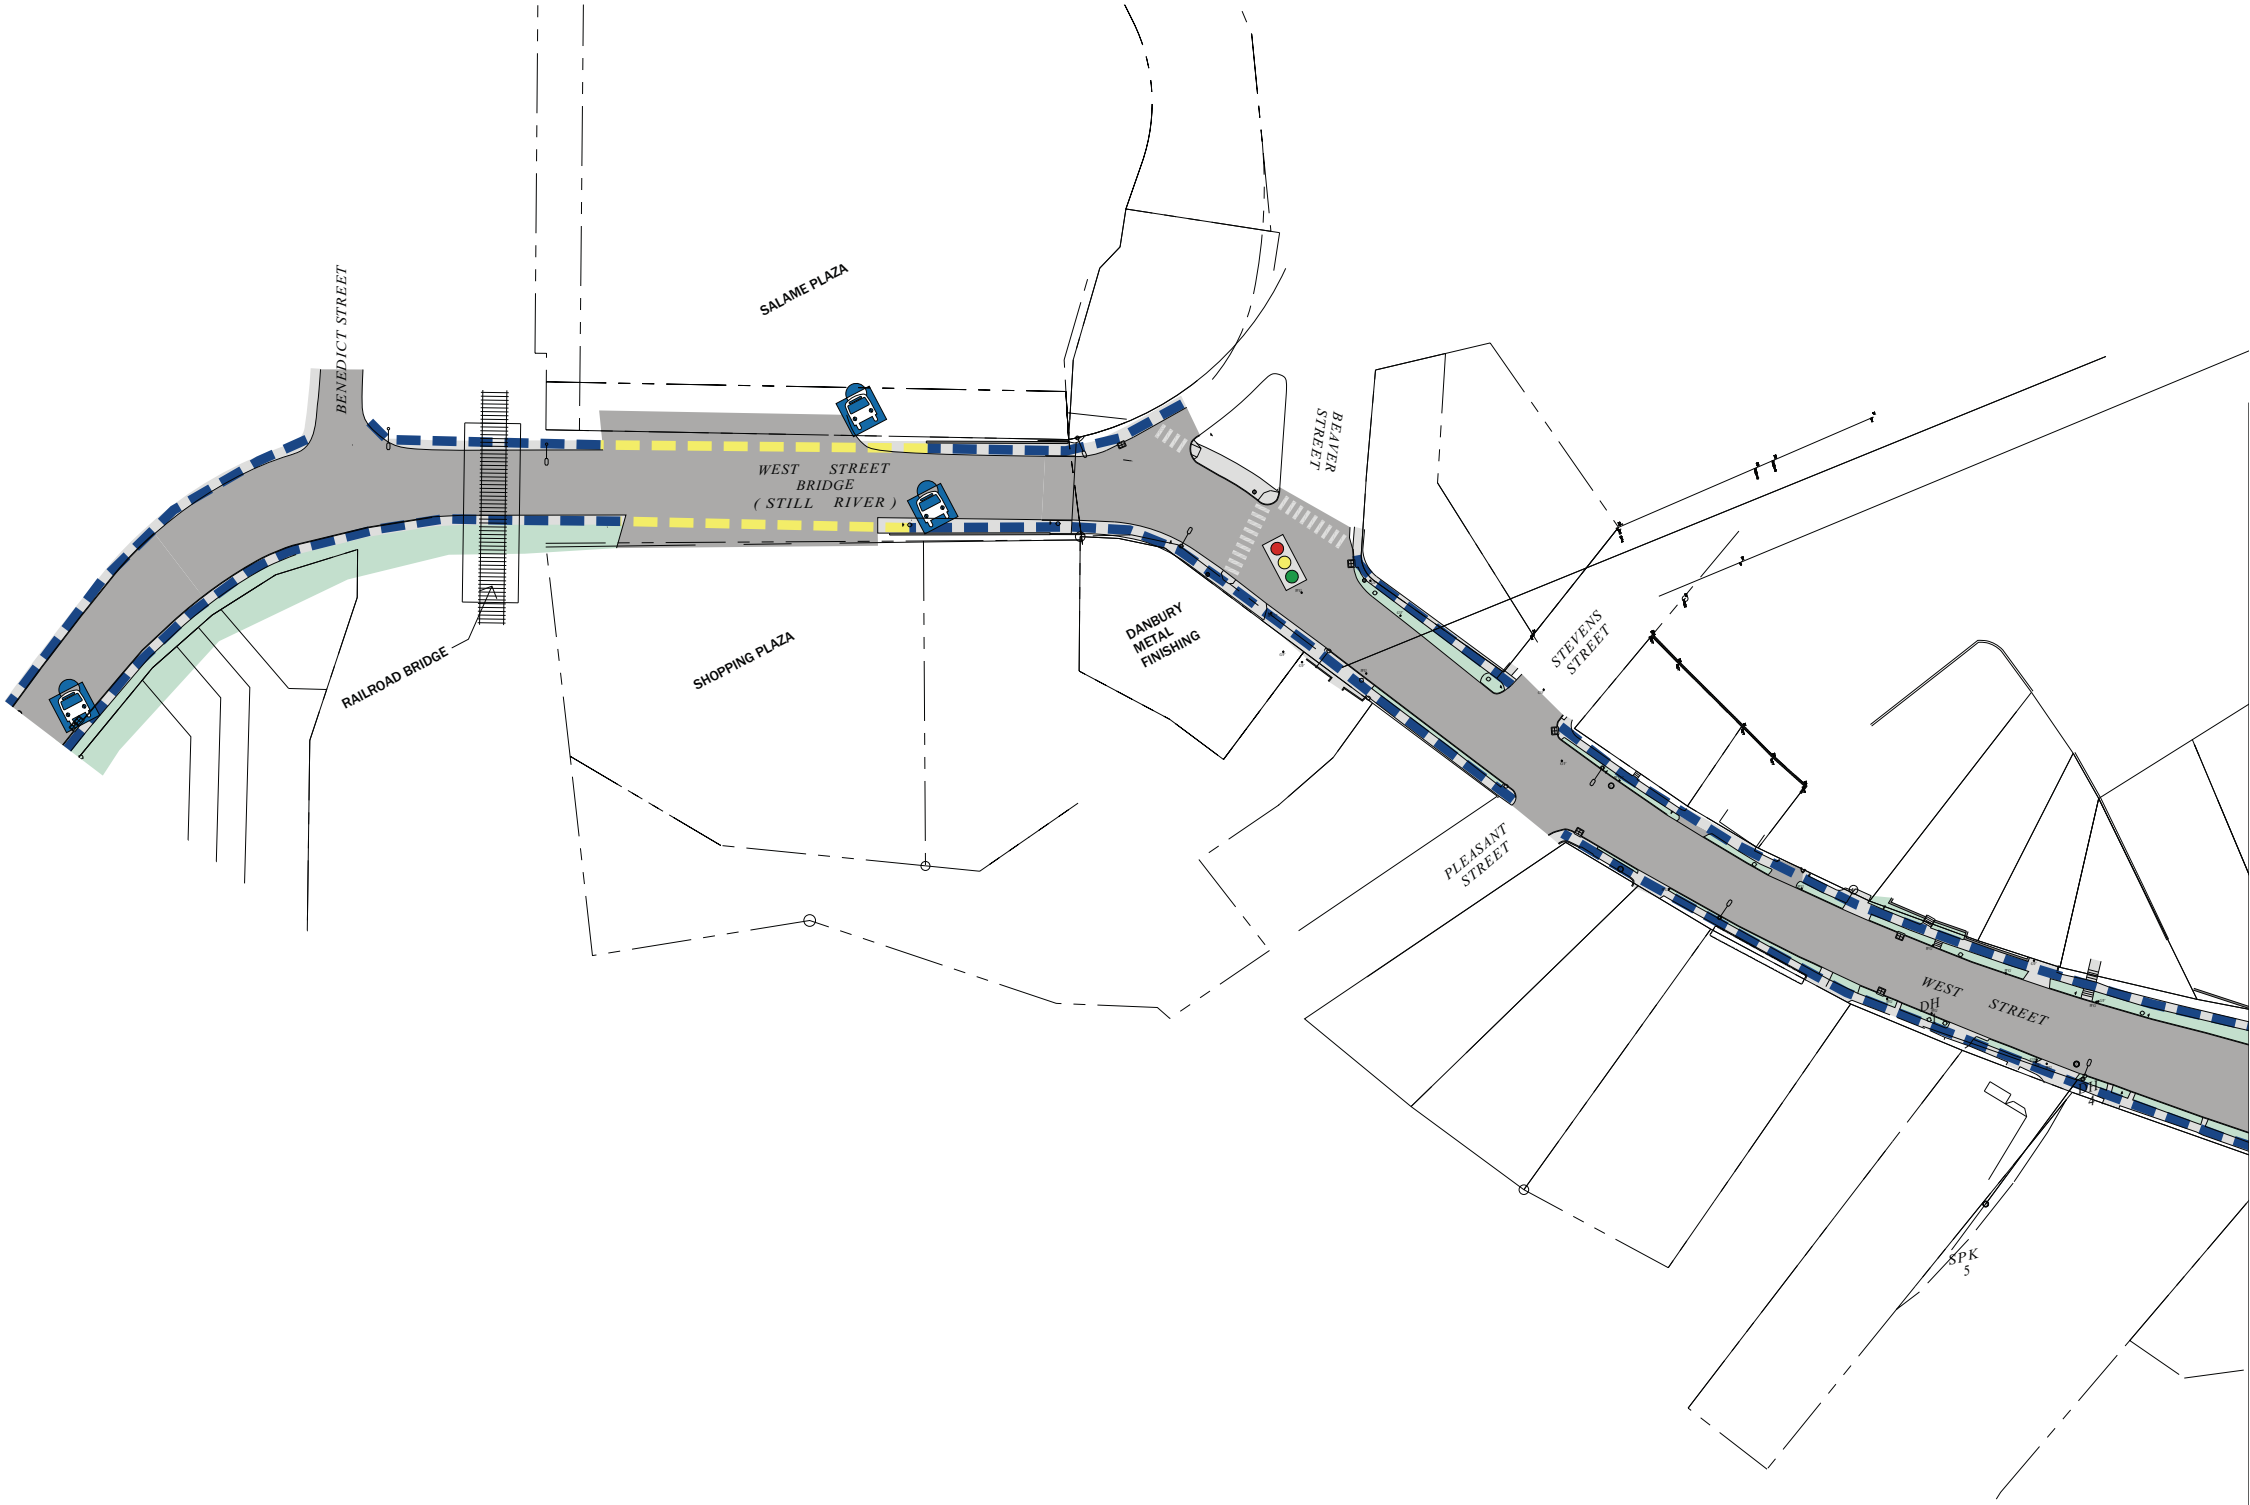
Project Title:	TRANSPORTATION PLAN FOR LAKE AVENUE AND WEST STREET	
Location:	DANBURY, CT	
Figure Title:	PROPOSED STREETSCAPE STYLE WELL AVENUE/MORRIS STREET AREA	Figure Number: 13C

PROPOSED STREETScape STYLE	STREETScape ELEMENTS
<u>NEIGHBORHOOD STREETScape</u> 	<ul style="list-style-type: none">CONCRETE WALK PAVEMENT WITH 5' PANEL SCORE PATTERN - HEAVY DUTY PAVEMENT AT DRIVEWAY CROSSINGSLAWN STRIP BETWEEN WALK AND ROAD WHERE POSSIBLESTREET TREESPAINTED CROSSWALKS
<u>STREETScape AT STORE FRONT PARKING</u> 	<ul style="list-style-type: none">HEAVY DUTY CONCRETE WALK PAVEMENT WITH 5' PANEL SCORE PATTERNPAINTED CROSSWALKS
