Transportation Management Plan Lake Avenue and West Street Danbury, CT

June, 2013

VN Engineers, Inc.
116 Washington Avenue
North Haven, CT 06473
Phone (203) 234-7862

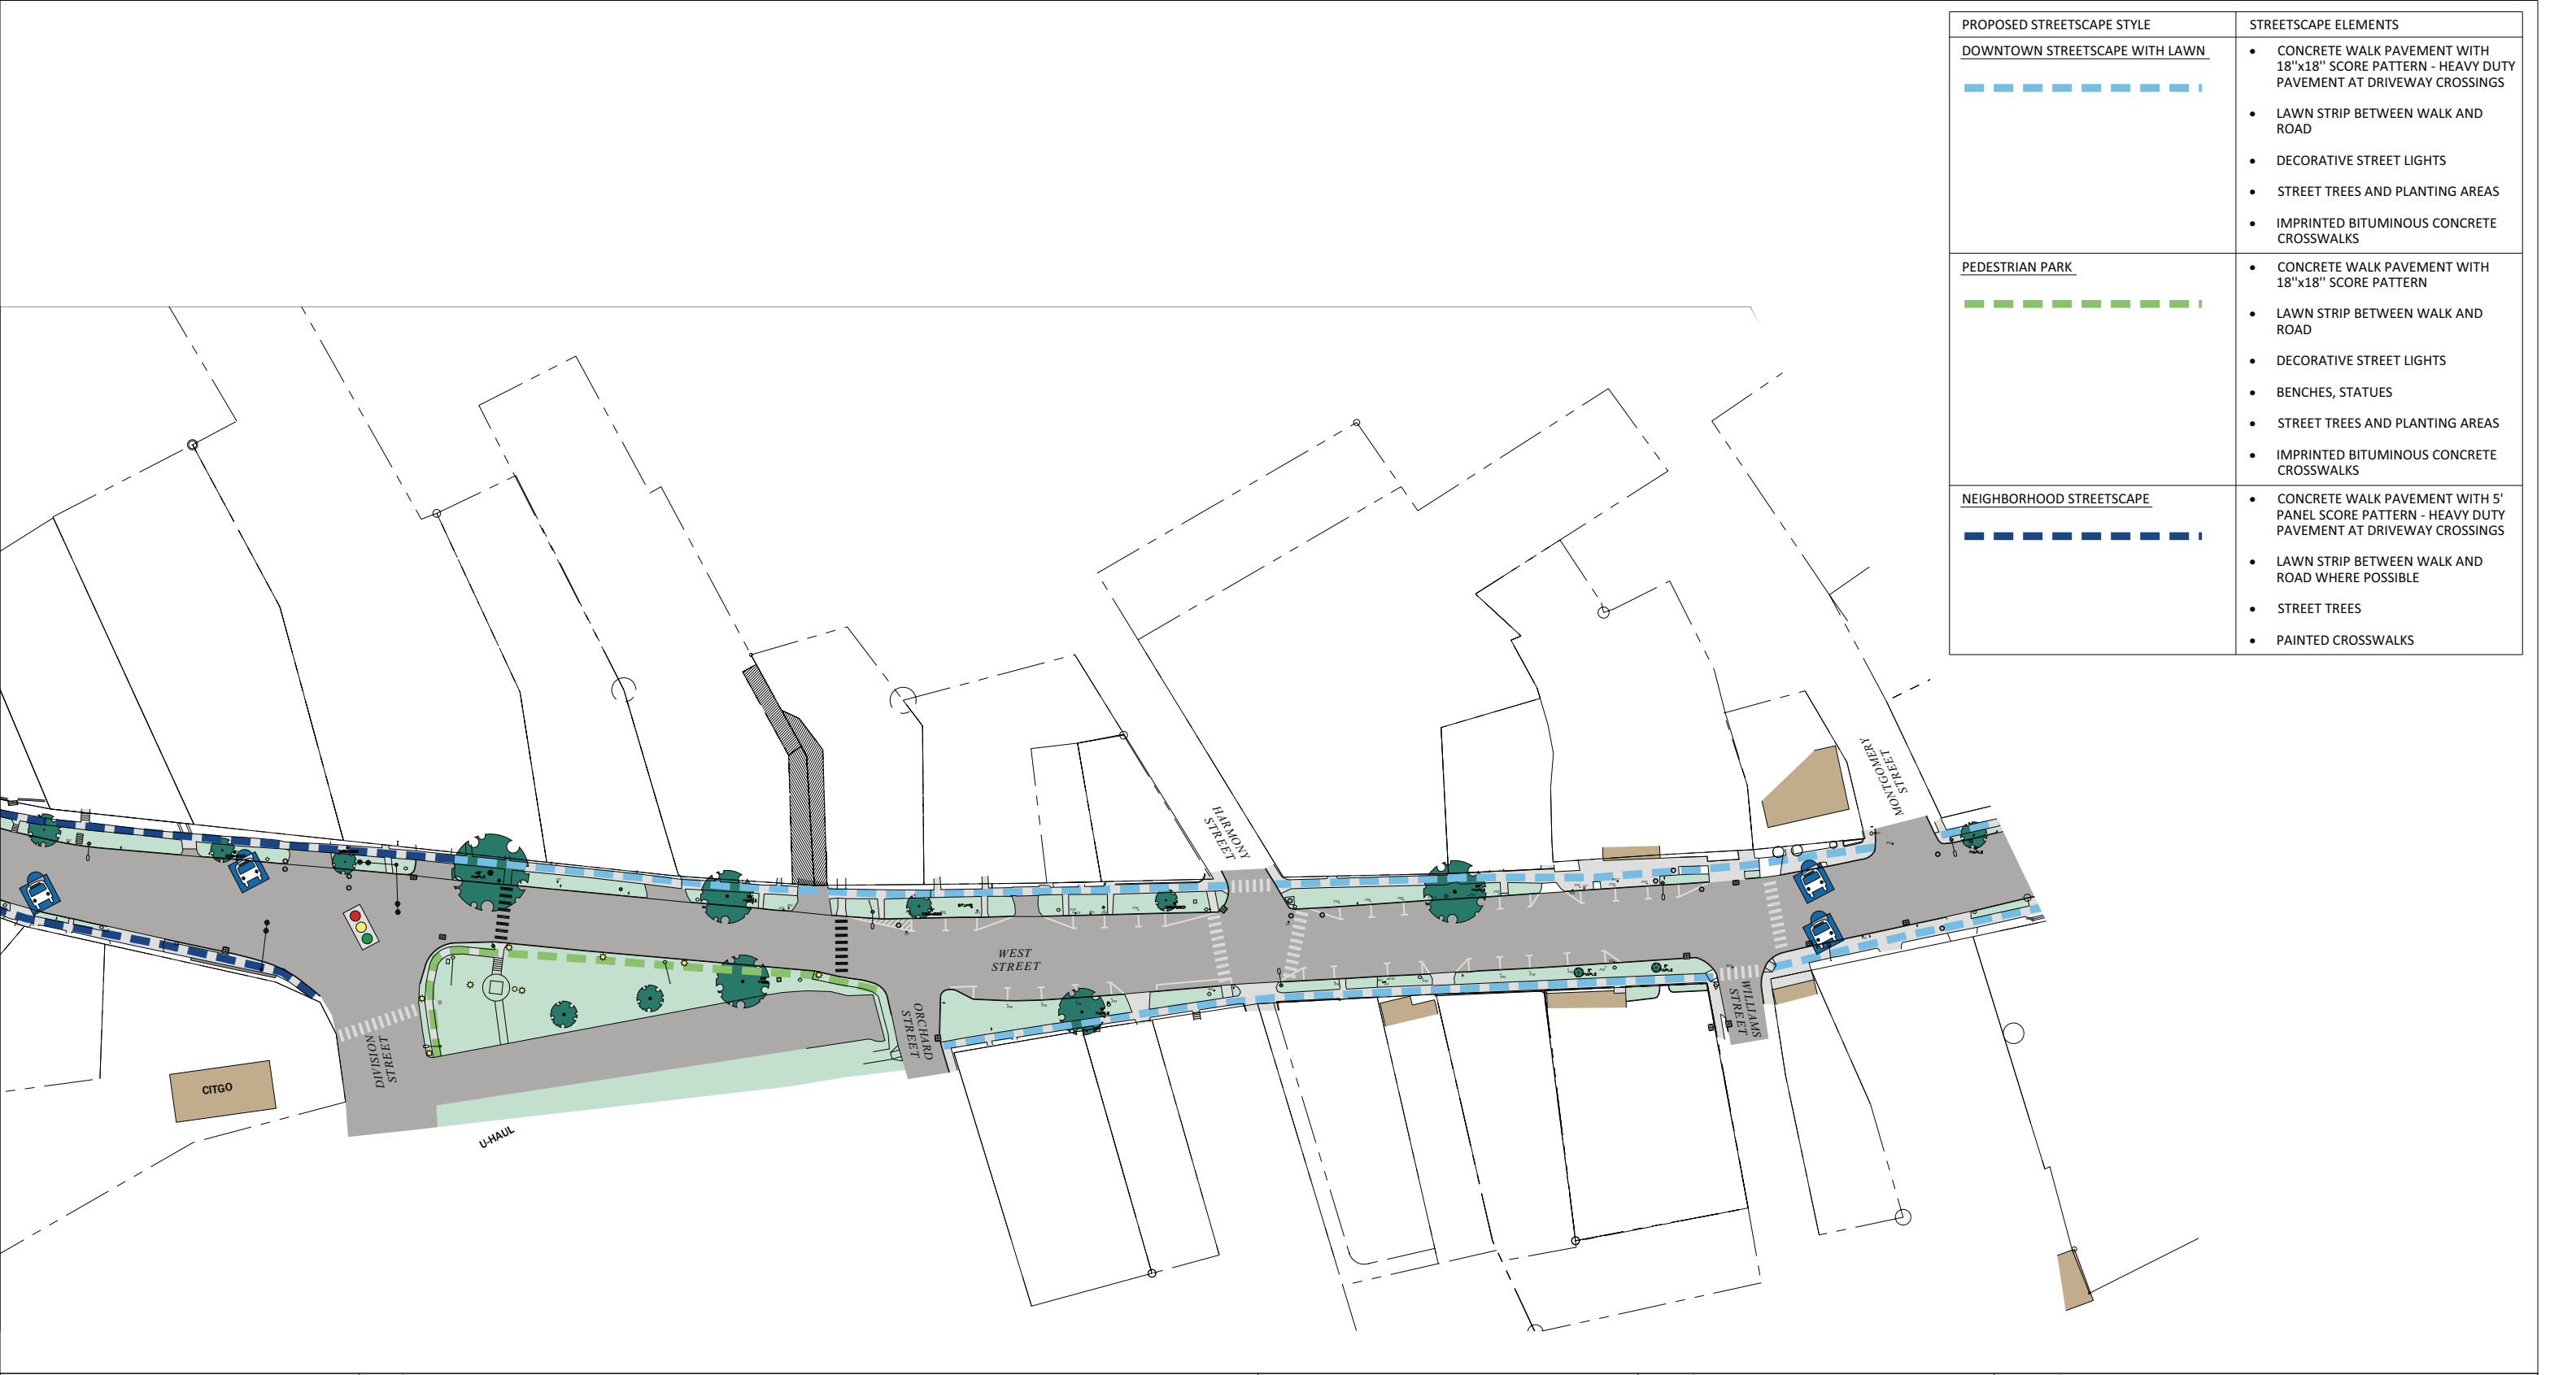
Project Title: TRANSPORTATION PLAN FOR LAKE AVENUE AND WEST STREET	
Location: DANBURY, CT	
Figure Title: PROPOSED STREETScape STYLE MORRIS STREET/BEAVER STREET AREA	Figure Number: 13D

PROPOSED STREETScape STYLE	STREETScape ELEMENTS
DOWNTOWN STREETScape WITH LAWN 	<ul style="list-style-type: none">• CONCRETE WALK PAVEMENT WITH 18"x18" SCORE PATTERN - HEAVY DUTY PAVEMENT AT DRIVEWAY CROSSINGS• LAWN STRIP BETWEEN WALK AND ROAD• DECORATIVE STREET LIGHTS• STREET TREES AND PLANTING AREAS• IMPRINTED BITUMINOUS CONCRETE CROSSWALKS
PEDESTRIAN PARK 	<ul style="list-style-type: none">• CONCRETE WALK PAVEMENT WITH 18"x18" SCORE PATTERN• LAWN STRIP BETWEEN WALK AND ROAD• DECORATIVE STREET LIGHTS• BENCHES, STATUES• STREET TREES AND PLANTING AREAS• IMPRINTED BITUMINOUS CONCRETE CROSSWALKS
NEIGHBORHOOD STREETScape 	<ul style="list-style-type: none">• CONCRETE WALK PAVEMENT WITH 5' PANEL SCORE PATTERN - HEAVY DUTY PAVEMENT AT DRIVEWAY CROSSINGS• LAWN STRIP BETWEEN WALK AND ROAD WHERE POSSIBLE• STREET TREES• PAINTED CROSSWALKS

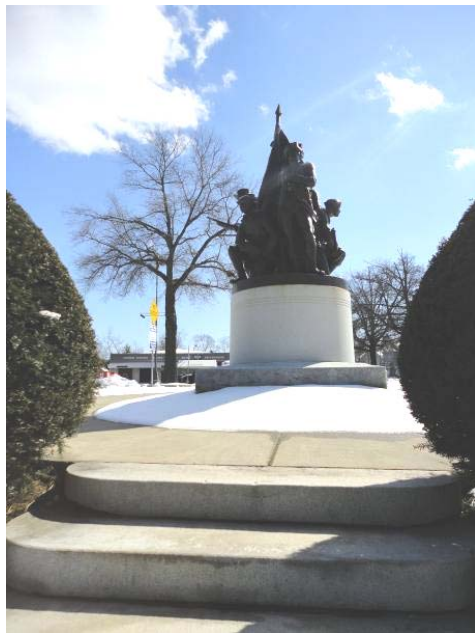
War Memorial on West Street Island at Division Street

West Street Island at Division Street – Proposed renovations for the island at the southeast corner of Division Street at West Street intersection are shown in **Figure 15**. The proposed design follows the parameters of the “Pedestrian Park” model, with the elements of the streetscape beginning to take on the more detailed aspects of the downtown streetscape further east. The most prominent element of this park is the War Memorial statue which would remain in its present location. A new paver walk and planting would encircle the statue with benches and decorative lighting added to increase pedestrian use. The existing flagpole would be relocated so it provides a backdrop to the statue from West Street. New steps to the War Memorial statue, and a concrete walk with 18 inch x 18 inch score pattern will complete the pedestrian way.

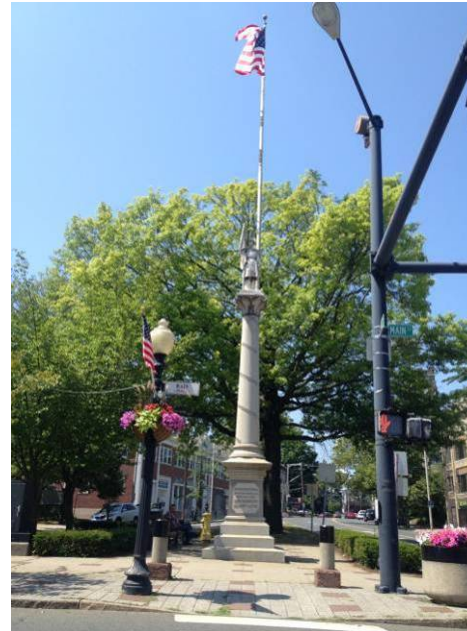
West Street Island at Main Street

Street. The biggest change proposed is to the balance of the concrete walks and the lawn areas. This island is the entry to the project corridor's east end and aside from the items being retained it does not have the punch that such an important location requires. This issue will be addressed by simplifying the existing walk system which will allow for decorative plantings to replace these walks and lawn areas. New decorative site lighting and imprinted bituminous concrete crosswalks will tie this island in with the rest of the corridor and set the stage for the corridor as users enter from this location. All new sidewalks on the island as well as those on the sides of West Street will be constructed with the same 18 inch x 18 inch score pattern proposed for other new concrete sidewalks that the users will see while moving along the corridor. Another detail that will be seen on the West Street sidewalks is permeable paver tree pits. Constructed with structural soil and decorative permeable pavers, these tree pits will provide protection for the roots, allow water and air to get to the roots to improve and maintain plant health, and create a decorative detail in the streetscape of this very important intersection.
