# Bicycle-Pedestrian Safety Corridors Study

# **FINAL REPORT**

## **SWRPA BICYCLE - PEDESTRIAN SAFETY CORRIDORS STUDY**

**June, 2012**

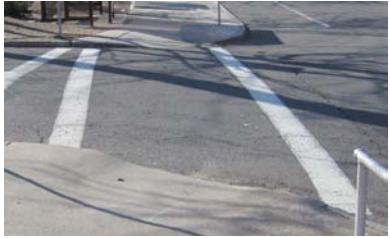
Crosswalk over side street

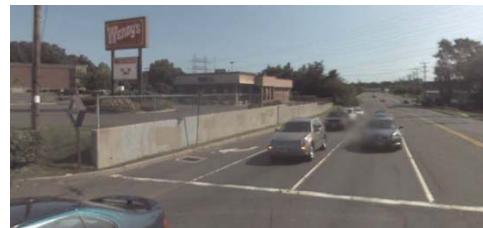
**View of southbound right turn lane proposed for replacement with a sidewalk**

- Consider removal of the 150-foot southbound US 1 right-turn lane into the Kohl's shopping center access driveway in order to construct a sidewalk. Figure 4 shows this possible improvements in the vicinity of this intersection including the removal of the southbound right-turn lane.

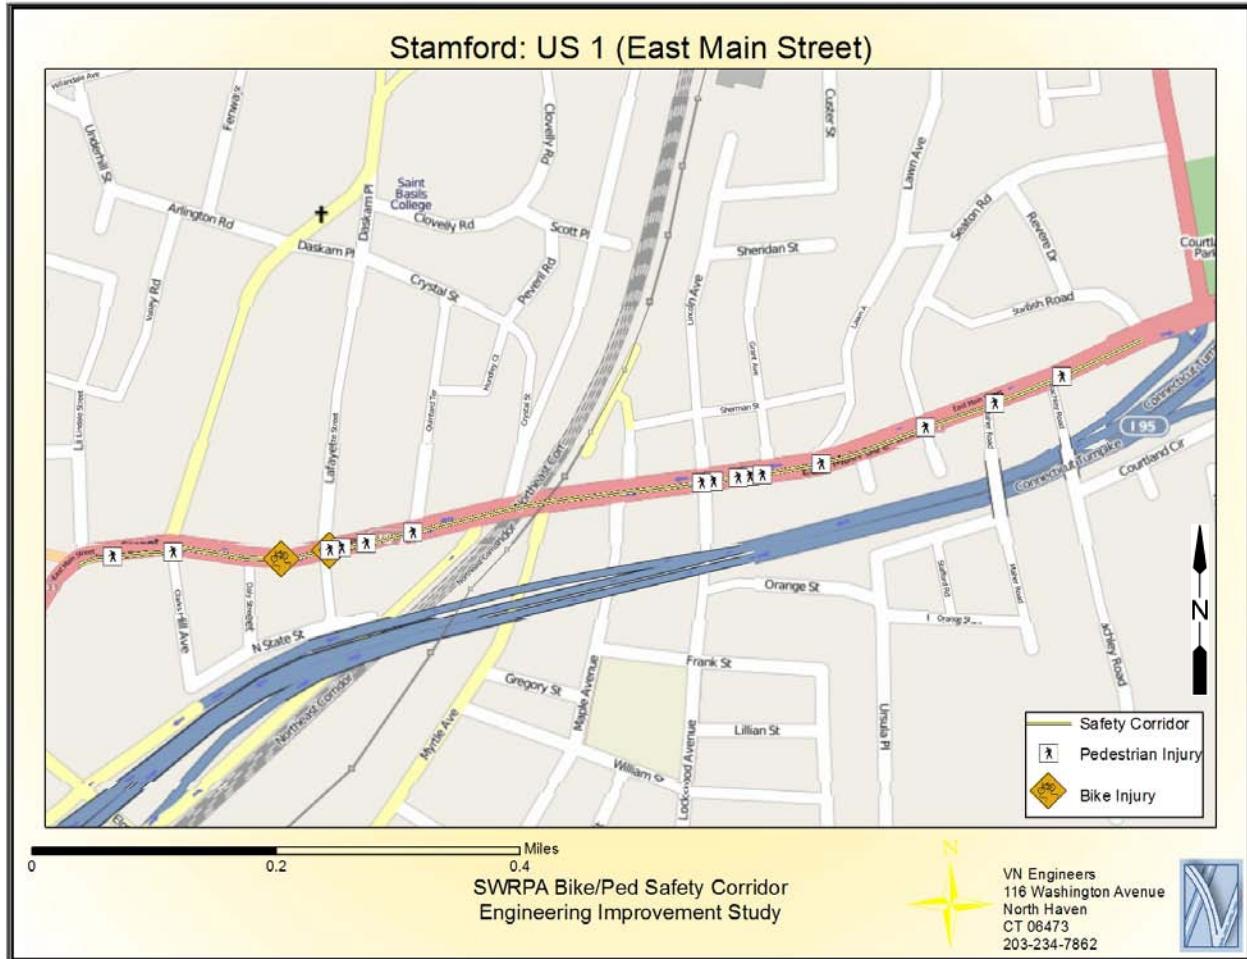
Figure 7: Bicycle/Pedestrian Accident Locations for Stamford US 1 (East Main Street) Corridor

There are significant accident clusters where the cross section changes from two lanes to one, in both directions. For example, there were 9 accidents reported in the 600-foot stretch between Lawn Avenue and Lincoln Avenue (a rate of 82 accidents per mile). These areas are complicated for both pedestrians and vehicles to navigate. Vehicles are turning in and out of driveways while through-moving traffic is merging. Pedestrians are highly exposed because of the number and configuration of driveways combined with the complex driving conditions.

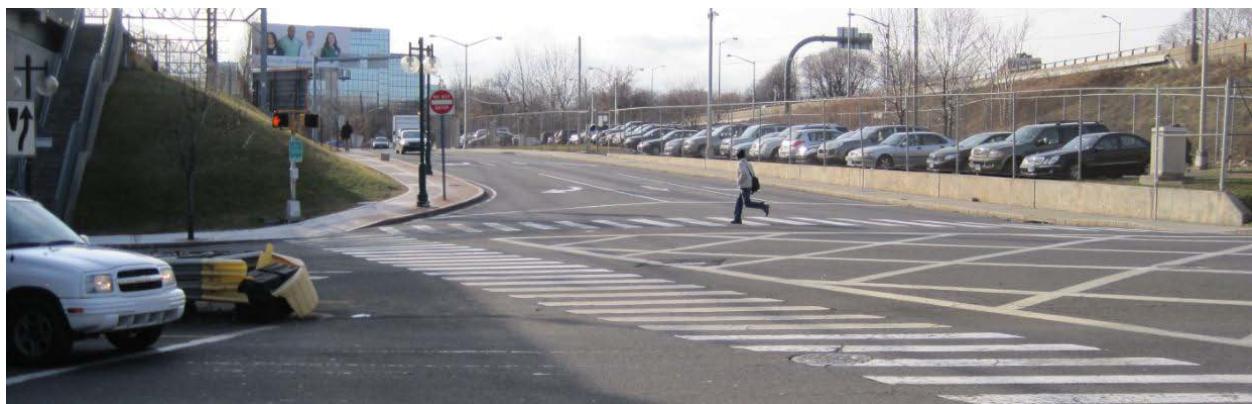
South State Street intersection looking West

Crossing distances over Washington Boulevard vary considerably in the corridor from 56 feet across the south leg of the Bell Street intersection to 125 feet across the south leg of the South State Street intersection, although most crossings are approximately 70 feet. Although some observed pedestrians opted to cross Washington Boulevard at mid-block locations, most used the available pedestrian infrastructure, and waited for the signal to cross.

- Install a channelized right-turn lane on the eastbound approach of the South State Street intersection, similar to the one recently installed for the westbound approach of the North State Street intersection to act as a pedestrian refuge island.
- Consider removing exclusive right-turn lanes at intersections and replacing them with on-street parking and curb extensions. Particular locations to consider include: northbound, southbound and westbound approaches to the Broad Street intersection, and northbound and southbound approaches to Main Street. Figure 12 shows conceptual improvements to the Washington Boulevard at Broad Street intersection.

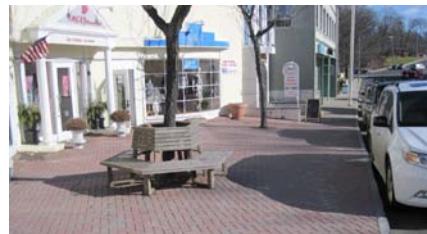
Sidewalks are protected from moving vehicles by on-street parking for roughly half of the corridor, between Main Street and Myrtle Avenue. The level of pedestrian comfort varies from very high on the wide, buffered brick sidewalks in the downtown area, to very low on narrow, more exposed sections. In the northern portion of the corridor pedestrians are vulnerable where sidewalks run adjacent to parking lots and roadways with no buffers to separate pedestrian space from vehicle space. Also contributing to hazardous conditions for pedestrians in this portion are wide driveways and a property (286 Post Road East) with continuous access and angle parking.

Parking protected, brick sidewalk

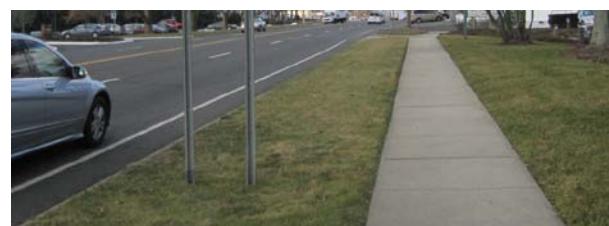
The sidewalk network along this corridor is incomplete, and absent in most locations. Where sidewalks are provided, mostly on the southbound side of the street, they are 5 feet in width and separated from roadway lanes by a grass buffer area that varies in width. Where

Buffered sidewalk

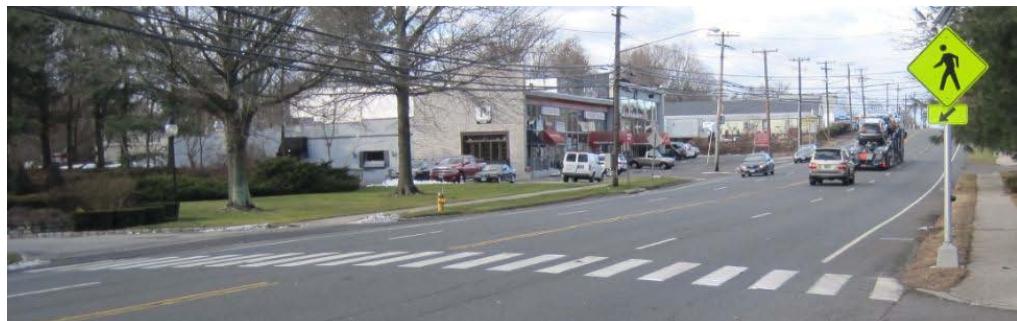
There are four crosswalks over US 1 in this corridor. There are two are signal controlled, crosswalks at the intersections at either end of the corridor, at Buckley Avenue, and Maple Avenue. The other two pedestrian crossings at Lansdowne Condo Road, and Westfair Drive are unsignalized, although there are signs warning drivers of the crossing. The Lansdowne Condo Road crossing also features a flashing sign that is activated by a pedestrian push button. During the walk audit pedestrians were observed crossing with the flashing beacon activated, although it did not appear to cause any drivers to reduce their speed or stop for pedestrians trying to cross. The crosswalks in the corridor are spaced from 700 to 1,300 feet apart.

Flashing pedestrian signal at Lansdowne Condo Road
