# Bicycle-Pedestrian Safety Corridors Study

# FINAL REPORT

## SWRPA BICYCLE - PEDESTRIAN SAFETY CORRIDORS STUDY

June, 2012

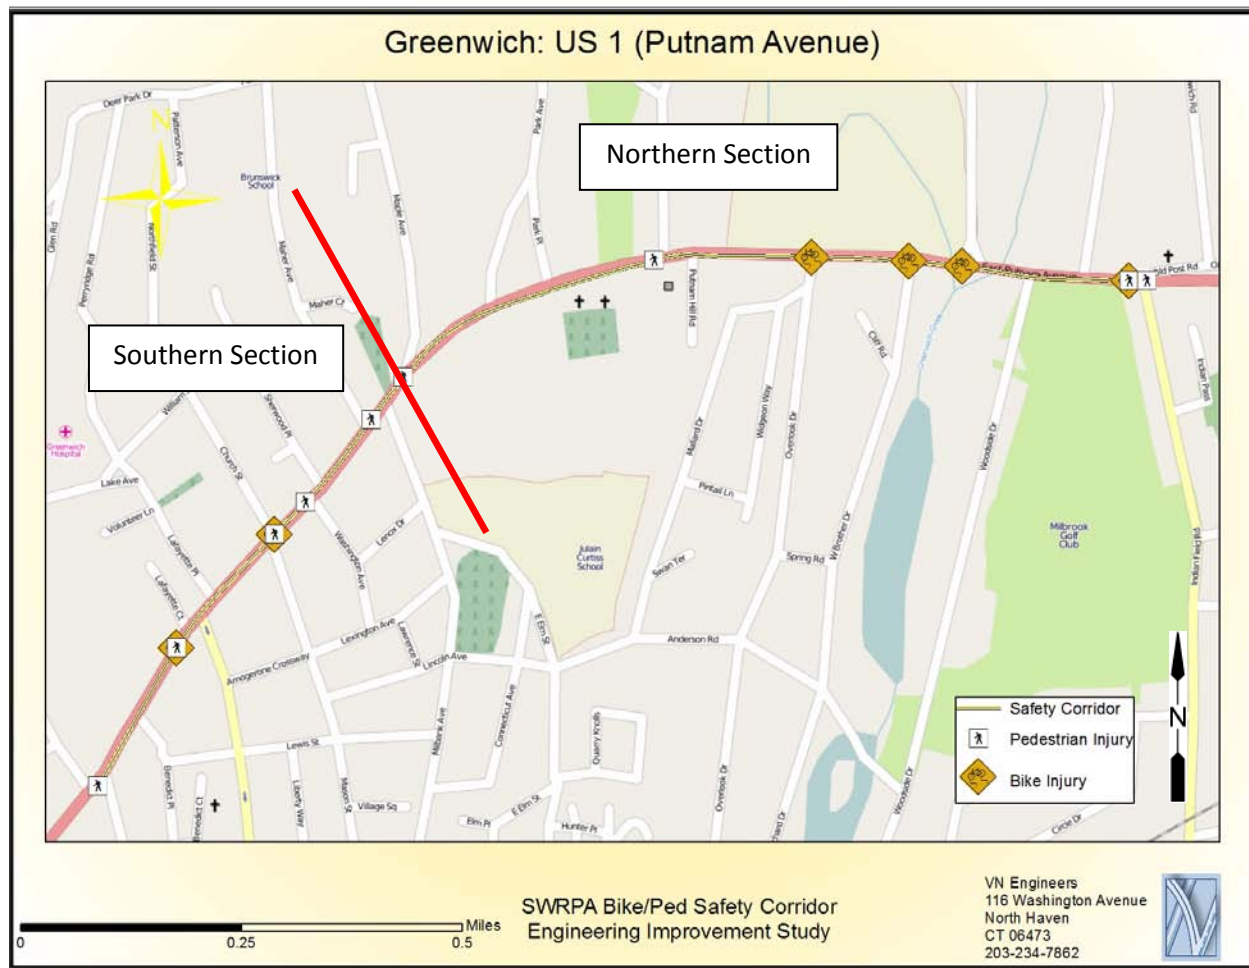
**Figure 1: Bicycle/Pedestrian Accident Locations for Greenwich US 1 (Putnam Avenue) Corridor**

The Milbank Avenue intersection is particularly dangerous for pedestrians. The angle of the slip lanes and the 45-foot turning radius allow for potentially high vehicular speeds. Drivers may be preoccupied with looking left to find a safe gap in traffic, and may not see pedestrians trying to cross from the right. During the walk audit, an elderly pedestrian was observed navigating the Milbank Avenue side street intersection with great difficulty, taking a very indirect route to avoid crossing the slip lanes.

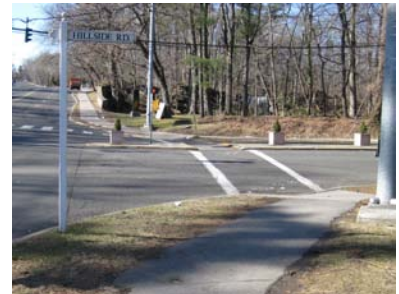
Pedestrian refuge at Hillside Drive

- Install a crosswalk over US 1 on the north leg of the Hillside Road intersection with a pedestrian refuge in the existing striped median.
- As a short-term solution, add sharrows to the outer through lanes on downhill and flat sections and add bike boxes at intersections. Also consider restriping lanes as 11 feet wide and striping a shoulder on uphill sections for use by bicycles. Figure 2 shows a conceptual design incorporating these improvements for US 1 at the Indian Field Road intersection.

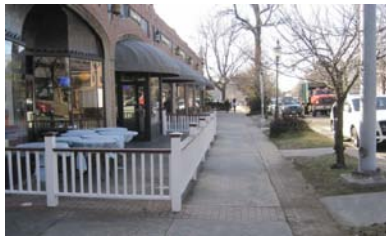
High level of pedestrian comfort in Downtown section

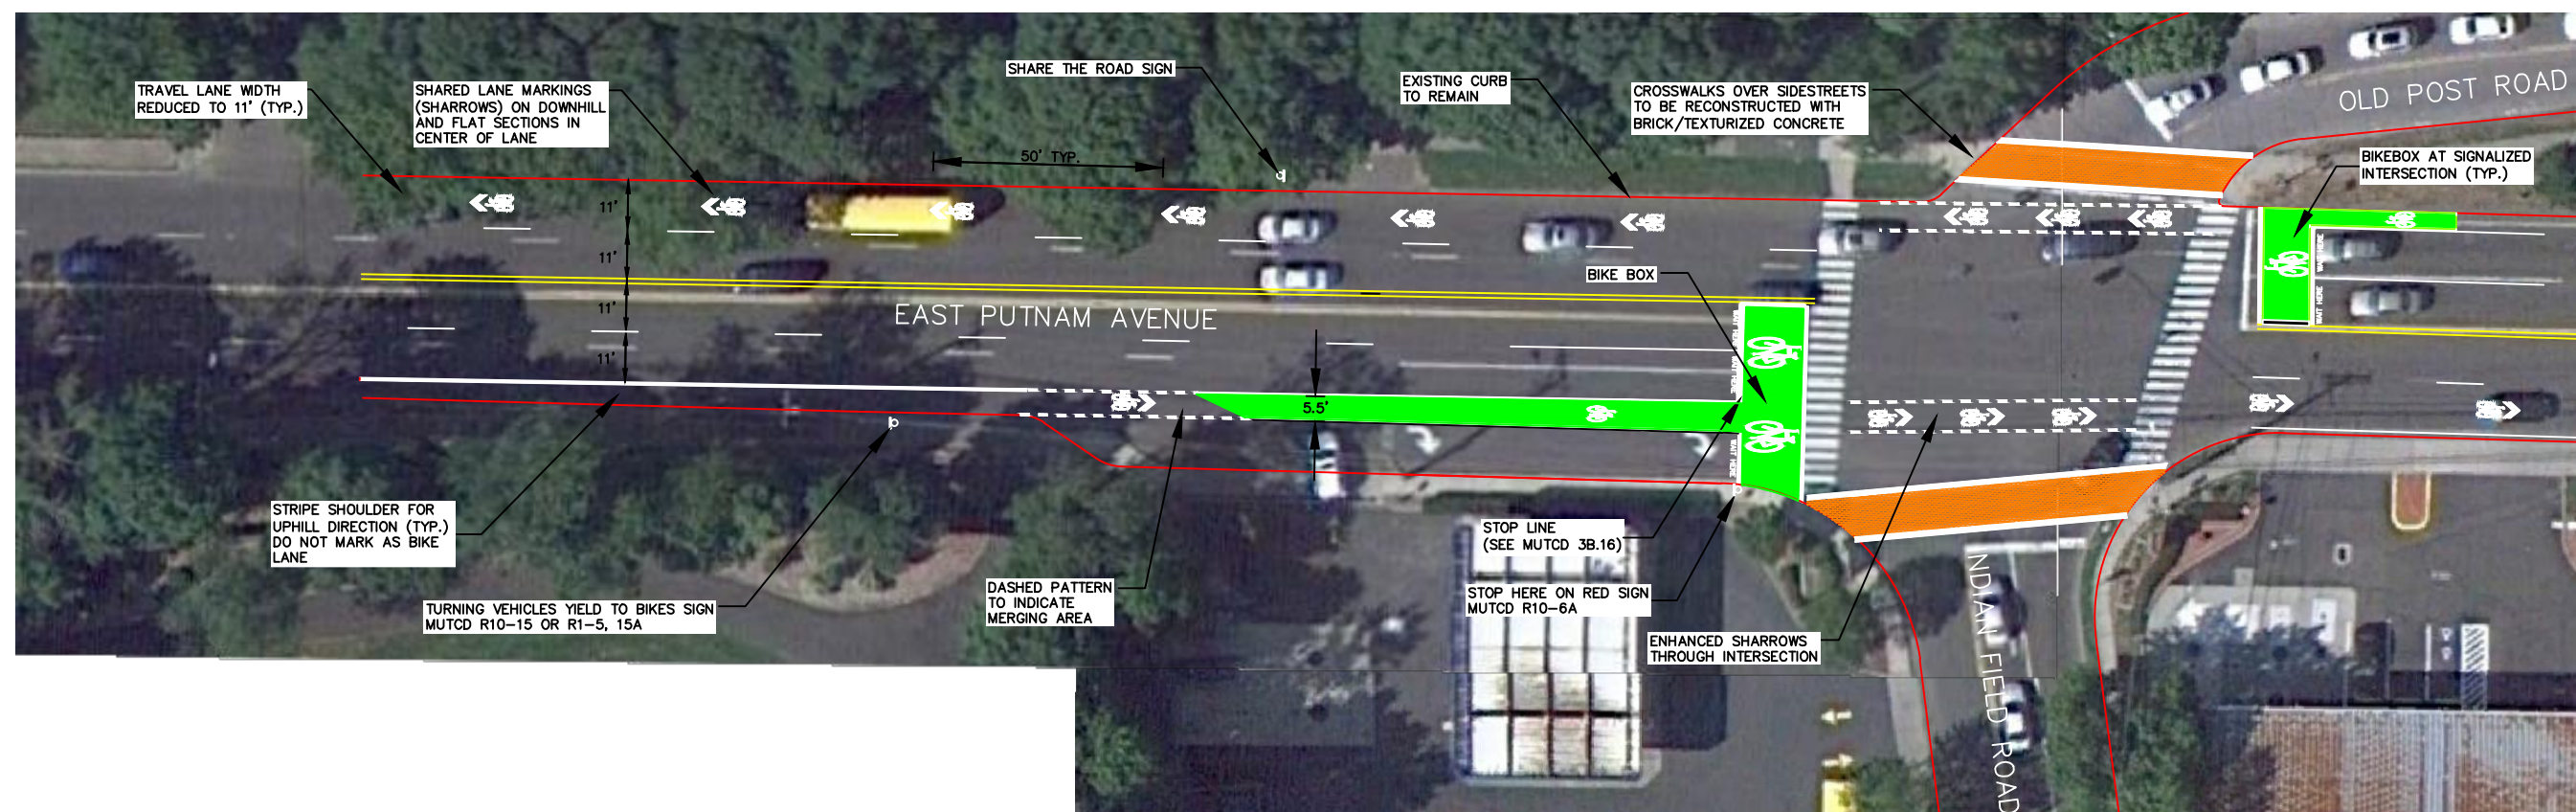
Figure 2: Conceptual Improvements for US 1 at Indian Field Road Intersection  
*Bicycle-Pedestrian Safety Corridors Study*  
*South Western Regional Planning Agency*

Pedestrians observed during the walk audit in this section generally consisted of high school students walking to the Sonoco gas station at the Indian Field Road intersection. To reach the gas station, they must cross US 1. Although most of the observed pedestrians used the Hillside Road crosswalk, none were observed waiting for the pedestrian signal phase. Other pedestrians were observed crossing at unmarked locations, suggesting existing crossings do not offer sufficiently direct routes to destinations.

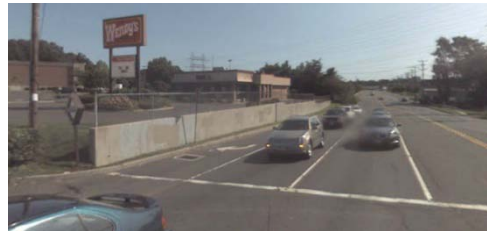
View of southbound right turn lane proposed for replacement with a sidewalk

- Consider removal of the 150-foot southbound US 1 right-turn lane into the Kohl's shopping center access driveway in order to construct a sidewalk. Figure 4 shows this possible improvements in the vicinity of this intersection including the removal of the southbound right-turn lane.

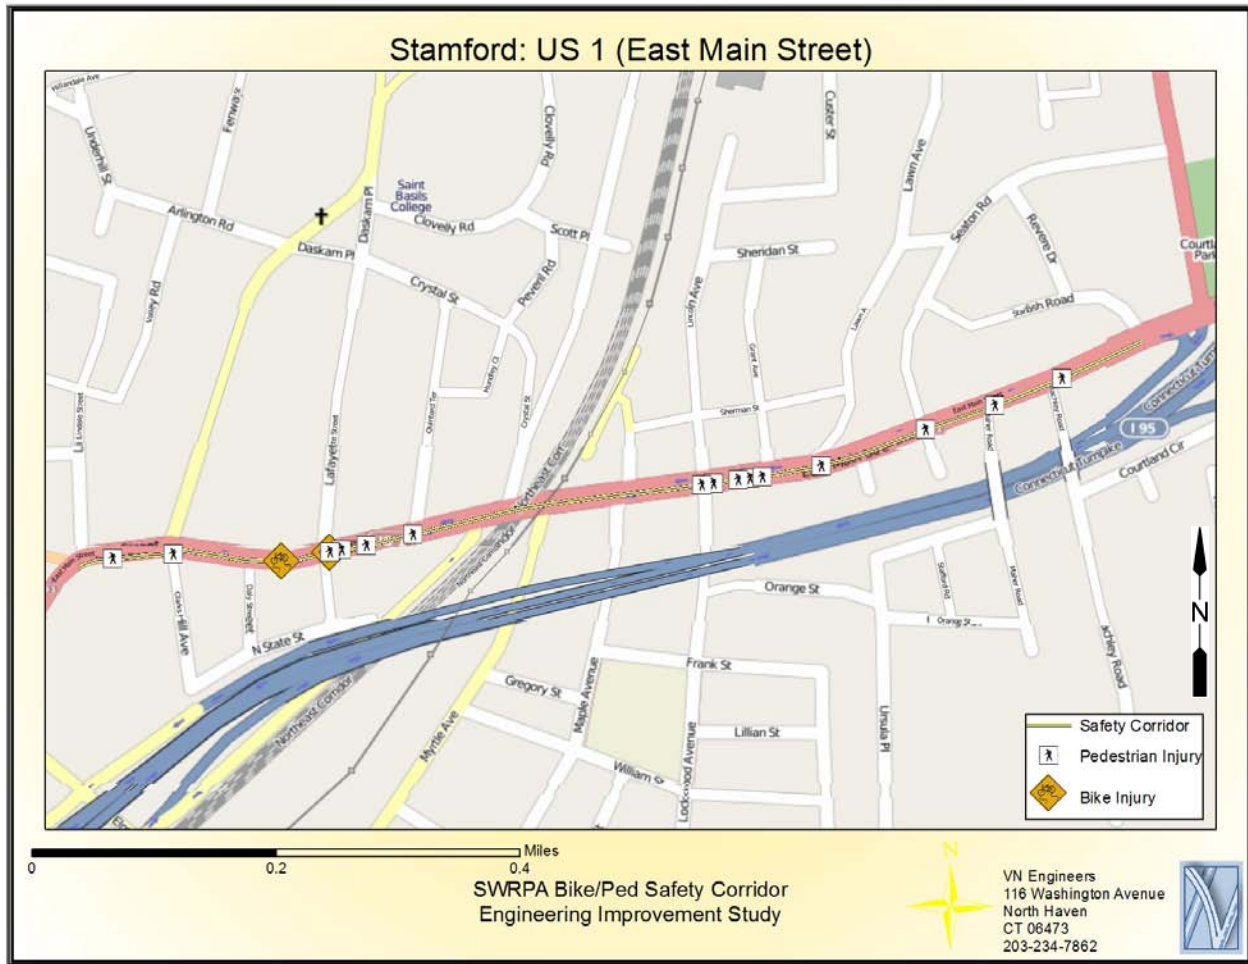
Figure 7: Bicycle/Pedestrian Accident Locations for Stamford US 1 (East Main Street) Corridor

This 0.9-mile long section of US 1 has the highest accident rate of any of the corridors in this study, with 30 reported bike and pedestrian crashes over a three-year period. Pedestrian activity is high in this section, due to the adjacent densely populated neighborhoods, and the wide variety of small businesses in the area.

There are significant accident clusters where the cross section changes from two lanes to one, in both directions. For example, there were 9 accidents reported in the 600-foot stretch between Lawn Avenue and Lincoln Avenue (a rate of 82 accidents per mile). These areas are complicated for both pedestrians and vehicles to navigate. Vehicles are turning in and out of driveways while through-moving traffic is merging. Pedestrians are highly exposed because of the number and configuration of driveways combined with the complex driving conditions.

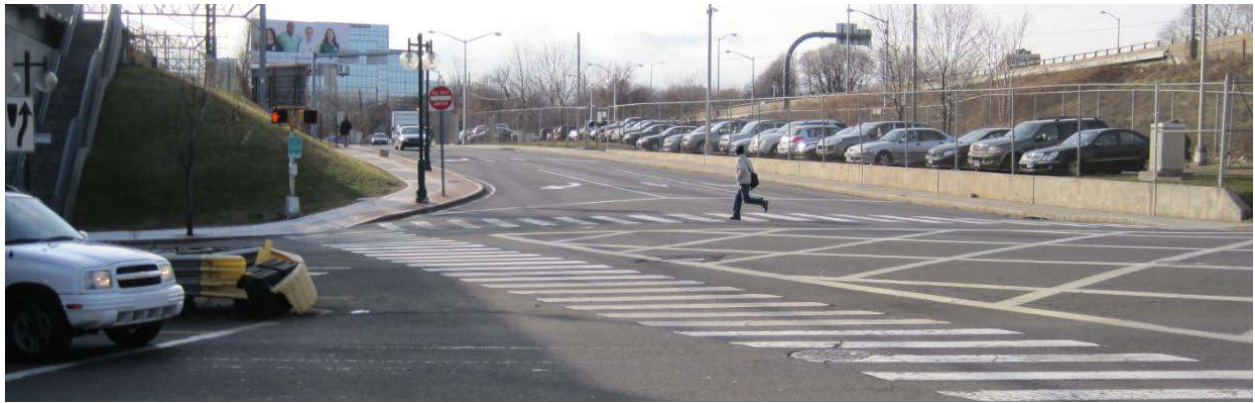
South State Street intersection looking West

Crossing distances over Washington Boulevard vary considerably in the corridor from 56 feet across the south leg of the Bell Street intersection to 125 feet across the south leg of the South State Street intersection, although most crossings are approximately 70 feet. Although some observed pedestrians opted to cross Washington Boulevard at mid-block locations, most used the available pedestrian infrastructure, and waited for the signal to cross.

- Install a channelized right-turn lane on the eastbound approach of the South State Street intersection, similar to the one recently installed for the westbound approach of the North State Street intersection to act as a pedestrian refuge island.
- Consider removing exclusive right-turn lanes at intersections and replacing them with on-street parking and curb extensions. Particular locations to consider include: northbound, southbound and westbound approaches to the Broad Street intersection, and northbound and southbound approaches to Main Street. Figure 12 shows conceptual improvements to the Washington Boulevard at Broad Street intersection.

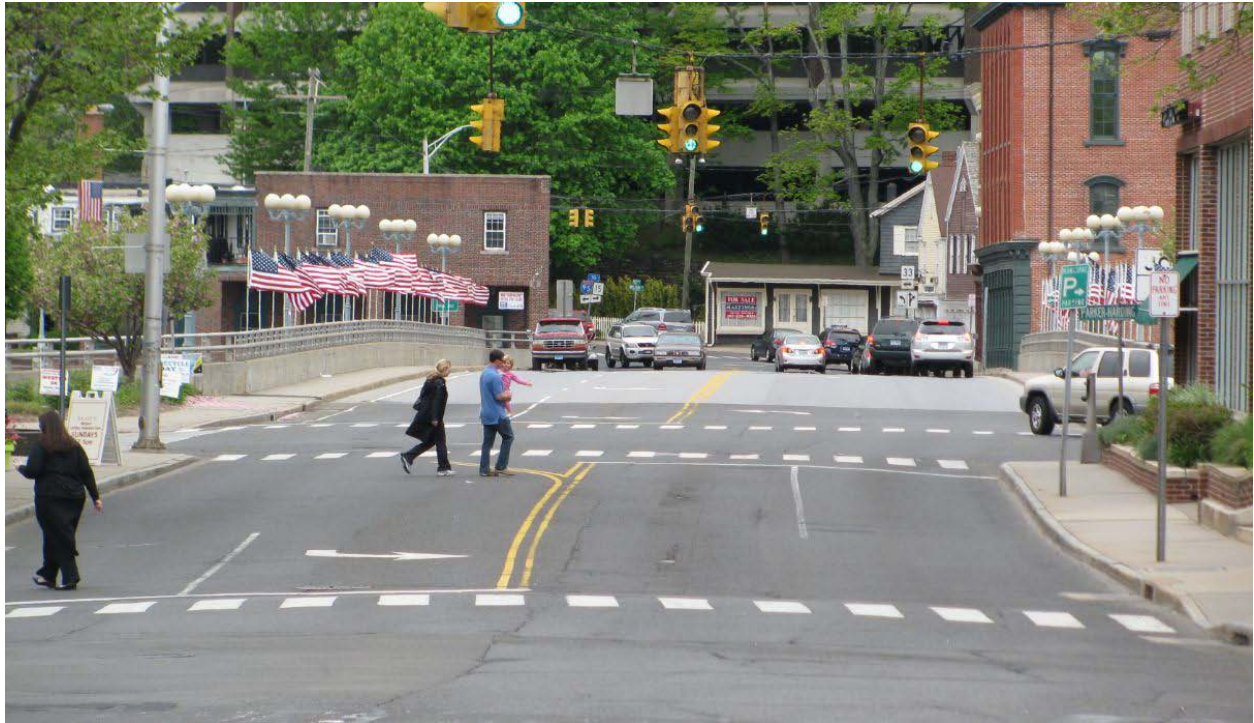
View from downtown area towards Riverside Avenue intersection

- Ensure that the revision planned for the traffic signal at the Riverside Avenue intersection will provide an exclusive pedestrian phase, with pedestrian signal heads, push buttons, and ADA compliant curb ramps for all of the proposed crosswalks. A curb extension for the crosswalk over the north leg of US 1 combined with a smaller curb radius for the right turn from Riverside Avenue onto northbound US 1 would also improve safety conditions for pedestrians as visibility would be improved and vehicular speeds would be reduced.

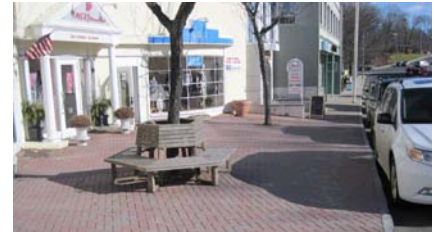
Parking protected, brick sidewalk

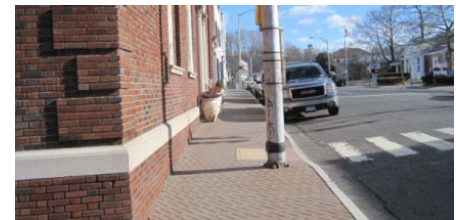
Parked vehicle obscuring pedestrian-driver visibility where parking is allowed up to crosswalk

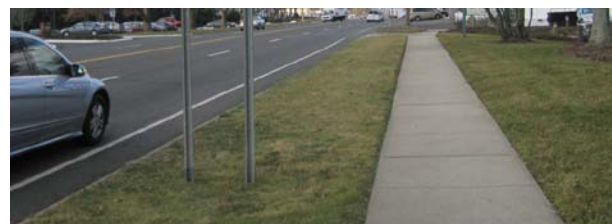
The sidewalk network along this corridor is incomplete, and absent in most locations. Where sidewalks are provided, mostly on the southbound side of the street, they are 5 feet in width and separated from roadway lanes by a grass buffer area that varies in width. Where

Buffered sidewalk

- To the extent possible given the existing access configuration, complete the pedestrian network by installing sidewalks where they are currently missing.

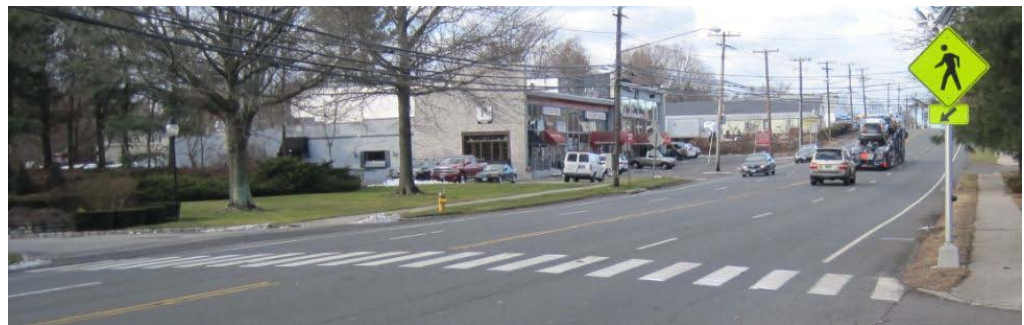
There are four crosswalks over US 1 in this corridor. There are two are signal controlled, crosswalks at the intersections at either end of the corridor, at Buckley Avenue, and Maple Avenue. The other two pedestrian crossings at Lansdowne Condo Road, and Westfair Drive are unsignalized, although there are signs warning drivers of the crossing. The Lansdowne Condo Road crossing also features a flashing sign that is activated by a pedestrian push button. During the walk audit pedestrians were observed crossing with the flashing beacon activated, although it did not appear to cause any drivers to reduce their speed or stop for pedestrians trying to cross. The crosswalks in the corridor are spaced from 700 to 1,300 feet apart.

Flashing pedestrian signal at Lansdowne Condo Road
