ROAD SAFETY AUDIT

New Fairfield—Gillotti Road

September 21, 2016

Western Connecticut
Council of Governments

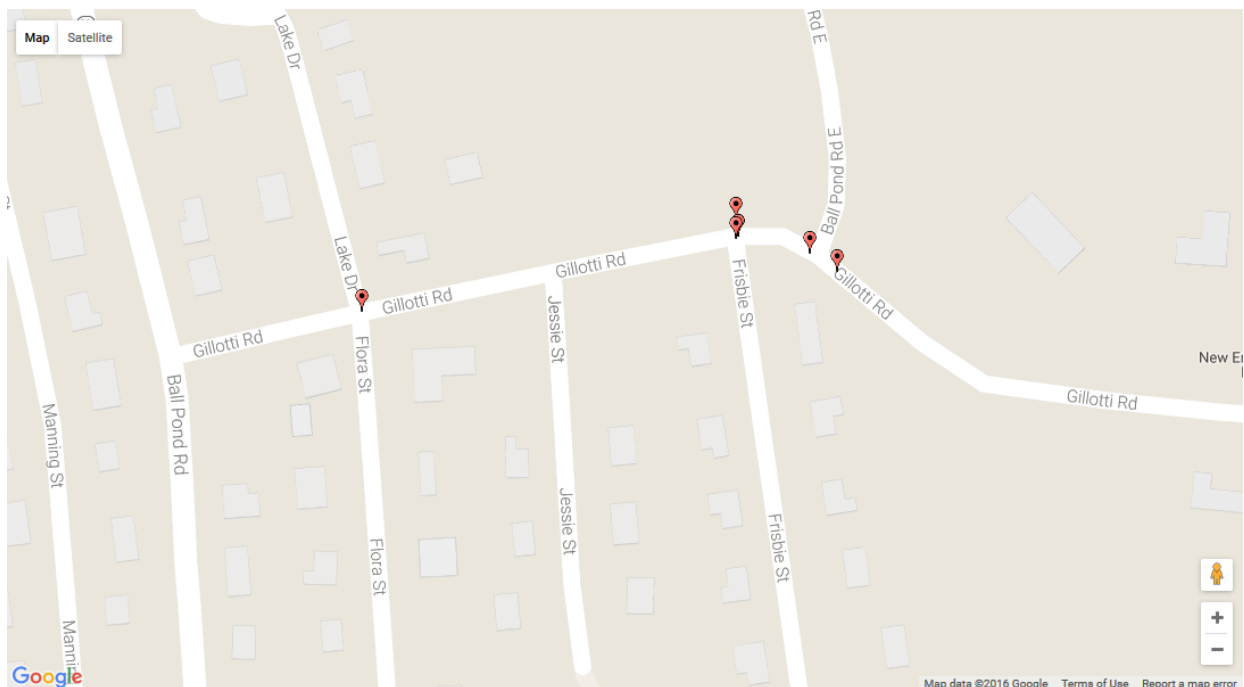
Figure 2. All Crashes from 2015 to present (Source: Connecticut Crash Data Repository)

Between 2013 and March 2016, there were 16 vehicles crashes in the RSA area. Table 1 and Table 2 provide information on the crashes that occurred on Gillotti Road between two different time periods: 2013 to 2014; and 2015 to present, respectively. These tables are separated because the State of Connecticut began using a new reporting format, the Model Minimum Uniform Crash Criteria, in 2015. Figure 2 displays crashes that occurred from 2015 to present; there is a cluster of crashes evident near one end of the “S curve” at the Ball Pond Road East and Frisbie Street intersections.

Out of the sixteen total crashes, eleven resulted in property damage and five resulted in injuries. No fatalities were reported and there were no crashes involving pedestrians or cyclists. Two crashes involved motorists that lost control of their vehicle, veered off the roadway and struck a fence. Inclement weather played a role in safety issues on Gillotti Road with road surface conditions (wet, icy, snow, slush) contributing to twelve of the reported crashes. In addition, twelve crashes involved striking fixed objects including curbing, fences, walls, ledges and utility poles. Additional information on each of the reported crashes that have occurred on Gillotti Road can be found in the appendix.
